DBC Building Inspection Report

Date: 11/28/2007

Location:	Ft Campbell, KY		
Building Name:	CSG Barracks		
Building Address	CSG Barracks Complex		
Building Number	6752, 6756		
Beneficial Occupancy Date	Apr-07		
Local POC:	Miller Moore, USACE		
DBC Inspection Team Lead	Mike Grussing, ERDC-CERL		
DBC Inspection Team Members:			
	1	Mike Grussing	
	2	Sam Hunter	
	3		
Inspection Date Start	11/7/2007	Inspection Date Complete	11/7/2007
Baseline / Pilot	Baseline	Inspection #	1
Inspection Weather:	Sunny, 43 deg Farenheit		
Resulting Initial BCI:	Combined BCI of both buildings = 99 (0-100 scale)		
Inspection Process Discription:	BUILDER Visual Distress Survey Inspection Process. Inspector observed distresses with input from building occupants/users.		
Comments:	<p>The survey encompassed all systems of physical fitness center on site. The initial component inventory for the building was developed previous to the site visit using construction drawings, and inventory was verified and adjusted during site-visit. The assessment scope included all aspects of the building deemed real property, including civil/structural, electrical, mechanical, and roofing. Overall building conditions for the init

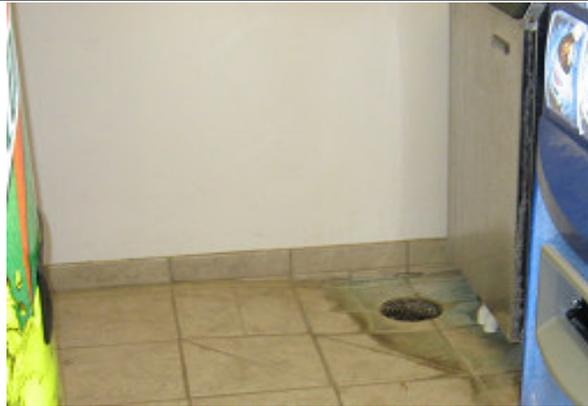
Water Stains on tile around floor drain near ice machine

Last Inspection Date: 11/7/2007 **Used Sampling?** No
Inspector: Sam Hunter **Inspection Source:** Inspection
Inspection Comments: Rm 106 VCT flooring has heavy localized staining due to inadequate ice machine drainage.

Last Inspection Date: 11/7/2007 **Used Sampling?** No
Inspector: Sam Hunter **Inspection Source:** Inspection
Inspection Comments: Rm 223 VCT flooring has heavy localized staining due to inadequate ice machine drainage.

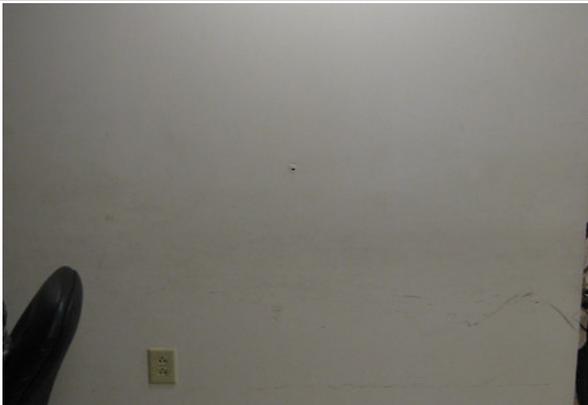
Gouges/Damage on gypsum wall board behind front desk

<i>Last Inspection Date:</i> 11/7/2007		<i>Used Sampling?</i> No		
<i>Inspector:</i> Sam Hunter		<i>Inspection Source:</i> Inspection		
<i>Inspection Comments:</i> Walls behind CQ desk have dents and gouges				
<i>SubComponent:</i> Surface	<i>Paint Rating:</i> N/A	<i>SubComponent Defect Free?</i> No

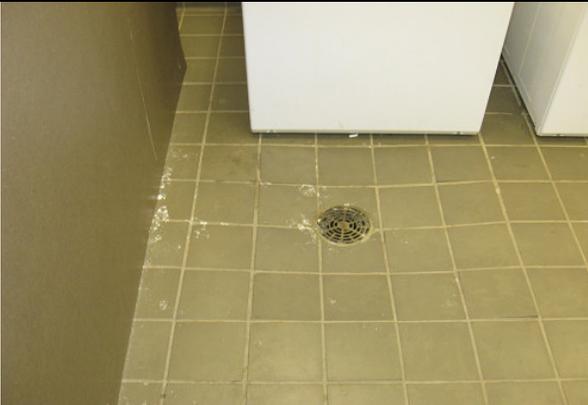
Stains on tile/grout in laundry rooms

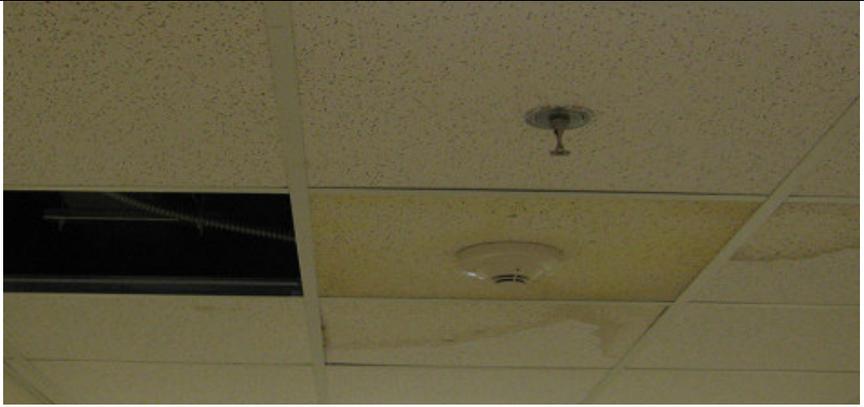
Water damage in ceiling tiles
above sprinkler head, hallway
bldg 6752

Last Inspection Date: 11/7/2007	Used Sampling? No
Inspector: Sam Hunter	Inspection Source: Inspection
Inspection Comments: The Acoustical ceiling tile ceiling on the third floor 'long' hallway is has 1 missing tile, 4 with heavy water stains, and 8 tiles located at a fire sprinkler are displaced.

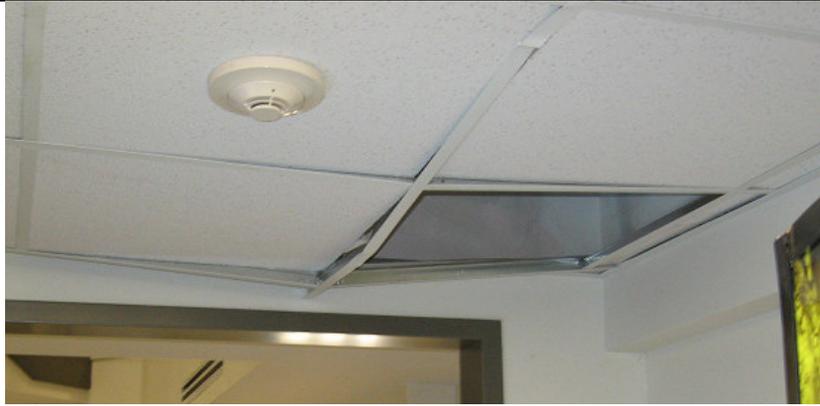
Damaged/bent ceiling tile track
with displaced tiles, vending area
bldg 6752

<i>Last Inspection Date:</i> 11/7/2007	<i>Used Sampling?</i> No
<i>Inspector:</i> Sam Hunter	<i>Inspection Source:</i> Inspection
<i>Inspection Comments:</i> Short hallway has 3 gouged tiles. Rm 106 has 2 missing tiles, 2 displaced tiles, and bent framing.
