DBC Building Inspection Report

Date: 11/28/2007

Location:	Ft Campbell, KY		
Building Name:	SOAR Barracks		
Building Address	SOAR Barracks Complex		
Building Number	2992, 2993		
Beneficial Occupancy Date	Oct-07		
Local POC:	Miller Moore, USACE / Joe Nash, Facility Services Inc (FSI)		
DBC Inspection Team Lead	Mike Grussing, ERDC-CERL		
DBC Inspection Team Members:			
	1	Mike Grussing	
	2	Sam Hunter	
	3		
Inspection Date Start	11/6/2007	Inspection Date Complete	11/6/2007
Baseline / Pilot	Baseline	Inspection #	1
Inspection Weather:	Sunny, 45 deg Farenheit		
Resulting Initial BCI:	Combined BCI of both buildings = 100 (0-100 scale)		
Inspection Process Discription:	BUILDER Visual Distress Survey Inspection Process. Inspector observed distresses with input from building occupants/users.		
Comments:	<p>The survey encompassed all systems of physical fitness center on site. The initial component inventory for the building was developed previous to the site visit using construction drawings, and inventory was verified and adjusted during site-visit. The assessment scope included all aspects of the building deemed real property, including civil/structural, electrical, mechanical, and roofin

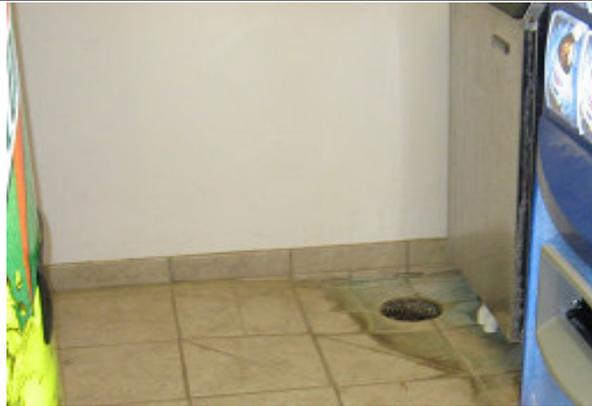
Water Stains on tile around floor drain near ice machine

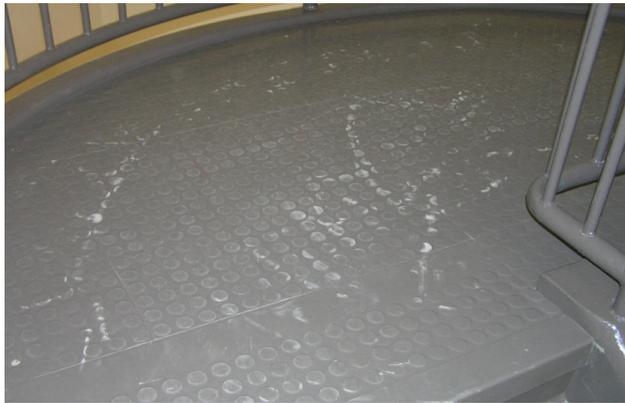
Gouges/Damaged stair treads from furniture move
