**Environmental Condition of Property Update Report
Armed Force Reserve Center (IL027)
7402 W. Roosevelt Road, Forest Park, Illinois 60130**

**Environmental Documentation in Support of
U.S. Army Reserve Facility Disposals**

January 2022

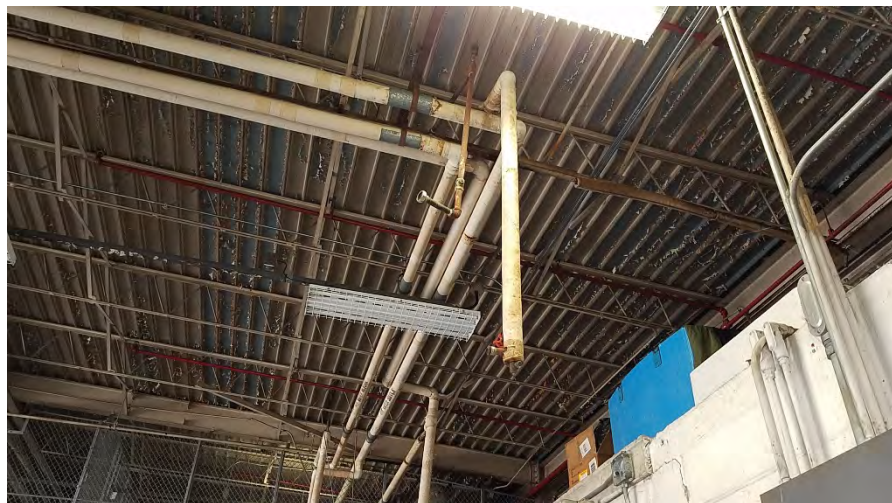
47. Metal sheet ceiling inside the OMS. Peeling paint and potentially damaged pipe insulation.

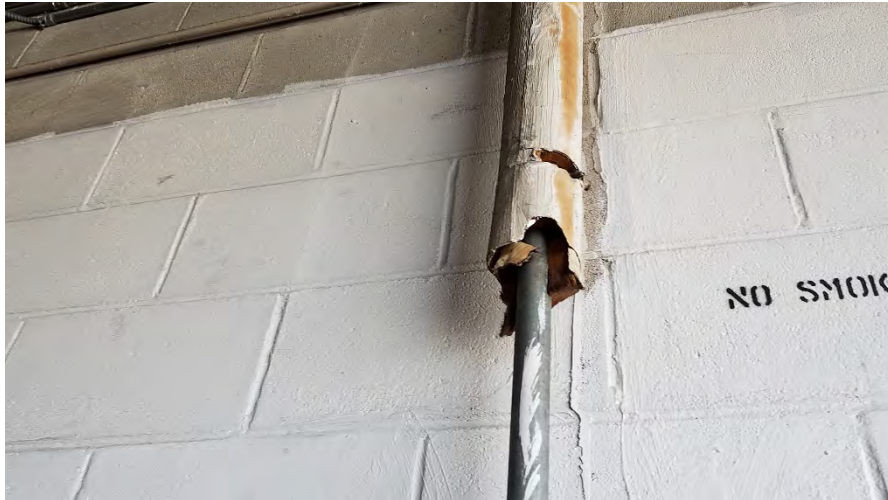
49. Damaged pipe insulation inside the OMS

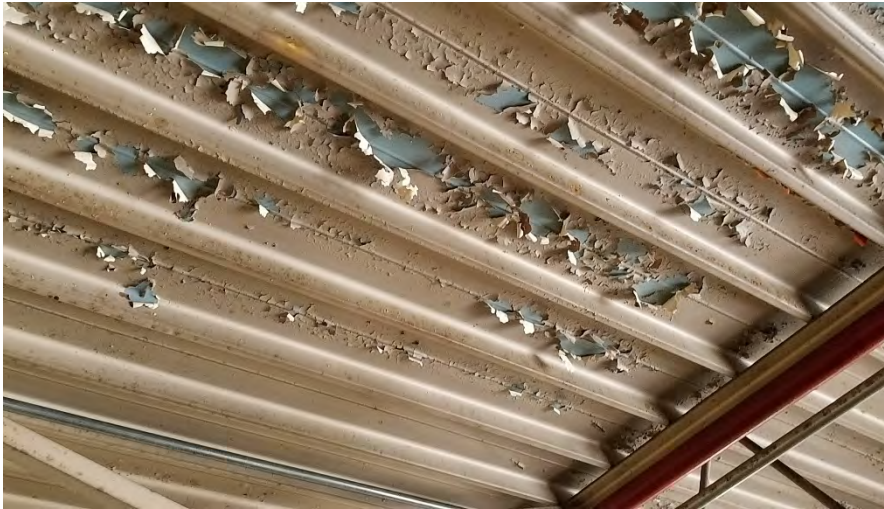
55. Peeling paint from the metal ceiling of the OMS. Based on the age of the building, the paint may contain lead

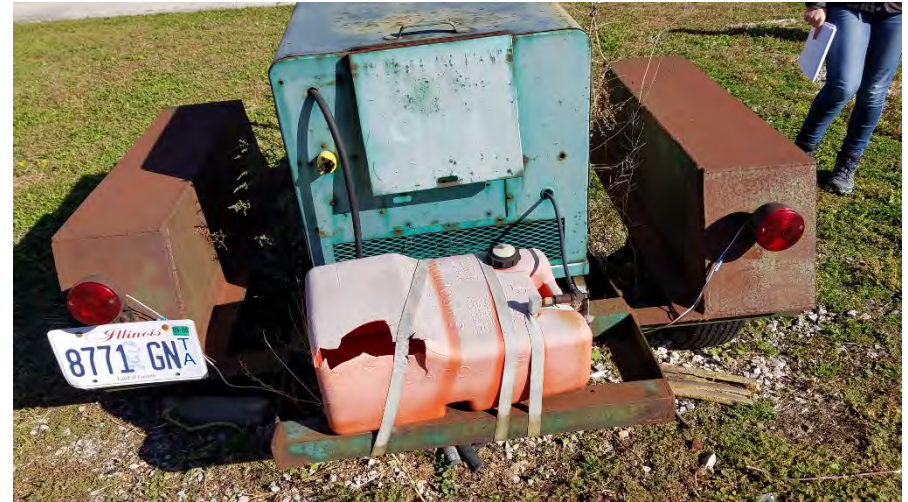
66. Abandoned gasoline powered generator present near the former wash rack area. No visible signs of leak or discoloration was observed around the generator. Below image from 03 June 2021 depicts absence of the generator in the area.

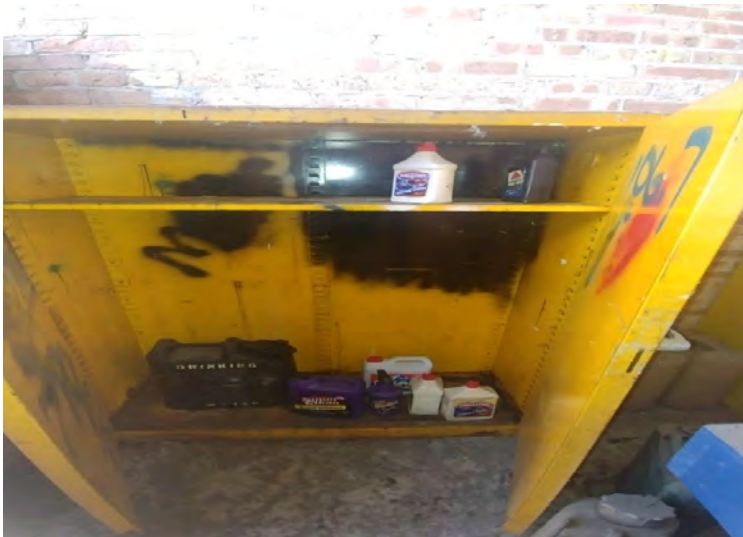
69. Hazardous materials storage cabinet 1 - charcoal lighter fluid, motor oil, degreaser, water canister. Below image from 03 June 2021 depicts absence of materials from the Navy Storage Building.

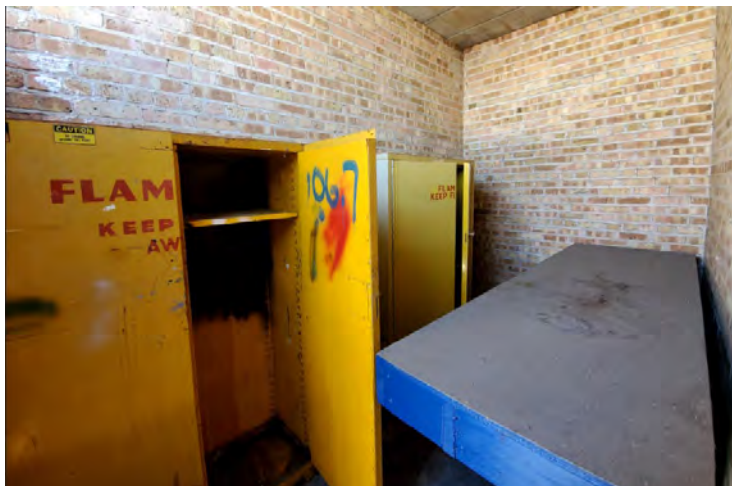
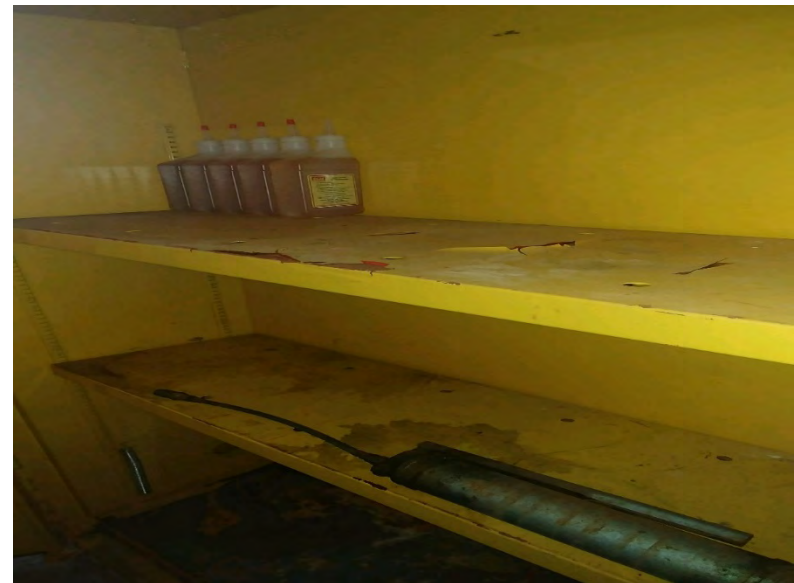
70. Hazardous materials storage cabinet 2 – shredder Oil, Tire pump. Below image from 03 June 2021 depicts absence of materials

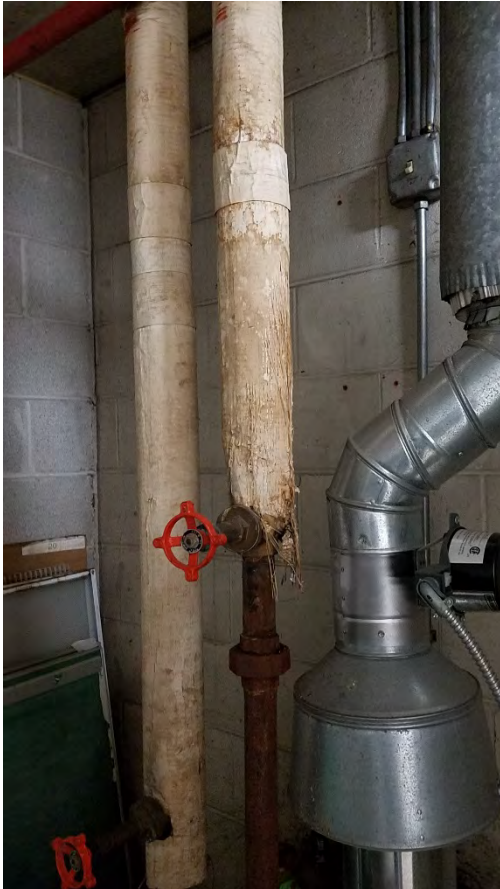
81. Damaged Thermal System Insulation (TSI) in the boiler room in the Admin Building

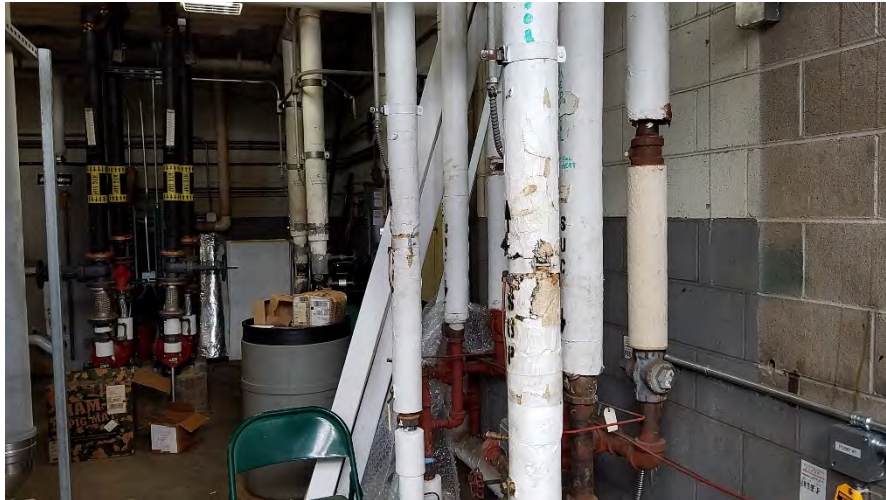
85. Damaged TSI in the boiler room

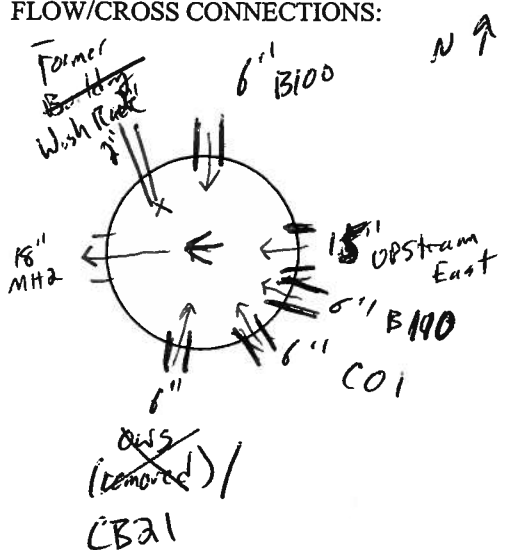
<div style="margin-left: 20px;"> <p>COMMENTS:</p> <p><i>7303-7308</i></p> <p><i>7203-7208</i></p> <p>- 2" connection to NW is abandoned. Probably formerly connected to removed wash rack.</p> <p>- Debris on bench</p> </div> </div>

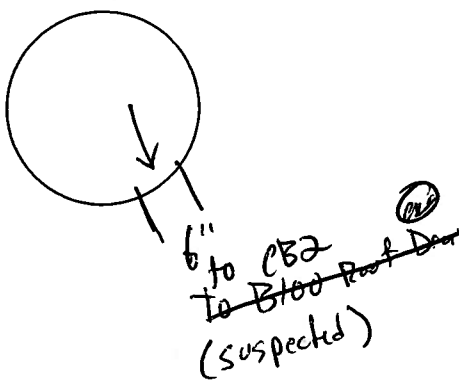
</div> <div style="flex: 1;"> COMMENTS: <u>7227-7229</u> <u>Manhole corer broken through in place after FM granted permission to gain access to manhole. Corer was used to frame heavy debris in manhole and line.</u> <u>Line may be abandoned.</u> </div> </div>

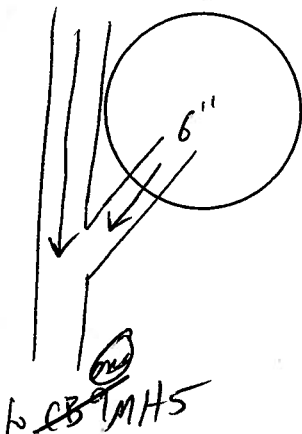
<p>to CB11 MH5</p>		<p>7258-7259</p> <p>Could not open cover, stuck to frame.</p>

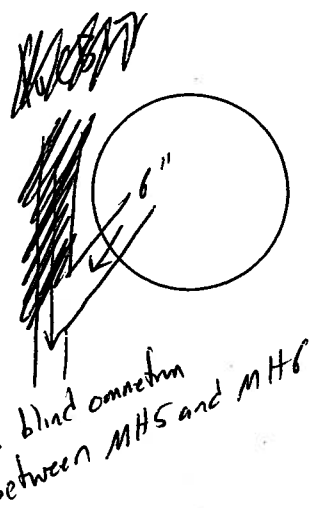
<p style="margin-top: 10px;">to blind connection between MHS and MHS</p> </div> <div style="width: 50%;"> <p style="font-size: 1.2em; margin-top: 0;">7251-7252</p> <p style="margin-top: 10px;">Could not open cover, stuck to frame.</p> </div> </div>

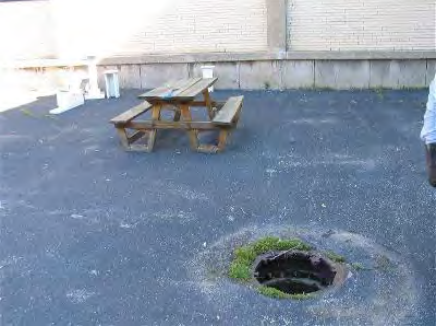
Photograph ID: 32 Date: May 21, 2008 Location: Catch Basin CB3 Direction: North Comments: An exterior view of catch basin CB3 (after cover was broken in for access).

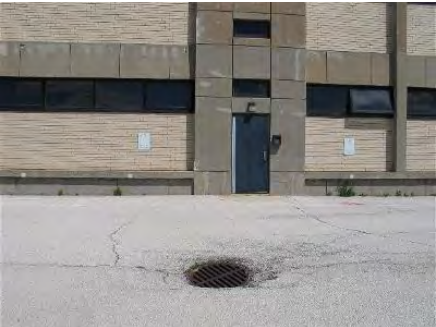
Photograph ID: 66 Date: May 21, 2008 Location: Catch Basin CB20 Direction: North Comments: An exterior view of catch basin CB20. Note that the southwest portion of the catch basin has collapsed significantly and the area around CB20 is very distorted and damaged.

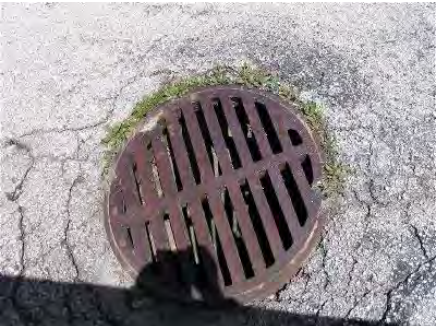
Photograph ID: 67 Date: May 21, 2008 Location: Catch Basin CB20 Direction: North (Top) Comments: View of catch basin CB20. The cover was stuck to the frame (possibly paved) and could not be opened after several attempts.
