USACE Savannah District's Quick Response to Reported Petroleum at Buxton Beach

On Tuesday, September 10, 2024, the U.S. Army Corps of Engineers, Savannah District, deployed a four-person team to Buxton Beach to respond to a reported petroleum release at the former Buxton Naval Facility, a Formerly Used Defense Sites property located within the Cape Hatteras Seashore in Dare County, North Carolina. The team arrived on-site Wednesday morning and coordinated with National Park Service personnel, who had proactively increased the beach closure area to ensure public safety. The team stayed on-site until September 22, 2024.

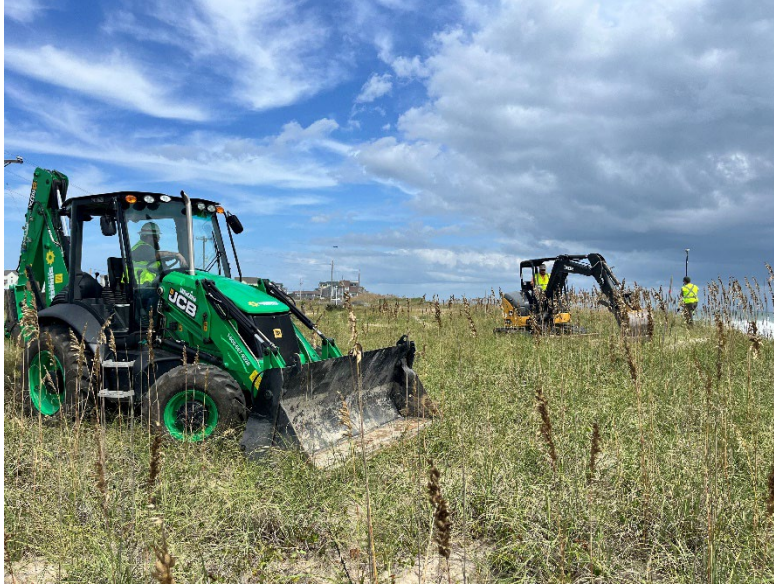
The USACE team consisted of two professional geologists and two heavy equipment operators tasked with limiting petroleum releases into the Atlantic Ocean and conducting a limited test pit investigation to identify the extent of the petroleum. To conduct site operations, an excavator and backhoe were mobilized to the site. **Photo 1** is a picture of the equipment mobilized on Buxton Beach.

Photo 1. Equipment Mobilized to Buxton Beach, September 12, 2024

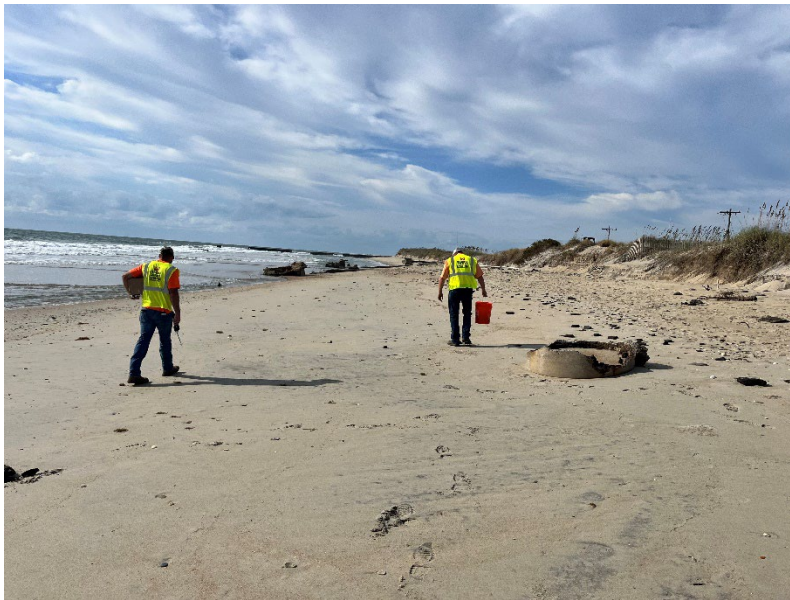
The team conducted visual inspections of the beach front, including along and around the exposed infrastructure for signs of an active or potential petroleum release (e.g. odors, stained soils, and/or sheens). A photoionization detector (PID) and field test kits were also used to detect petroleum. **Photo 2** shows the USACE team conducting a beach inspection. The team did not identify any ongoing petroleum releases due to recent sand accumulation along the beach.

Photo 2. USACE Team conducts a beach inspection, Buxton Beach, September 12, 2024

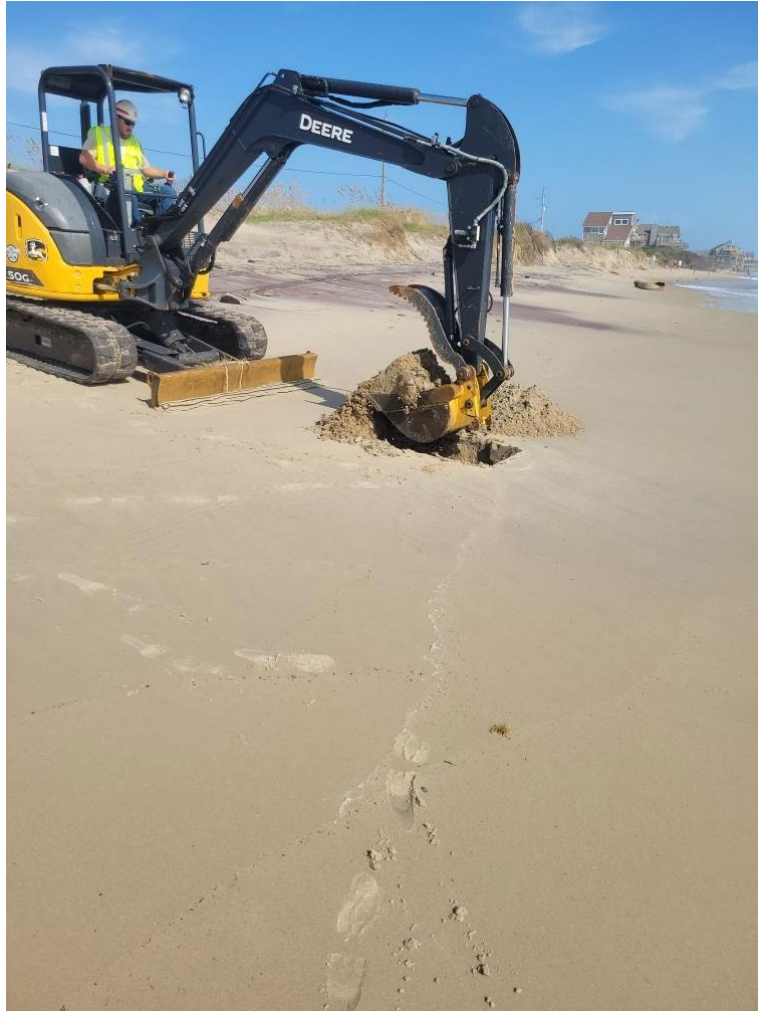
The team conducted a limited test pit investigation to better define the extent of petroleum in the subsurface and to inform the follow-up response action. The response action is currently underway by a contractor which involves the removal of petroleum-impacted soil. The USACE team excavated 62 test pits along the beach and behind the dune area as shown in **Figure 1**. Test pits were excavated with hand tools and heavy equipment, with each pit generally excavated to the top of the water table. The test pits were then examined for evidence of petroleum, such as odors, staining, sheens, PID response, and/or screening with the field test kits. Petroleum-impacted soil was observed in the subsurface in two areas - an area around the northern footprint of building 19 and an area slightly south of the building 19 footprint. The petroleum-impacted soil was generally observed at the water table. **Photo 3** shows a test pit excavation using the compact excavator.

Photo 3. Test pit excavation on Buxton Beach, September 18, 2024.
