**FINAL**  
**FIRST FIVE-YEAR REVIEW REPORT FOR**  
**CP CROFT**  
**(also known as Camp Croft)**

**FORMERLY USED DEFENSE SITE**  
**(FUDS PROPERTY NO. I04SC0016)**

**SPARTANBURG, SOUTH CAROLINA**

**U.S. Army Corps of Engineers, Savannah District**

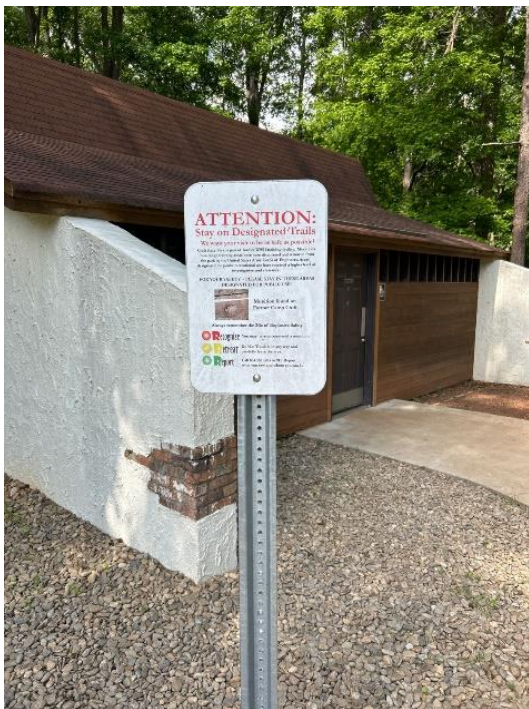
| <b>Photo No.</b><br><b>01</b> | <b>Date:</b><br>05/30/2023 | |

| <b>Description:</b><br>Project 7, Sign A22 - In good condition adjacent to park center | | |

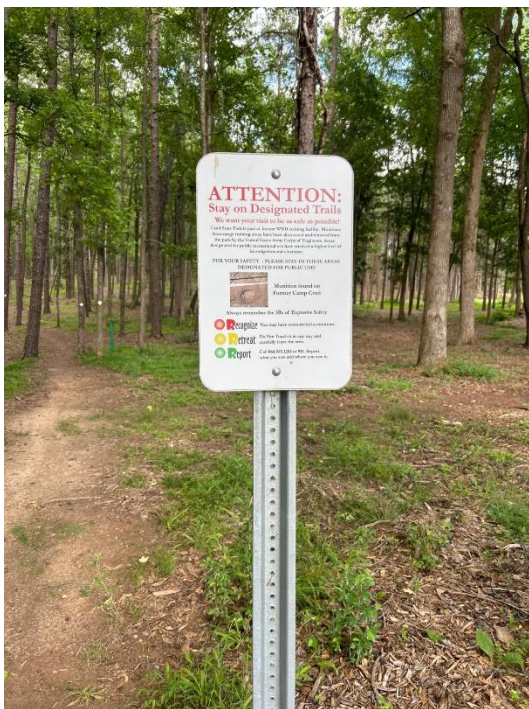
| <b>Photo No.</b><br><b>02</b> | <b>Date:</b><br>05/30/2023 | |

| <b>Description:</b><br>Project 7, Sign A26 - In good condition | | |

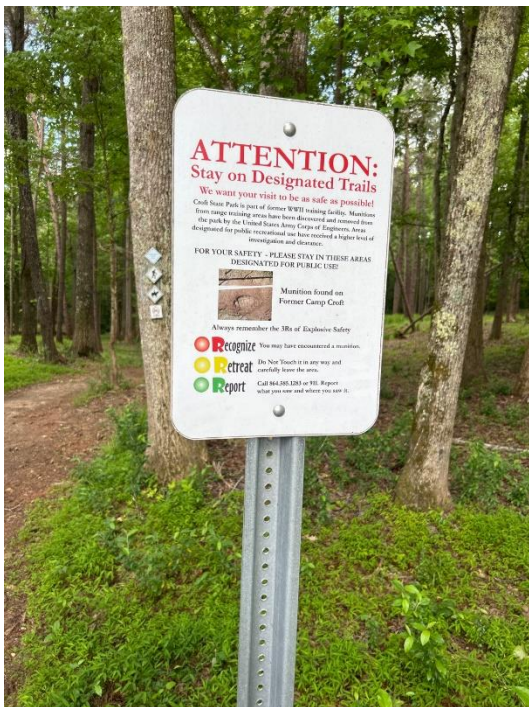
| <b>Photo No.</b><br><b>03</b> | <b>Date:</b><br>05/30/2023 | |

| <b>Description:</b><br>Project 7, Sign A17 - In good condition | | |

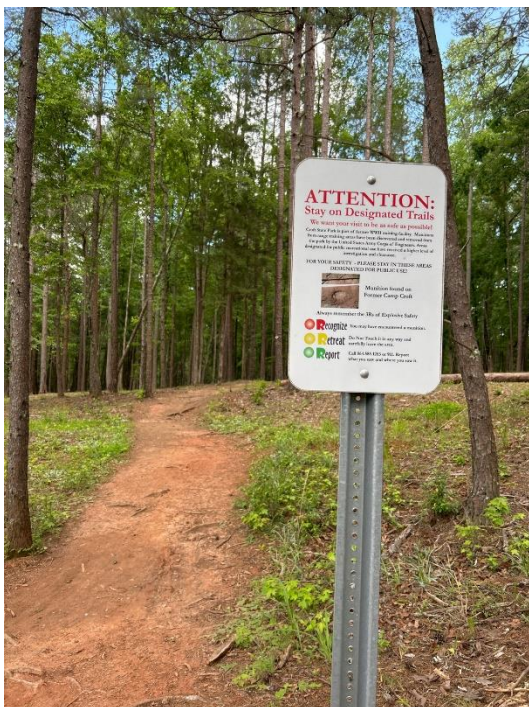
| <b>Photo No.</b><br><b>04</b> | <b>Date:</b><br>05/30/2023 | |

| <b>Description:</b><br>Project 7, Sign A16 - In good condition | | |

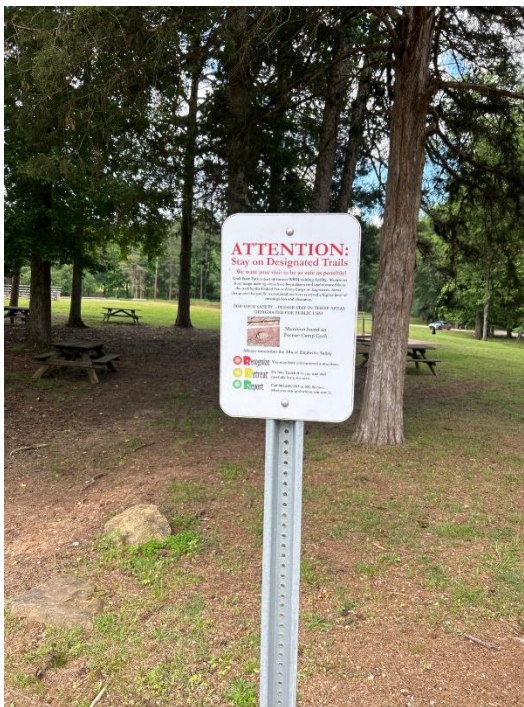
| <b>Photo No.</b><br>05 | <b>Date:</b><br>05/30/2023 | |

| <b>Description:</b><br>Project 7, Sign A21 - In good condition | | |

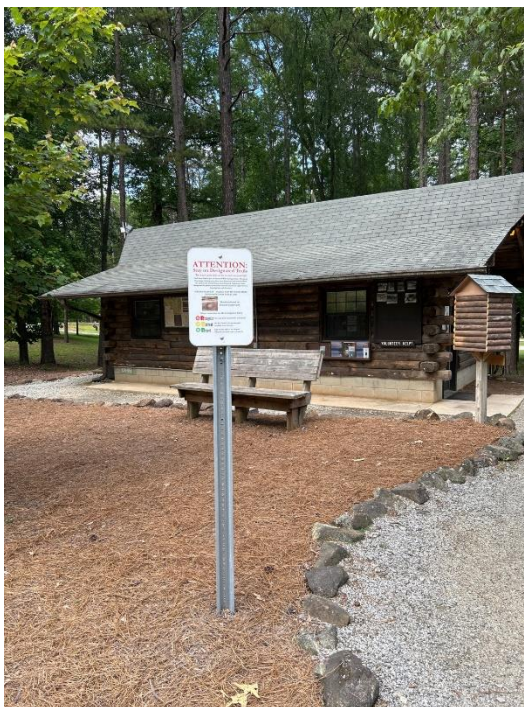
| <b>Photo No.</b><br>06 | <b>Date:</b><br>05/30/2023 | |

| <b>Description:</b><br>Project 7, Sign A15 - In good condition, adjacent to visitor's center | | |

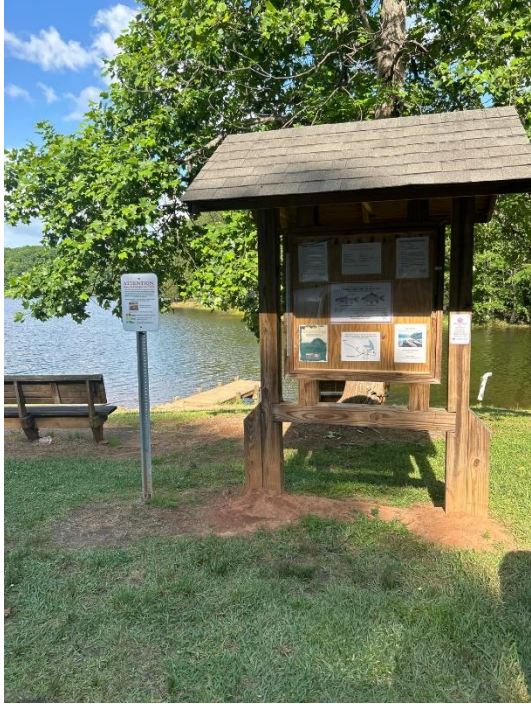
| <b>Photo No.</b><br><b>09</b> | <b>Date:</b><br>05/30/2023 | <b>Description:</b><br>Project 7, Sign A24 - In good condition, adjacent to lake and signage | |

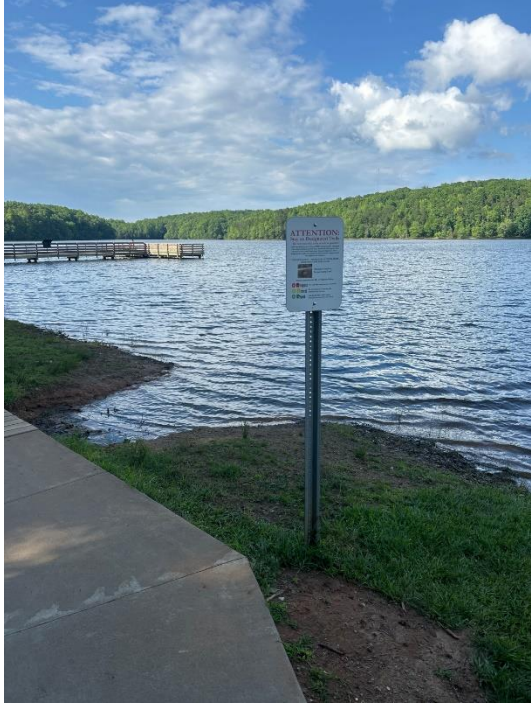
| <b>Photo No.</b><br><b>11</b> | <b>Date:</b><br>05/30/2023 | |

| <b>Description:</b><br>Project 7, Sign A25 - In good condition, adjacent to lake | | |

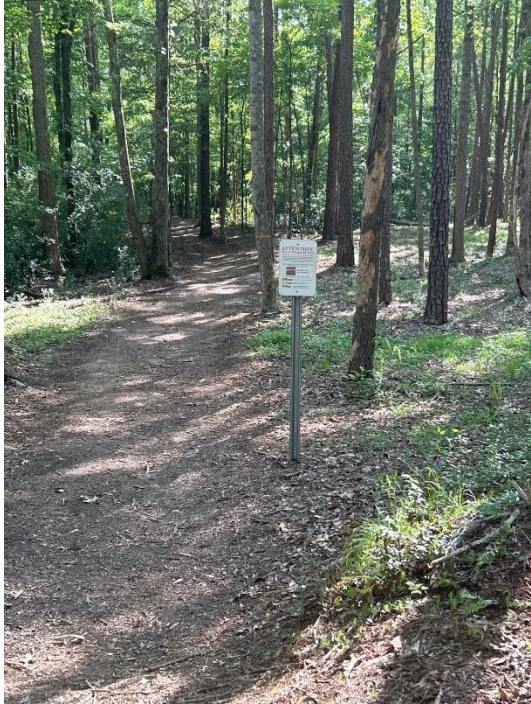
| <b>Photo No.</b><br><b>12</b> | <b>Date:</b><br>05/30/2023 | |

| <b>Description:</b><br>Project 7, Sign A18 - In good condition, adjacent to trail | | |

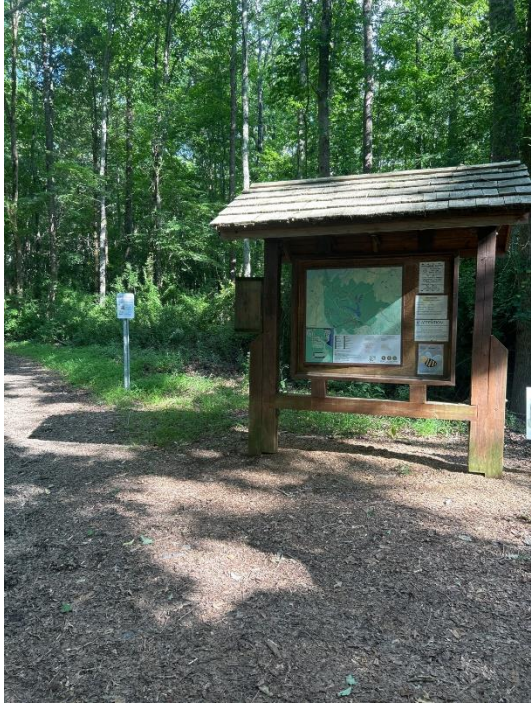
| <b>Photo No.</b><br><b>13</b> | <b>Date:</b><br>05/30/2023 | <b>Description:</b><br>Project 7, Sign A19 - In good condition, adjacent to trail and trail signs | |

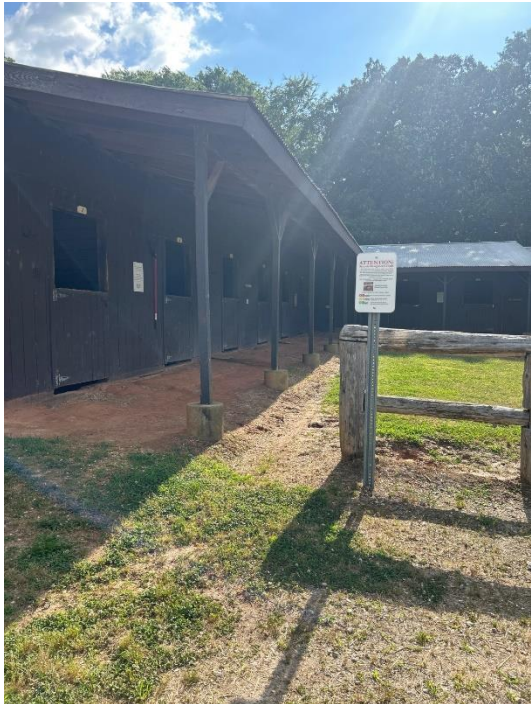
| <b>Photo No.</b><br><b>14</b> | <b>Date:</b><br>05/30/2023 | <b>Description:</b><br>Project 7, Sign A27 - In good condition, adjacent to stables | |

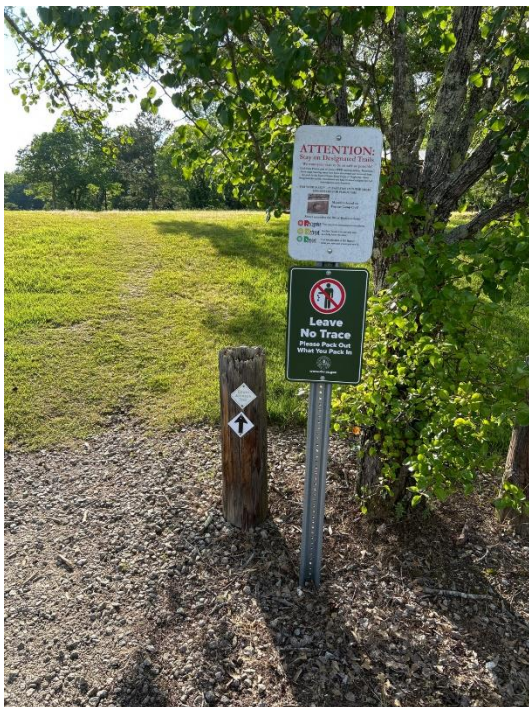
| <b>Photo No.</b><br><b>17</b> | <b>Date:</b><br>05/30/2023 | |

| <b>Description:</b><br>Project 5, Sign A6 - In good condition, adjacent to trail | | |

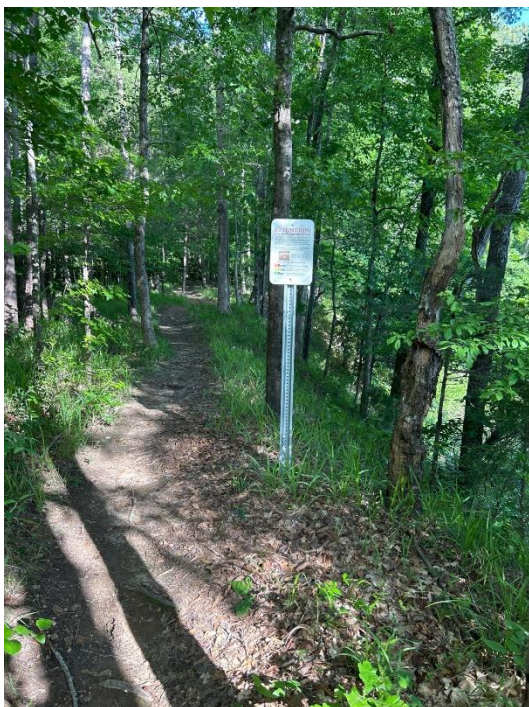
| <b>Photo No.</b><br><b>18</b> | <b>Date:</b><br>05/30/2023 | |

| <b>Description:</b><br>Project 5, Sign A5 - In good condition, adjacent to trail | | |

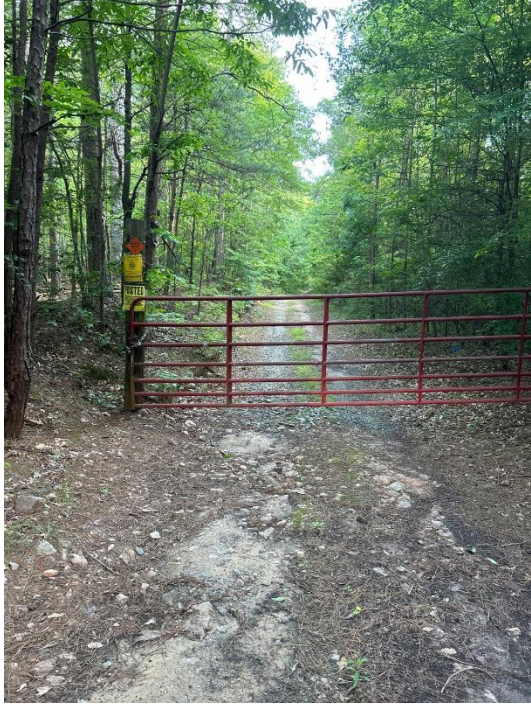
| <b>Photo No.</b><br><b>19</b> | <b>Date:</b><br>05/30/2023 | <b>Description:</b><br>Project 5 - Gate restricting access | |

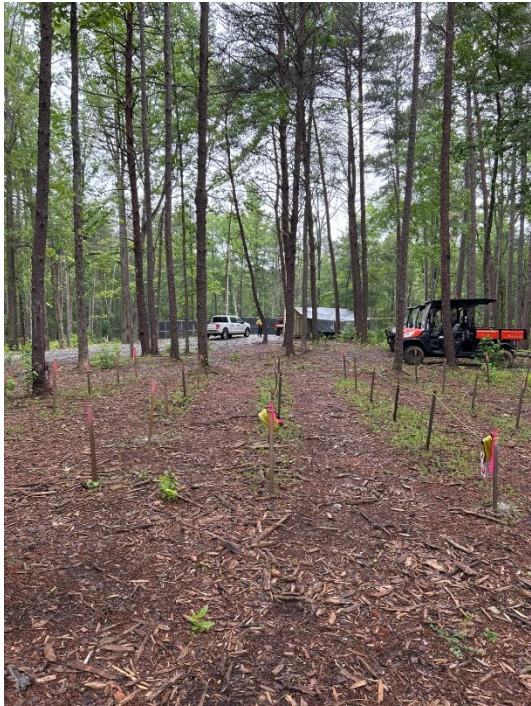
| <b>Photo No.</b><br><b>20</b> | <b>Date:</b><br>05/30/2023 | <b>Description:</b><br>Project 7 - Work site area | |

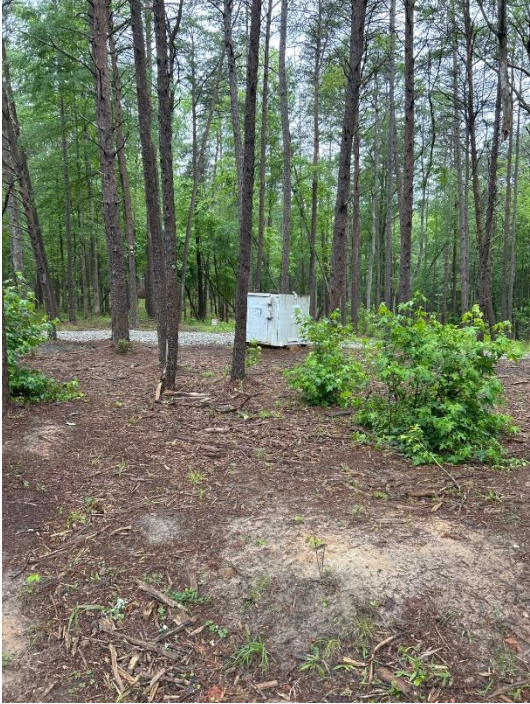
| <b>Photo No.</b><br><b>21</b> | <b>Date:</b><br>05/31/2023 | |

| <b>Description:</b><br>Project 7 - MEC storage magazine | | |

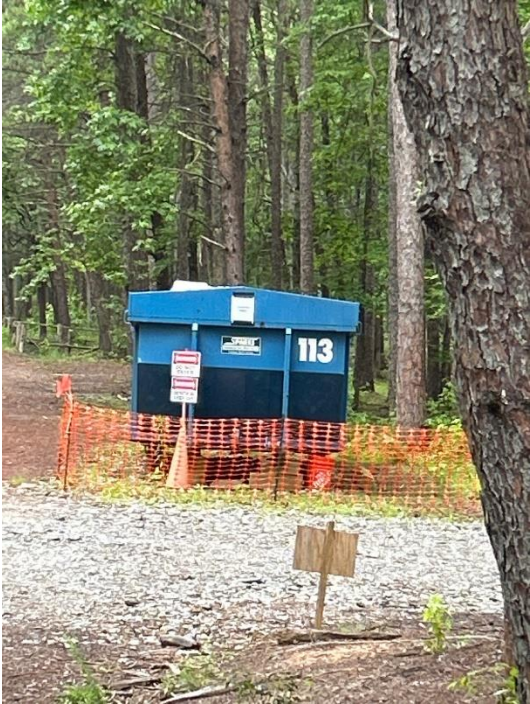
| <b>Photo No.</b><br><b>22</b> | <b>Date:</b><br>05/31/2023 | |

| <b>Description:</b><br>Project 7 - Metallic debris storage | | |

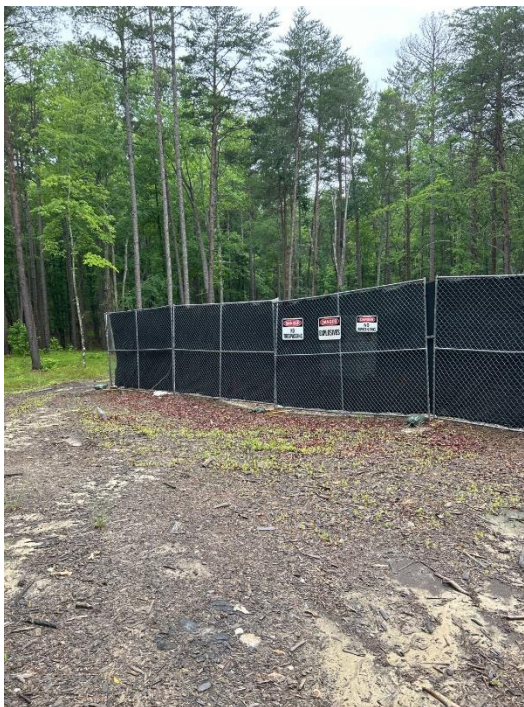
| <b>Photo No.</b><br><b>23</b> | <b>Date:</b><br>05/31/2023 | |

| <b>Description:</b><br>Project 7 - Secure project area | | |

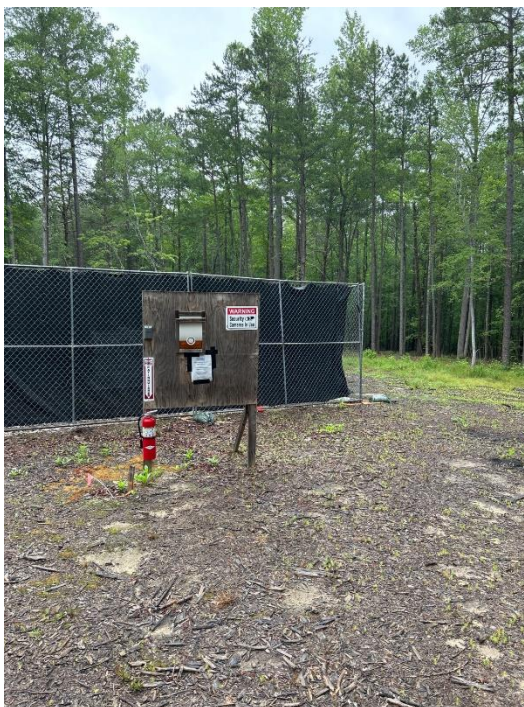
| <b>Photo No.</b><br><b>24</b> | <b>Date:</b><br>05/31/2023 | |

| <b>Description:</b><br>Project 7 - Secure project area | | |

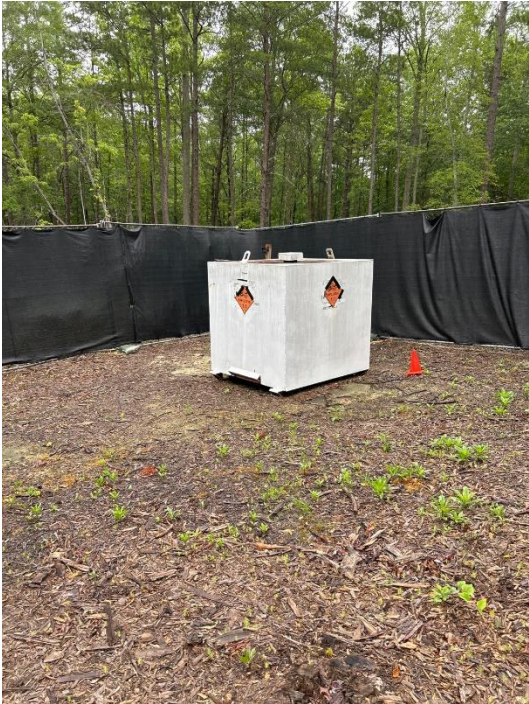
| <b>Photo No.</b><br><b>25</b> | <b>Date:</b><br>05/31/2023 | <b>Description:</b><br>Project 7 - Inside secure project area, donor explosives storage magazine | |

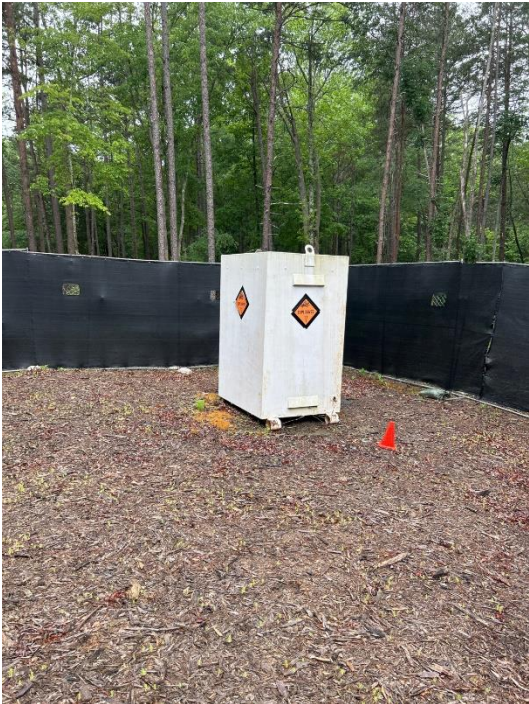
| <b>Photo No.</b><br><b>26</b> | <b>Date:</b><br>05/31/2023 | <b>Description:</b><br>Project 7 - Inside secure project area, donor explosives storage magazine | |

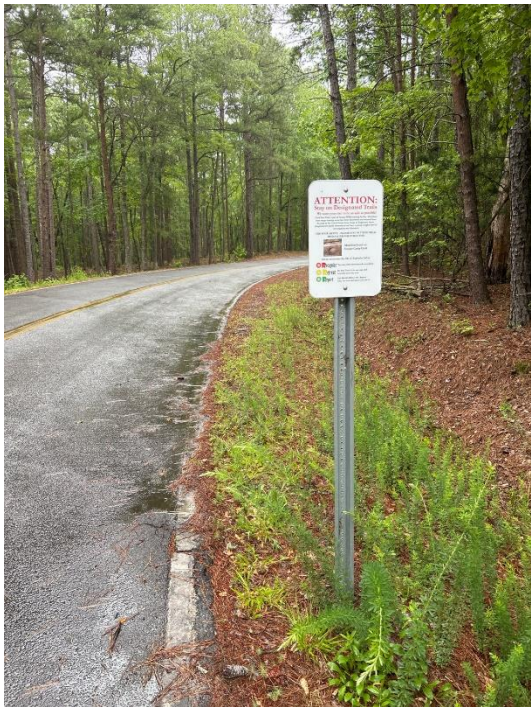
| <b>Photo No.</b><br><b>27</b> | <b>Date:</b><br>05/31/2023 | |

| <b>Description:</b><br>Project 7, Sign A28 - In good condition, adjacent to road | | |

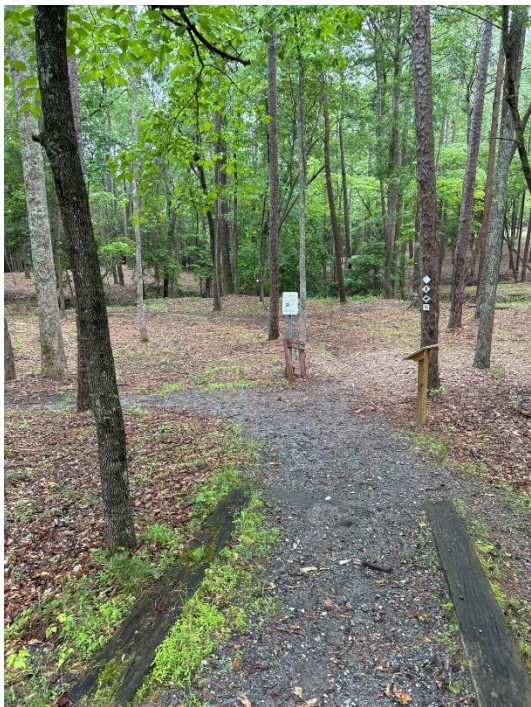
| <b>Photo No.</b><br><b>28</b> | <b>Date:</b><br>05/31/2023 | |

| <b>Description:</b><br>Project 7, Sign A11 - In good condition, adjacent to trail | | |

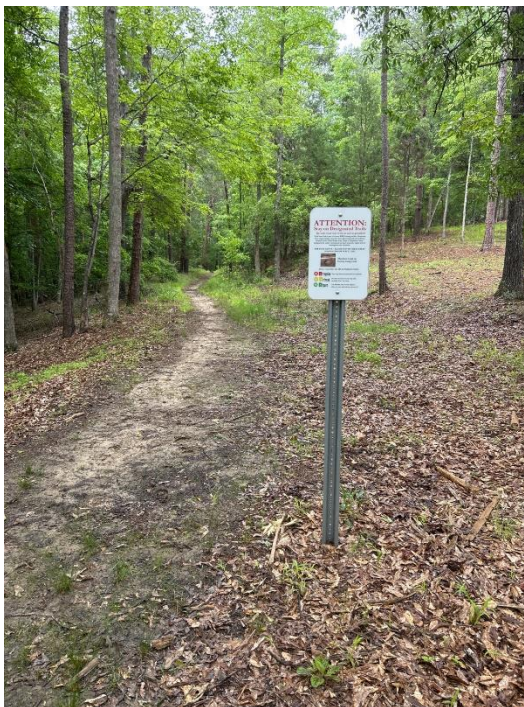
| <b>Photo No.</b><br><b>29</b> | <b>Date:</b><br>05/31/2023 | <b>Description:</b><br>Project 7, Sign A12 - In good condition, adjacent to trail | |

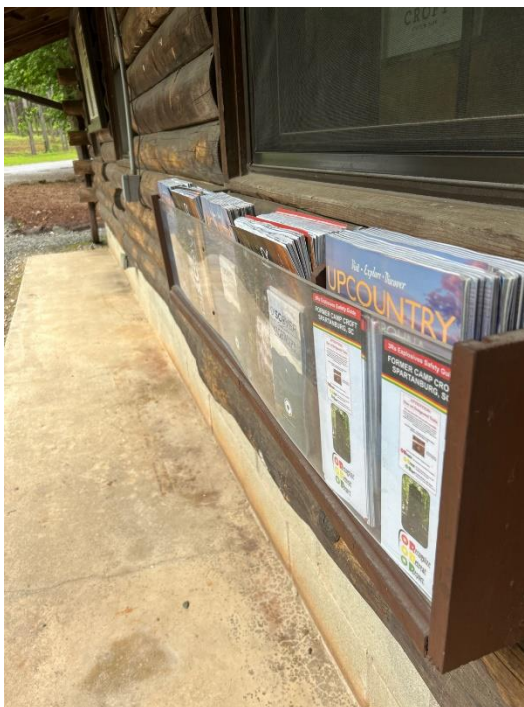
| <b>Photo No.</b><br><b>30</b> | <b>Date:</b><br>05/31/2023 | <b>Description:</b><br>Safety flyers at visitor center | |

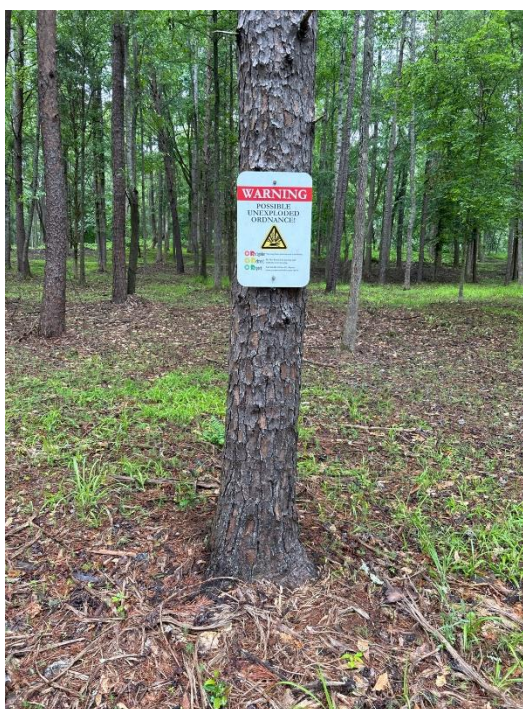
| <b>Photo No.</b><br><b>31</b> | <b>Date:</b><br>05/31/2023 | |

| <b>Description:</b><br>Project 7, Sign B1 - In good condition, wooded area | | |

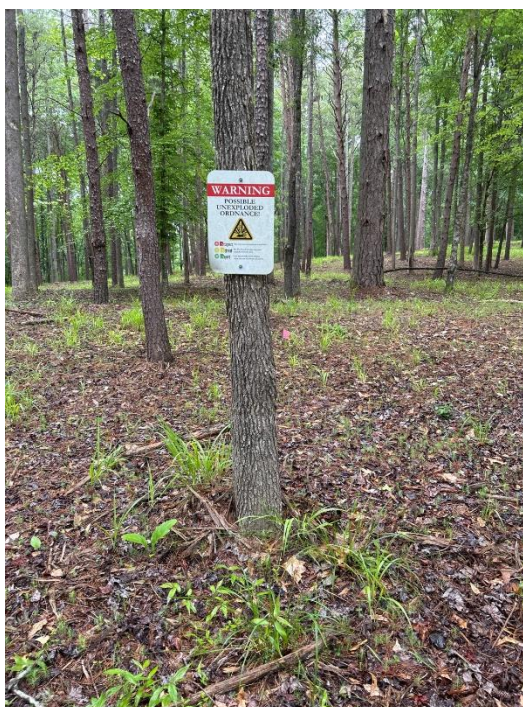
| <b>Photo No.</b><br><b>32</b> | <b>Date:</b><br>05/31/2023 | |

| <b>Description:</b><br>Project 7, Sign B4 - In good condition, wooded area | | |

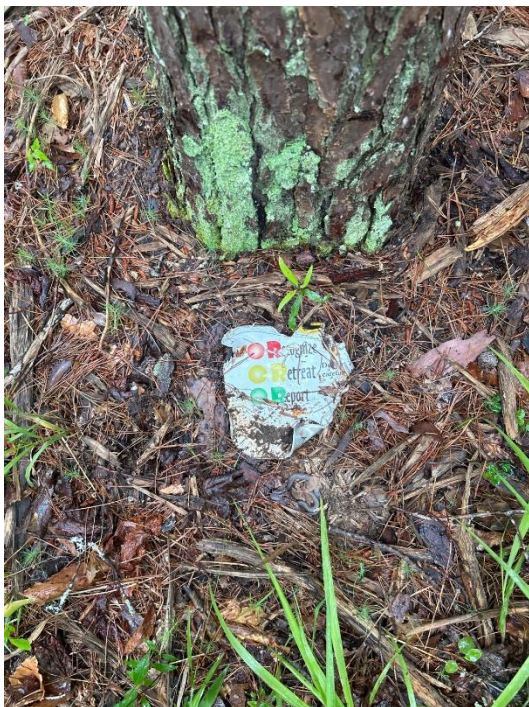
| <b>Photo No.</b><br><b>33</b> | <b>Date:</b><br>05/31/2023 | |

| <b>Description:</b><br>Project 7, Sign B7 -<br>Damaged sign on ground | | |

- Maintenance and repair of the warning signs should be performed annually as outlined in the Project 07 LUCIP. Maintenance should include trimming vegetative growth obscuring signs.

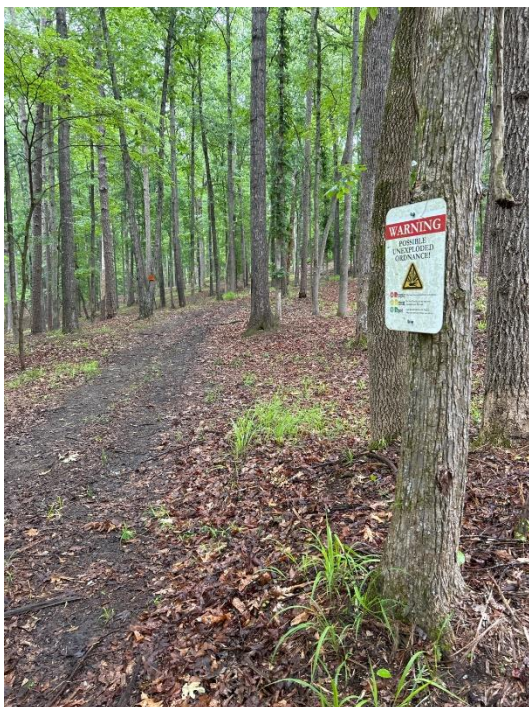
| <b>Photo No.</b><br><b>34</b> | <b>Date:</b><br>05/31/2023 | |

| <b>Description:</b><br>Project 7, Sign B10 - In<br>good condition, adjacent to<br>path | | |

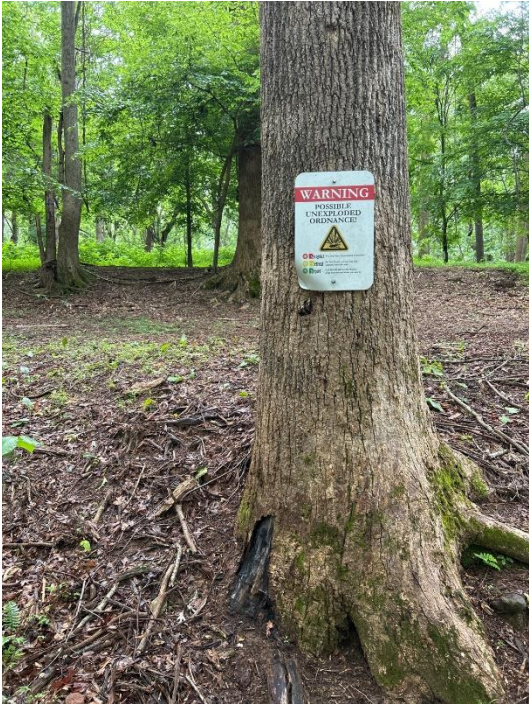
| <b>Photo No.</b><br><b>35</b> | <b>Date:</b><br>05/31/2023 | |

| <b>Description:</b><br>Project 7, Sign B16 - Bent lower left corner, still legible | | |

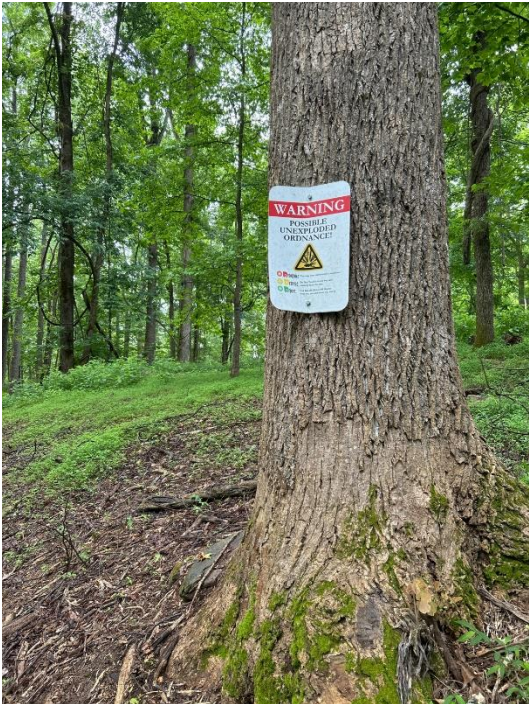
| <b>Photo No.</b><br><b>36</b> | <b>Date:</b><br>05/31/2023 | |

| <b>Description:</b><br>Project 7, Sign B19 - Bent sign, still legible | | |

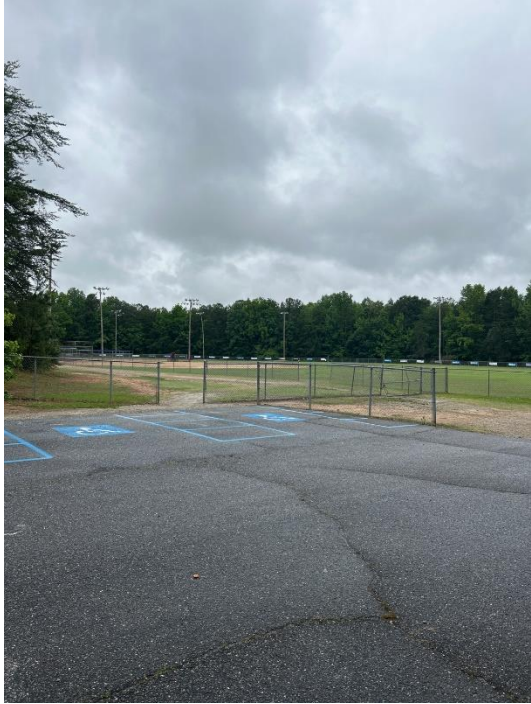
| <b>Photo No.</b><br><b>43</b> | <b>Date:</b><br>05/31/2023 | |

| <b>Description:</b><br>Project 5 - Land use is<br>baseball field/recreational | | |

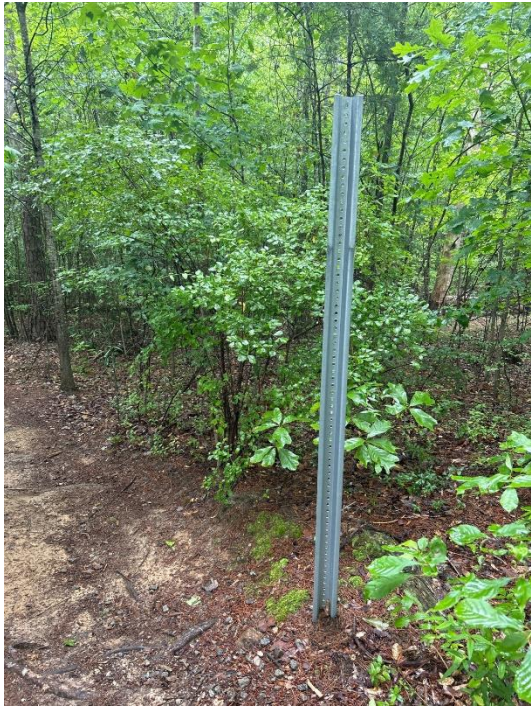
| <b>Photo No.</b><br><b>44</b> | <b>Date:</b><br>05/31/2023 | |

| <b>Description:</b><br>Project 5, Sign A9 location<br>- Signpost with no sign<br>attached, adjacent to trail | | |

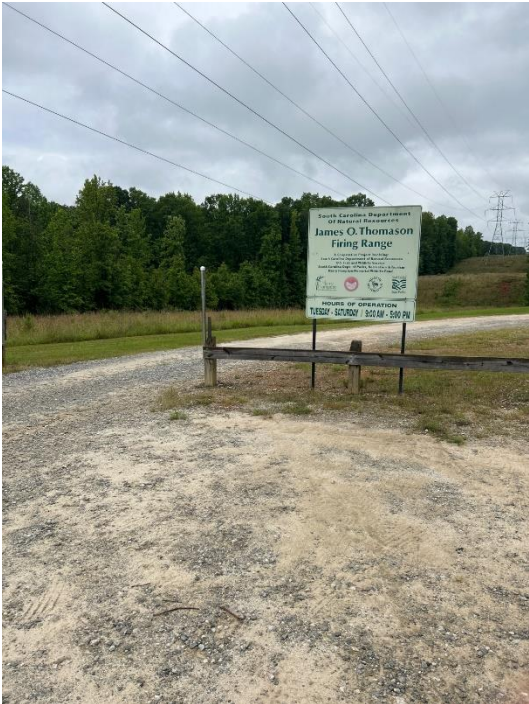
| <b>Photo No.</b><br><b>48</b> | <b>Date:</b><br>05/31/2023 | <div> <div> <b>Description:</b><br/> Project 5 - James O. Thomason Firing Range </div> </div> |

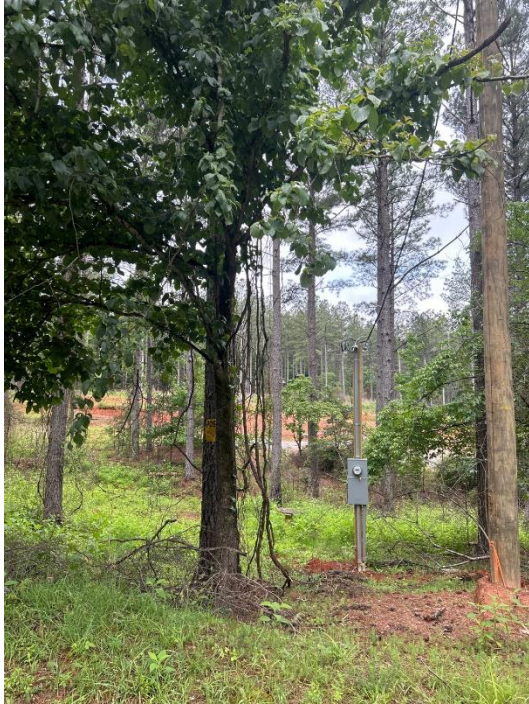
| <b>Photo No.</b><br><b>52</b> | <b>Date:</b><br>05/31/2023 | |

| <b>Description:</b><br>Project 3 (Rocket/Grenade Maneuver Area) - Land use is wooded/recreational | | |

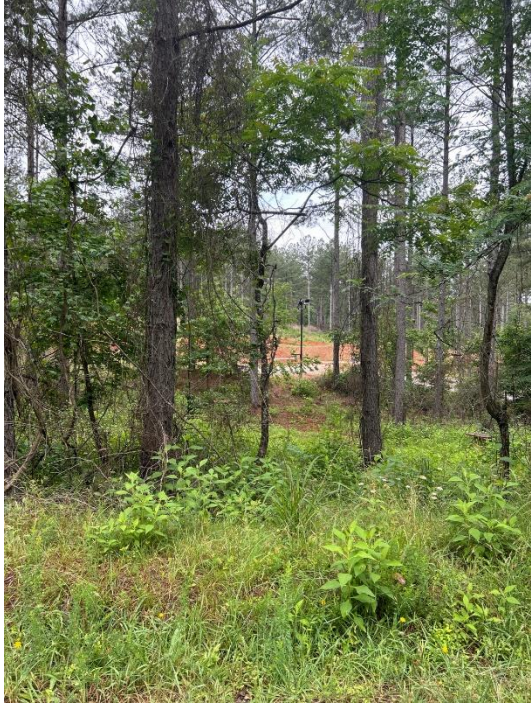
| <b>Photo No.</b><br><b>53</b> | <b>Date:</b><br>05/31/2023 | <b>Description:</b><br>Project 5 - Recent development, land use wooded/recreational | |

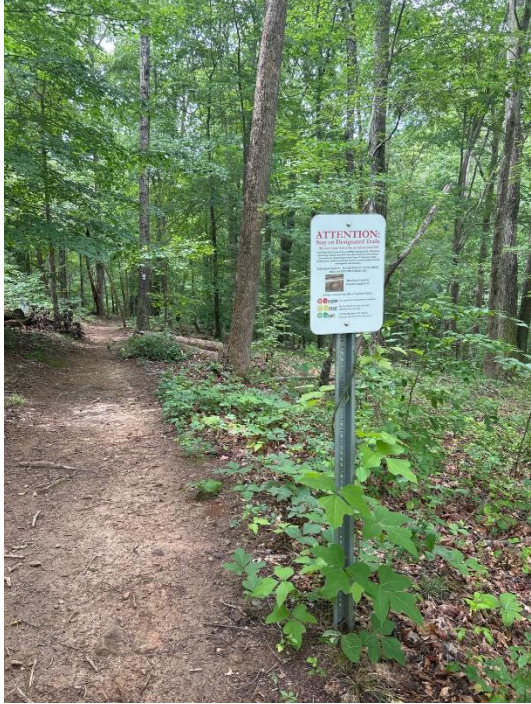
| <b>Photo No.</b><br><b>55</b> | <b>Date:</b><br>05/31/2023 | |

| <b>Description:</b><br>Sign A2 - In good condition, adjacent to trail, just outside of Project 5 to the north | | |

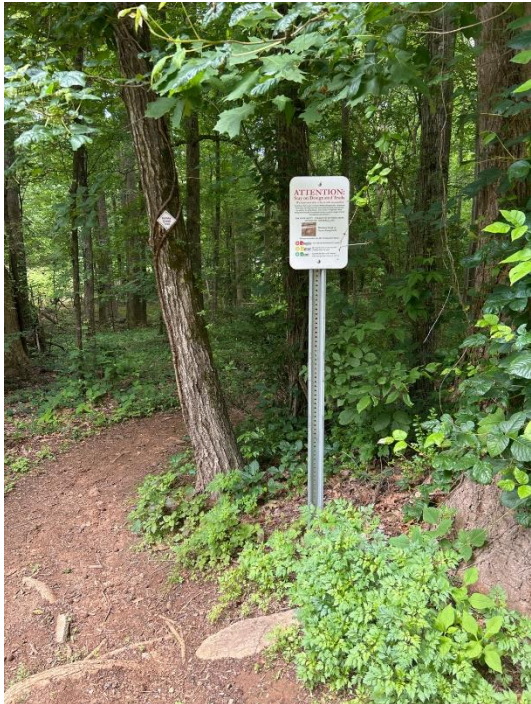
| <b>Photo No.</b><br><b>56</b> | <b>Date:</b><br>05/31/2023 | |

| <b>Description:</b><br>Sign A3 - In good condition, adjacent to trail, just outside of Project 5 to the north | | |

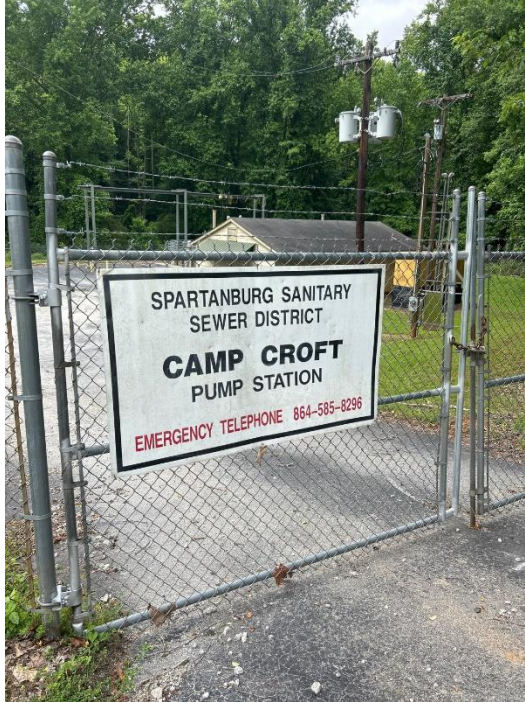
| <b>Photo No.</b><br><b>59</b> | <b>Date:</b><br>05/31/2023 | <b>Description:</b><br>Just east of Project 3 (Rocket Area) - Entrance to Spartanburg Sanitary Sewer District Pump Station | |

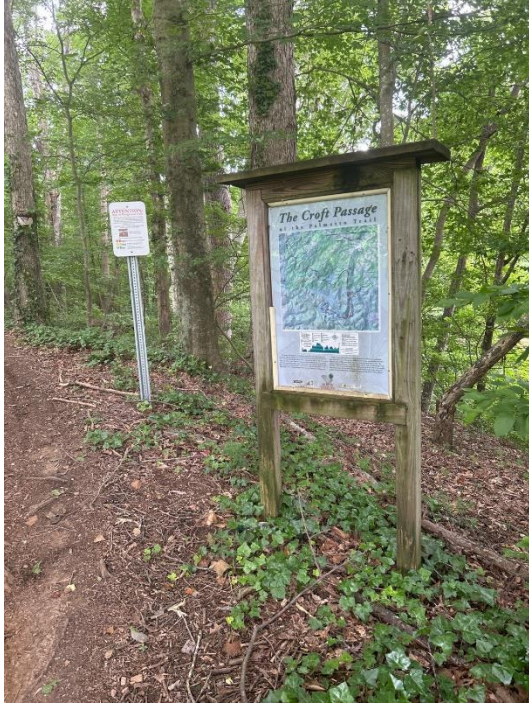
| <b>Photo No.</b><br><b>61</b> | <b>Date:</b><br>05/31/2023 | |

| <b>Description:</b><br>Sign A7 - In good condition, adjacent to trail and signage | | |

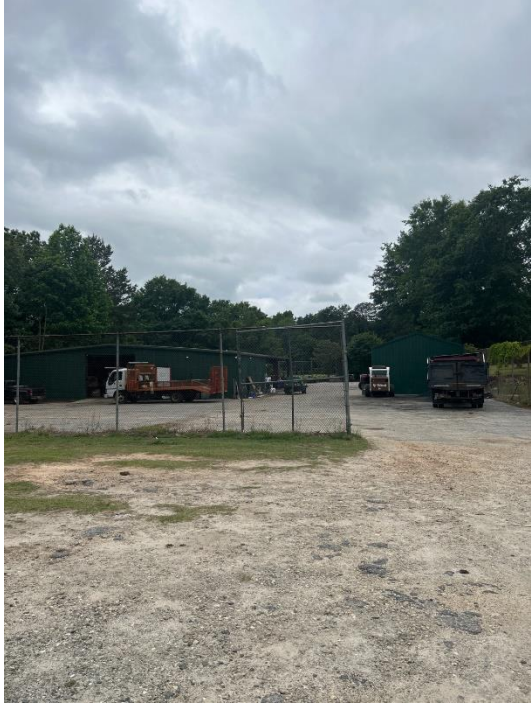
| <b>Photo No.</b><br><b>69</b> | <b>Date:</b><br>05/31/2023 | |

| <b>Description:</b><br>Project 3 (Grenade Area) - Golf course maintenance area, land use is recreational | | |

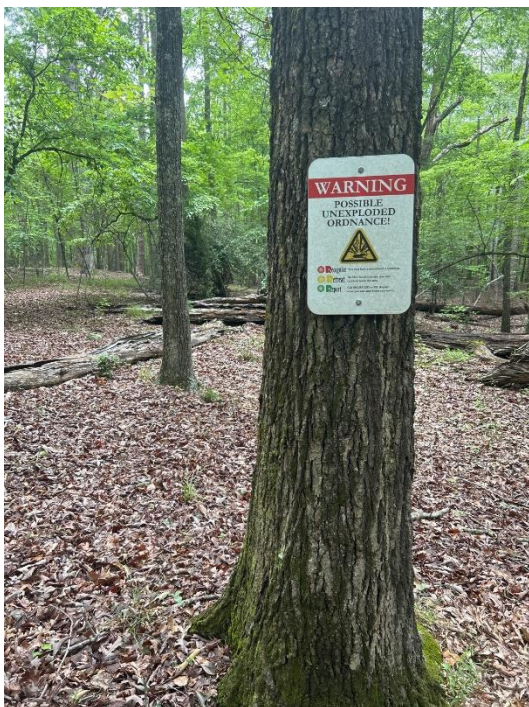
| <b>Photo No.</b><br><b>74</b> | <b>Date:</b><br>05/31/2023 | |

| <b>Description:</b><br>Project 5, Sign B50 - In good condition | | |

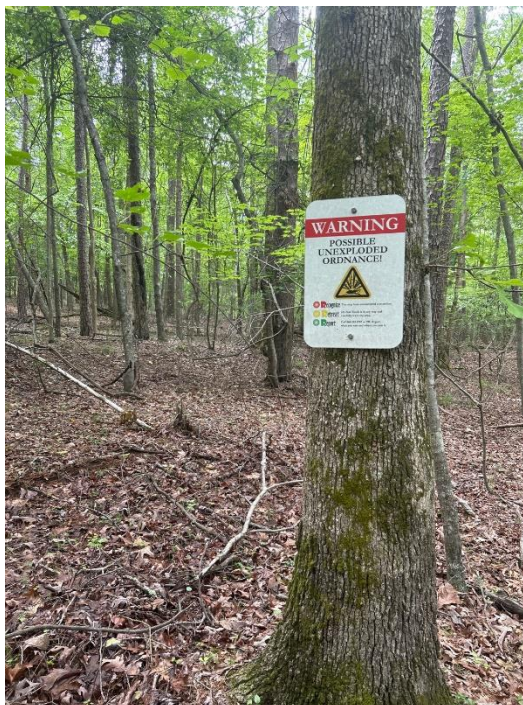
| <b>Photo No.</b><br><b>75</b> | <b>Date:</b><br>05/31/2023 | |

| <b>Description:</b><br>Project 5, Sign B51 - In good condition | | |

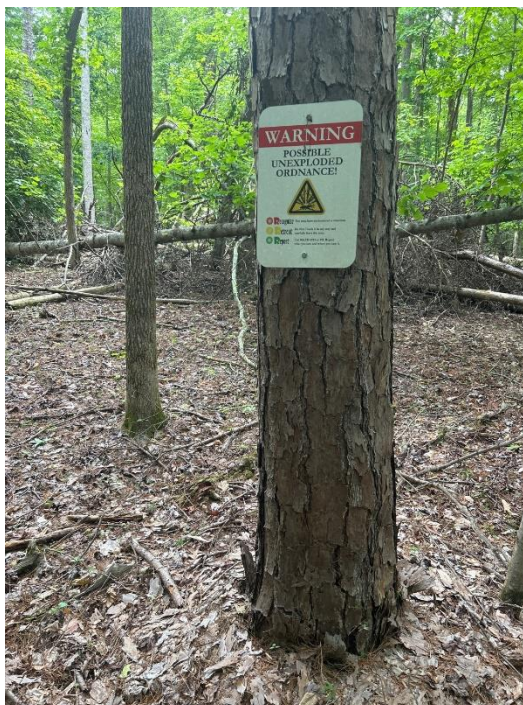
| <b>Photo No.</b><br><b>76</b> | <b>Date:</b><br>05/31/2023 | |

| <b>Description:</b><br>Project 5, Sign B52 - In good condition | | |

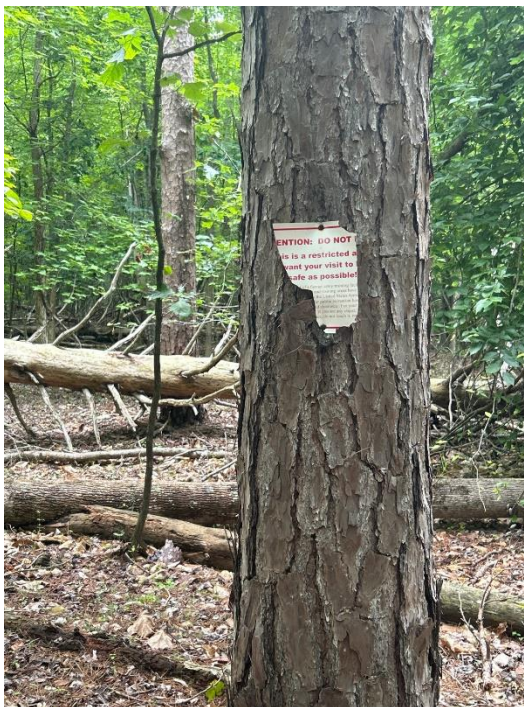
| <b>Photo No.</b><br><b>77</b> | <b>Date:</b><br>05/31/2023 | |

| <b>Description:</b><br>Project 5 - Sign restricting access to area, damaged | | |

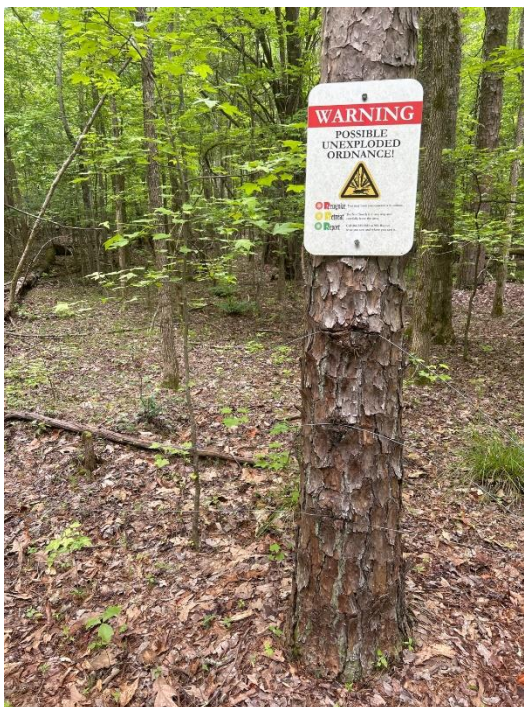
| <b>Photo No.</b><br><b>78</b> | <b>Date:</b><br>05/31/2023 | |

| <b>Description:</b><br>Project 5, Sign B53 - In good condition | | |

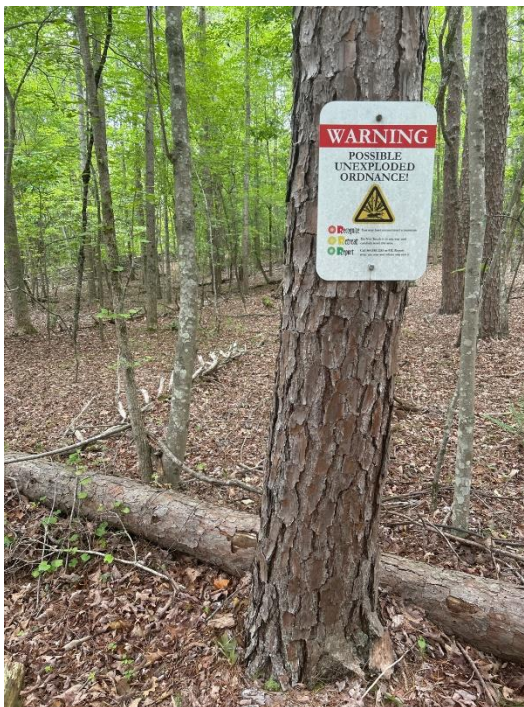
| <b>Photo No.</b><br><b>81</b> | <b>Date:</b><br>05/31/2023 | |

| <b>Description:</b><br>Project 5, Sign B47 - In good condition | | |

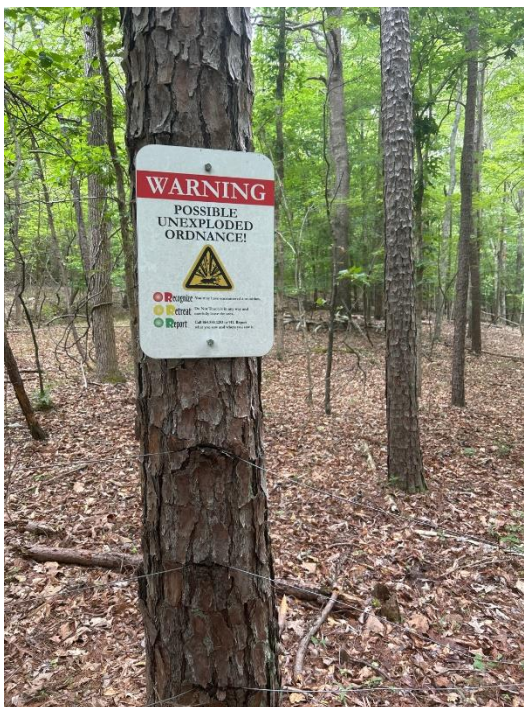
| <b>Photo No.</b><br><b>82</b> | <b>Date:</b><br>05/31/2023 | |

| <b>Description:</b><br>Project 5, Sign B46 - In good condition | | |

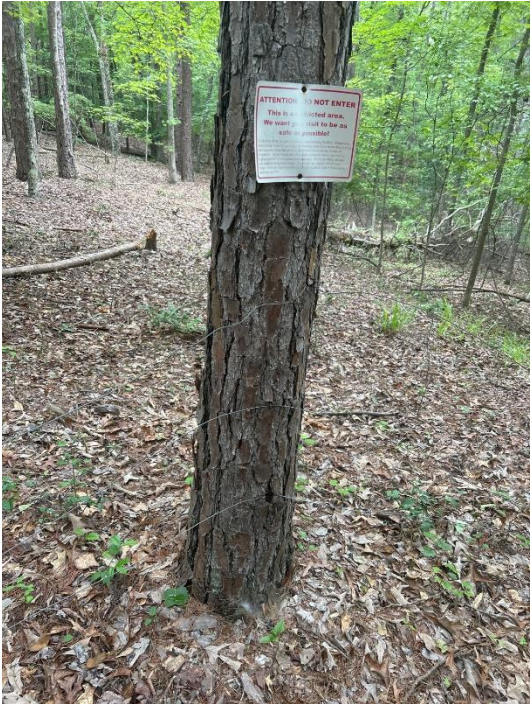
| <b>Photo No.</b><br><b>83</b> | <b>Date:</b><br>05/31/2023 | <div> <div> <b>Description:</b><br/> Project 5 - Sign restricting access to area, in good condition </div> </div> |

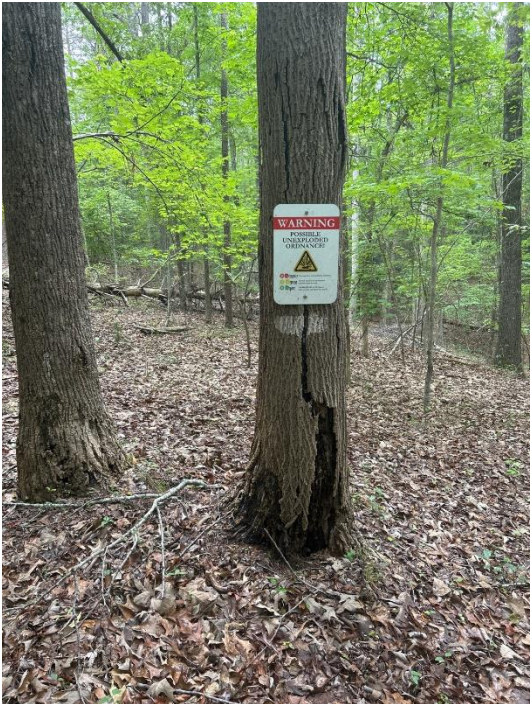
| <b>Photo No.</b><br><b>84</b> | <b>Date:</b><br>05/31/2023 | <div> <div> <b>Description:</b><br/> Project 5, Sign B45 - In good condition </div> </div> |

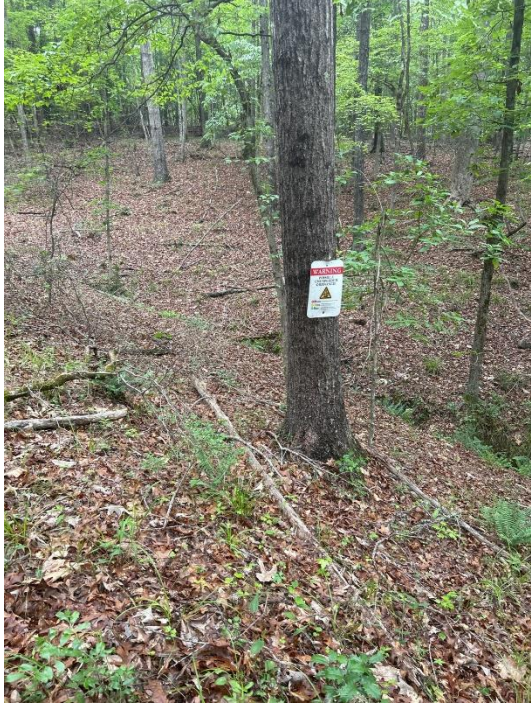
| <b>Photo No.</b><br><b>85</b> | <b>Date:</b><br>05/31/2023 | |

| <b>Description:</b><br>Project 5, Sign B44 - In good condition | | |

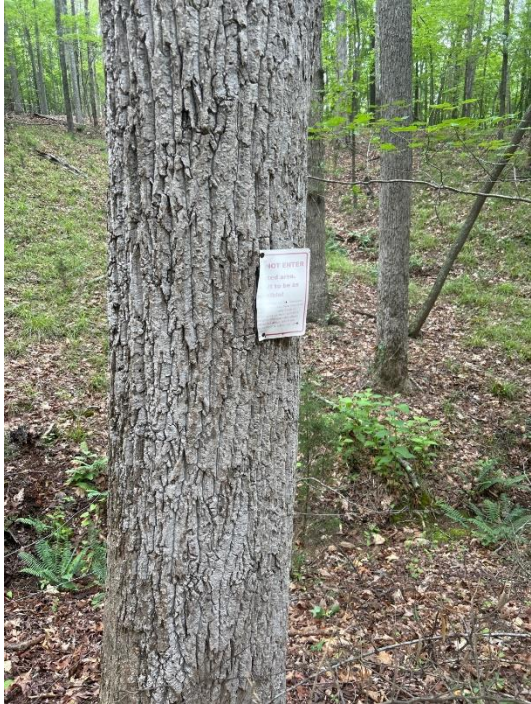
| <b>Photo No.</b><br><b>86</b> | <b>Date:</b><br>05/31/2023 | |

| <b>Description:</b><br>Project 5 - Sign restricting access to area, damaged | | |

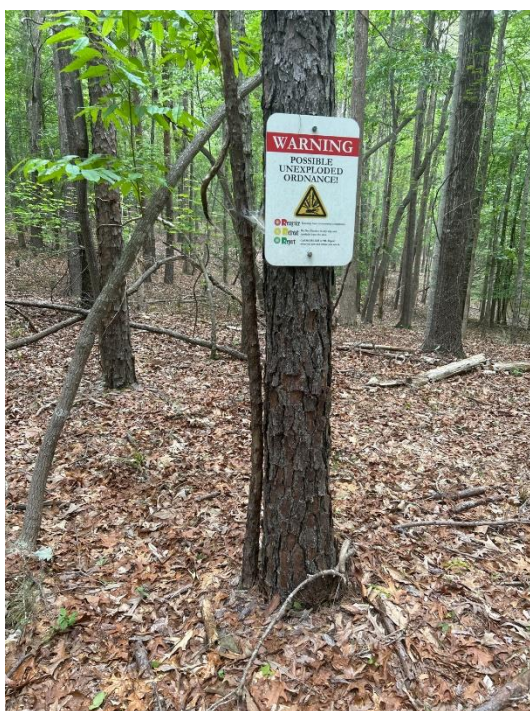
| <b>Photo No.</b><br><b>89</b> | <b>Date:</b><br>05/31/2023 | |

| <b>Description:</b><br>Project 5, Sign B41 - In good condition | | |

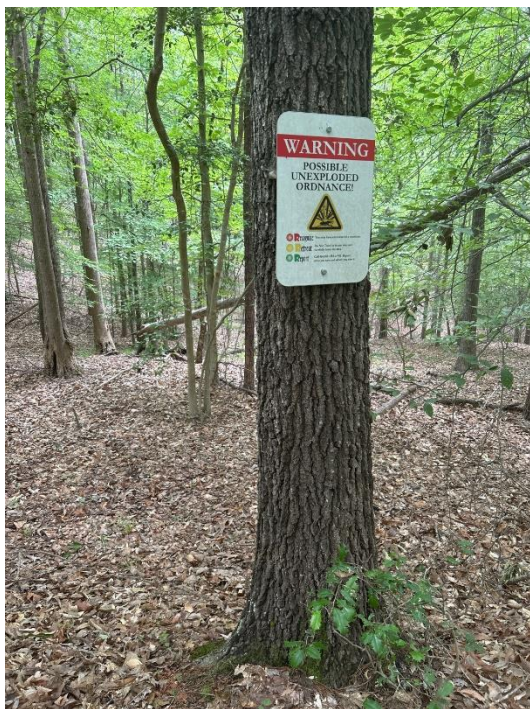
| <b>Photo No.</b><br><b>90</b> | <b>Date:</b><br>05/31/2023 | |

| <b>Description:</b><br>Project 5, Sign B40 - In good condition | | |

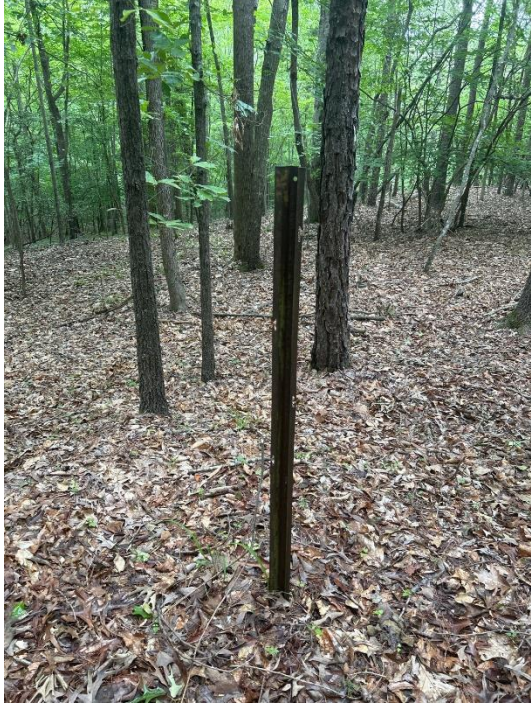
| <b>Photo No.</b><br><b>91</b> | <b>Date:</b><br>05/31/2023 | |

| <b>Description:</b><br>Project 5 - Signpost with no sign observed | | |
