**FINAL**  
**FIRST FIVE-YEAR REVIEW REPORT FOR**  
**CP CROFT**  
**(also known as Camp Croft)**

**FORMERLY USED DEFENSE SITE**  
**(FUDS PROPERTY NO. I04SC0016)**

**SPARTANBURG, SOUTH CAROLINA**

**U.S. Army Corps of Engineers, Savannah District**

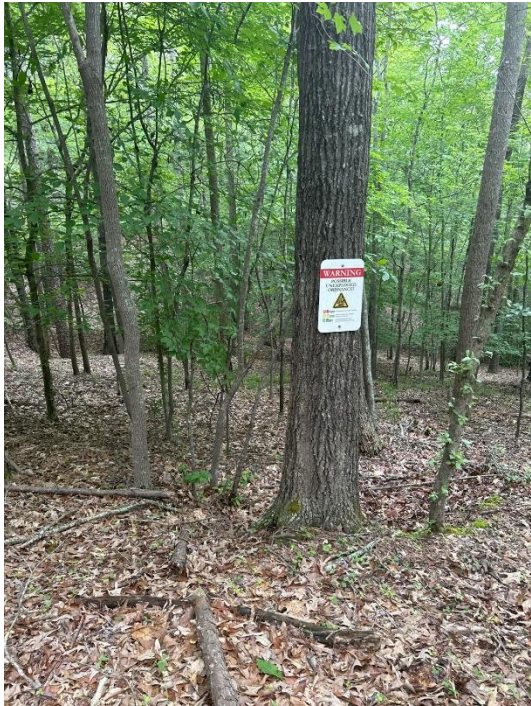
| <b>Photo No.</b><br><b>92</b> | <b>Date:</b><br>05/31/2023 | |

| <b>Description:</b><br>Project 5, Sign B39 - In good condition | | |

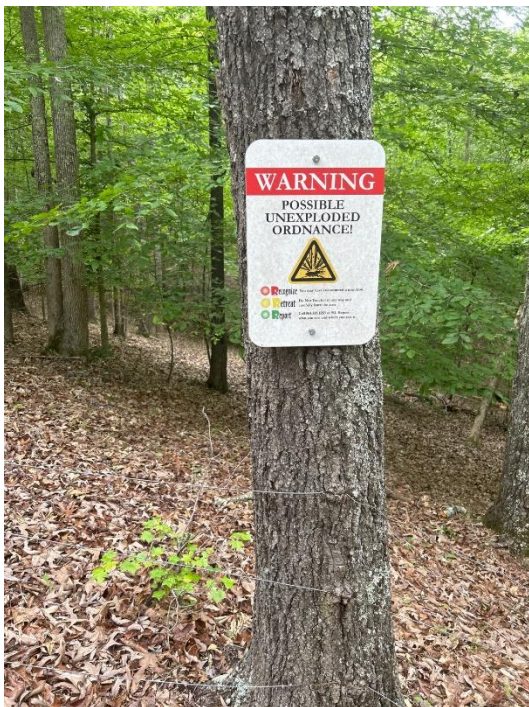
| <b>Photo No.</b><br><b>93</b> | <b>Date:</b><br>05/31/2023 | |

| <b>Description:</b><br>Project 5, Sign B38 - In good condition | | |

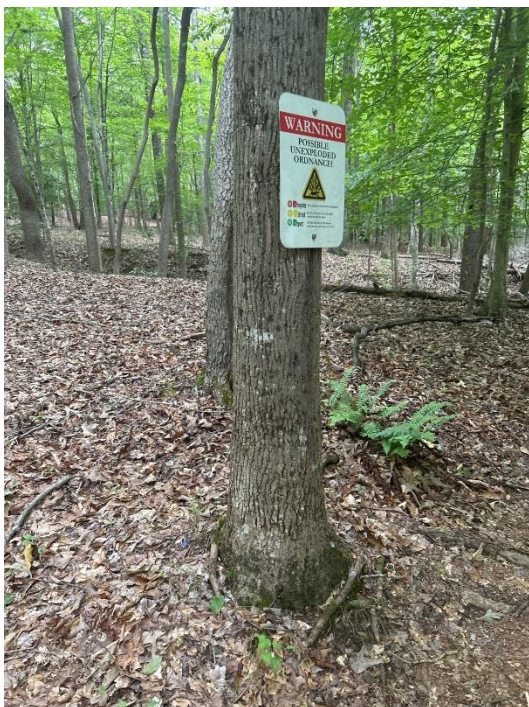
| <b>Photo No.</b><br><b>94</b> | <b>Date:</b><br>05/31/2023 | |

| <b>Description:</b><br>Project 5, Sign B37 - In good condition | | |

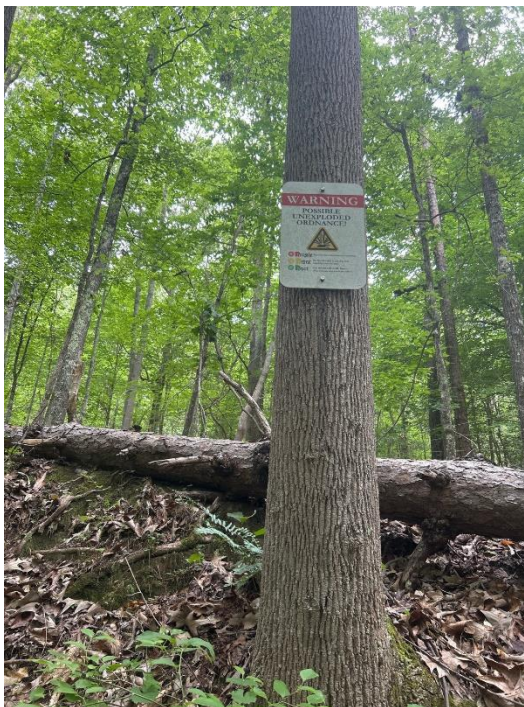
| <b>Photo No.</b><br><b>95</b> | <b>Date:</b><br>05/31/2023 | |

| <b>Description:</b><br>Project 5, Sign B36 - In good condition | | |

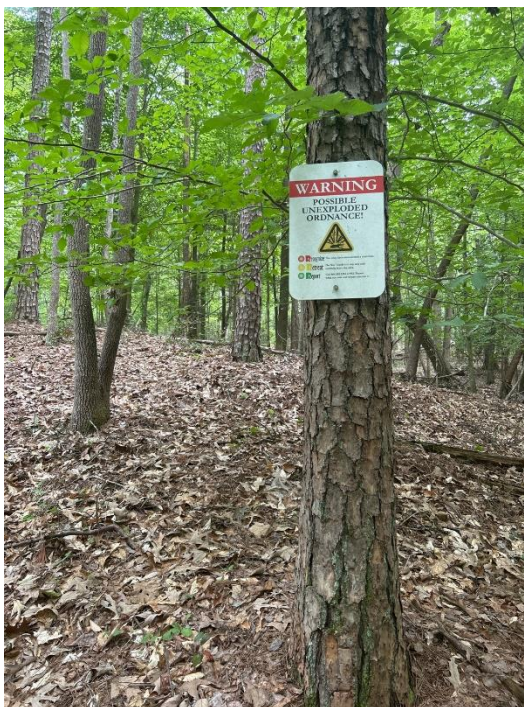
| <b>Photo No.</b><br><b>96</b> | <b>Date:</b><br>05/31/2023 | |

| <b>Description:</b><br>Project 5, Sign B35 - In good condition | | |

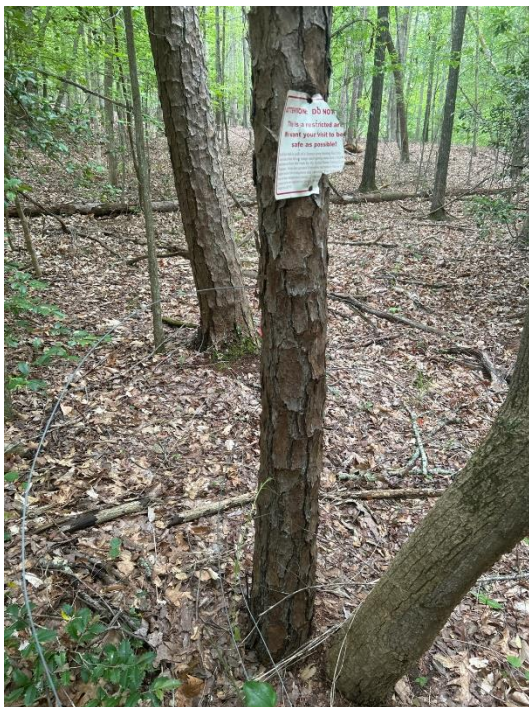
| <b>Photo No.</b><br><b>97</b> | <b>Date:</b><br>05/31/2023 | |

| <b>Description:</b><br>Project 5 - Sign restricting access to area, damaged, metal wiring on ground | | |

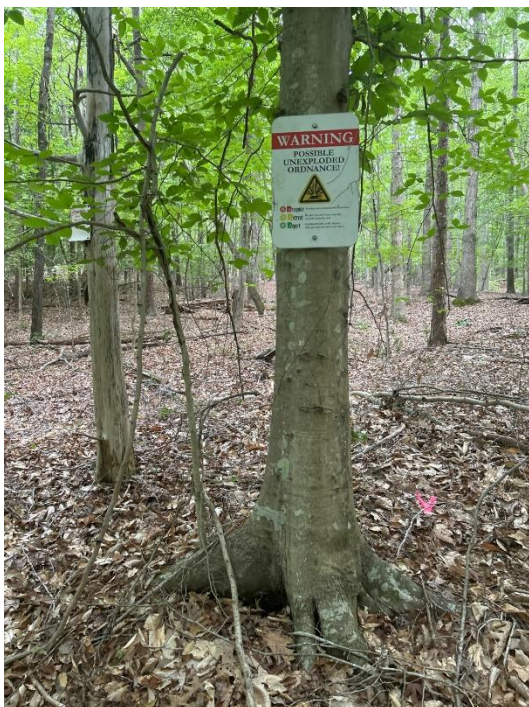
| <b>Photo No.</b><br><b>98</b> | <b>Date:</b><br>05/31/2023 | |

| <b>Description:</b><br>Project 5, Sign B34 - In good condition | | |

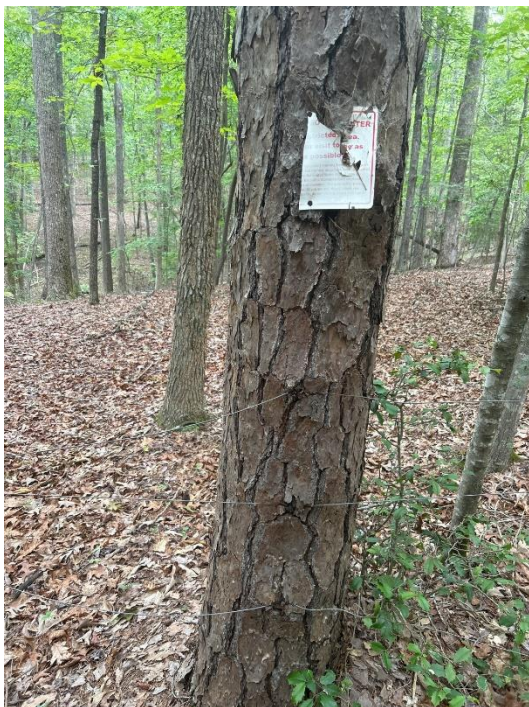
| <b>Photo No.</b><br><b>99</b> | <b>Date:</b><br>05/31/2023 | |

| <b>Description:</b><br>Project 5 - Sign restricting access to area, damaged | | |

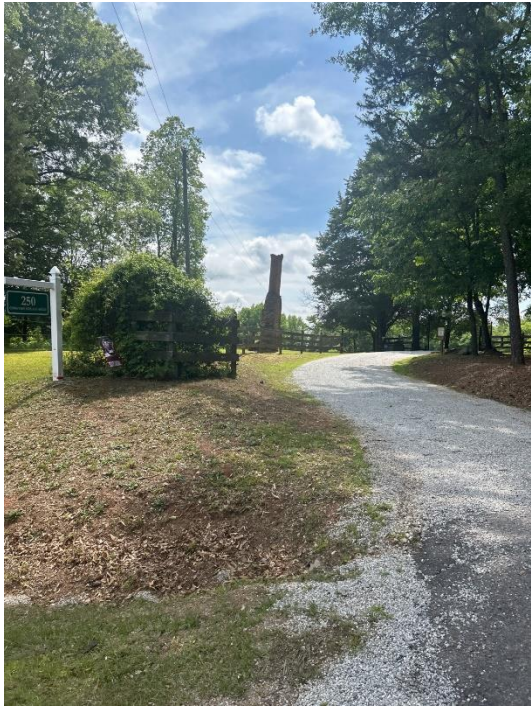
| <b>Photo No.</b><br><b>102</b> | <b>Date:</b><br>05/31/2023 | |

| <b>Description:</b><br>Project 5 - Land use is residential | | |

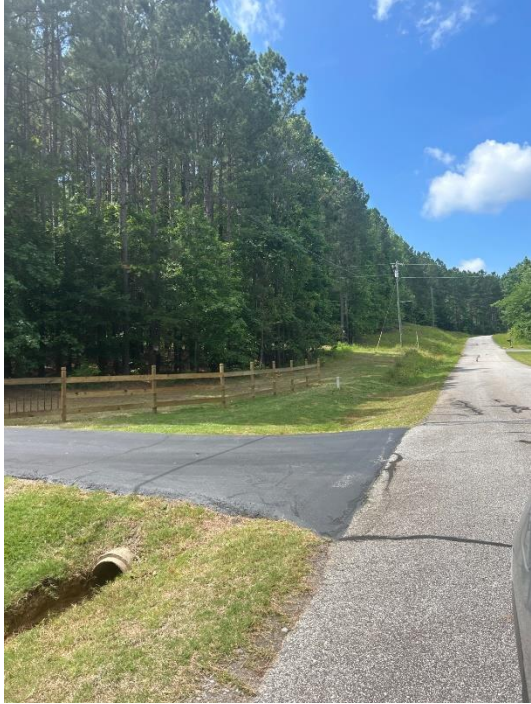
| <b>Photo No.</b><br><b>103</b> | <b>Date:</b><br>05/31/2023 | | |

| <b>Description:</b><br>Project 5 - Land use is residential | | | |

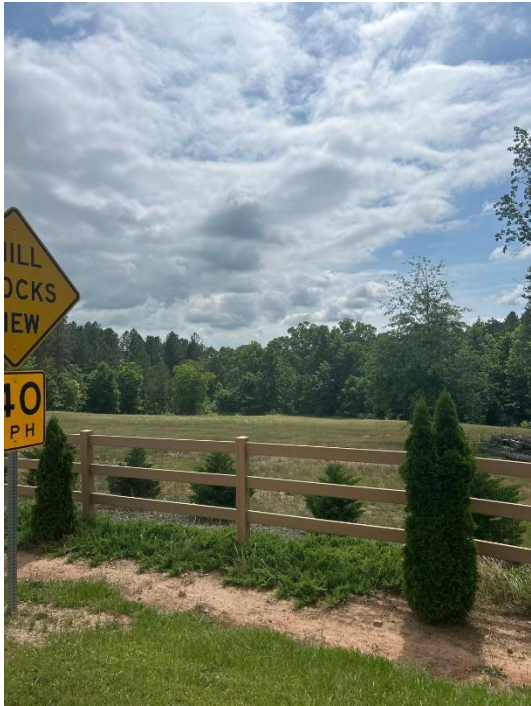
| <b>Photo No.</b><br><b>104</b> | <b>Date:</b><br>05/31/2023 | | |

| <b>Description:</b><br>Project 5 - Land use is residential and wooded | | | |

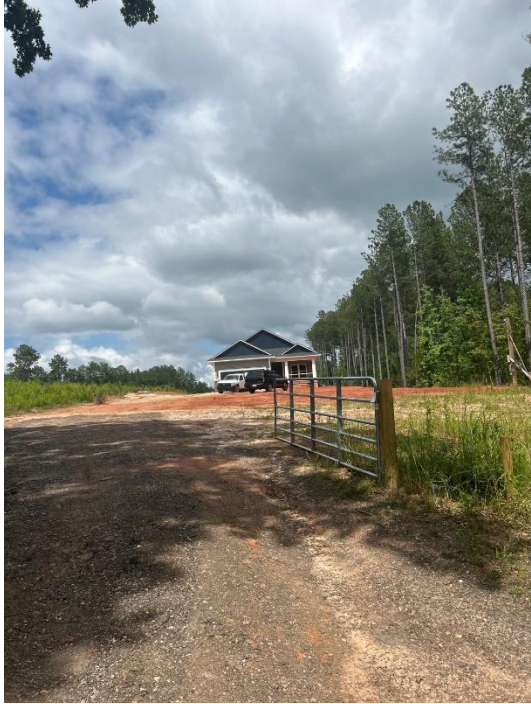
| <b>Photo No.</b><br><b>105</b> | <b>Date:</b><br>05/31/2023 | |

| <b>Description:</b><br>Project 5 - Land use is residential, recent construction | | |

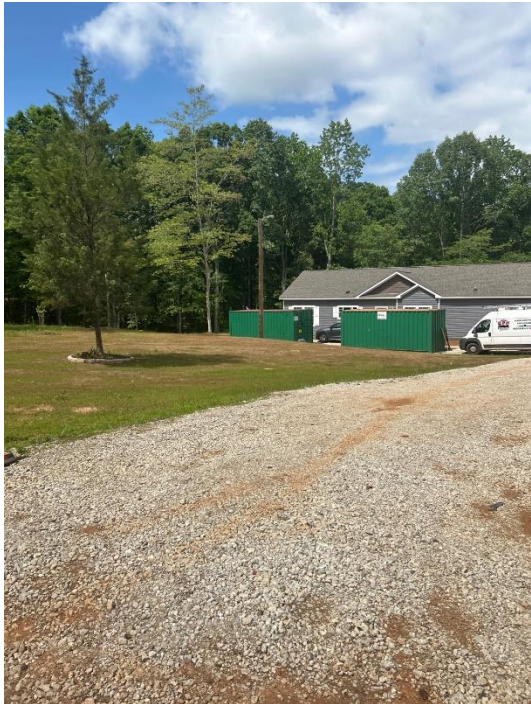
| <b>Photo No.</b><br><b>106</b> | <b>Date:</b><br>05/31/2023 | |

| <b>Description:</b><br>Project 5 - Land use is residential, recent construction | | |

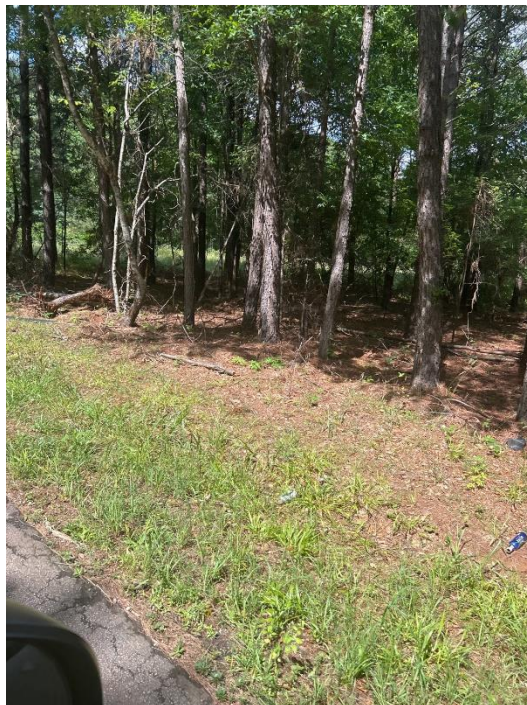
Project 5 - Land use is wooded

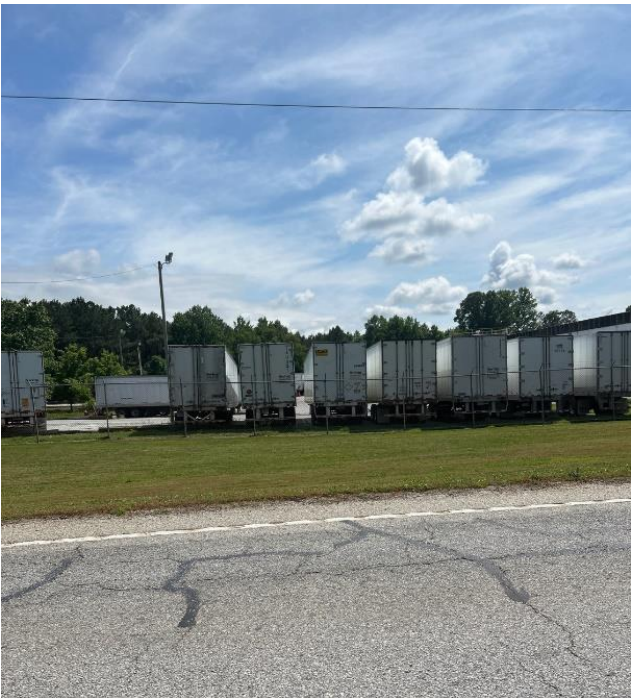
| <b>Photo No.</b><br><b>109</b> | <b>Date:</b><br>05/31/2023 | |

| <b>Description:</b><br>Project 5 – Industrial land use | | |

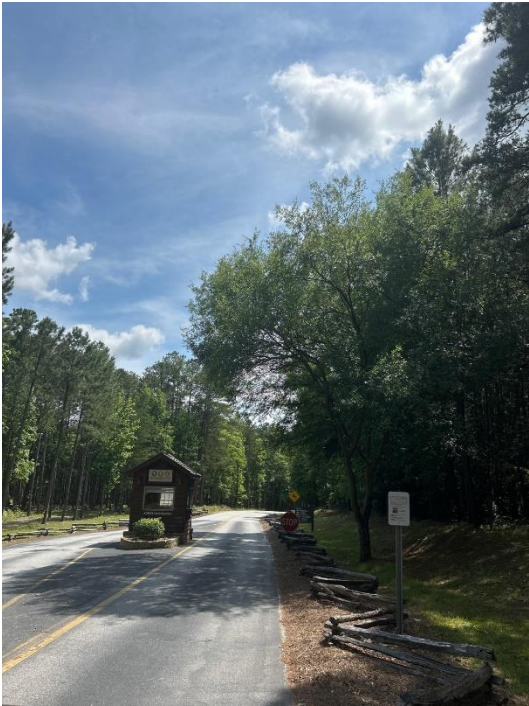
| <b>Photo No.</b><br><b>110</b> | <b>Date:</b><br>05/31/2023 | |

| <b>Description:</b><br>Project 7, Sign A1 - In good condition, located at the entrance of the park | | |
