## FINAL REMEDIAL INVESTIGATION REPORT

# FORMER CAMP CROFT SPARTANBURG, SOUTH CAROLINA

MRS 1, MRS 2, MRS 3, AoPI 3, AoPI 5, AoPI 8, AoPI 9E, AoPI 9G, AoPI 10A, AoPI 10B, AoPI 11B, AoPI 11C, and AoPI 11D

Contract No.: W912DY-10-D-0028 Task Order No.: 0005

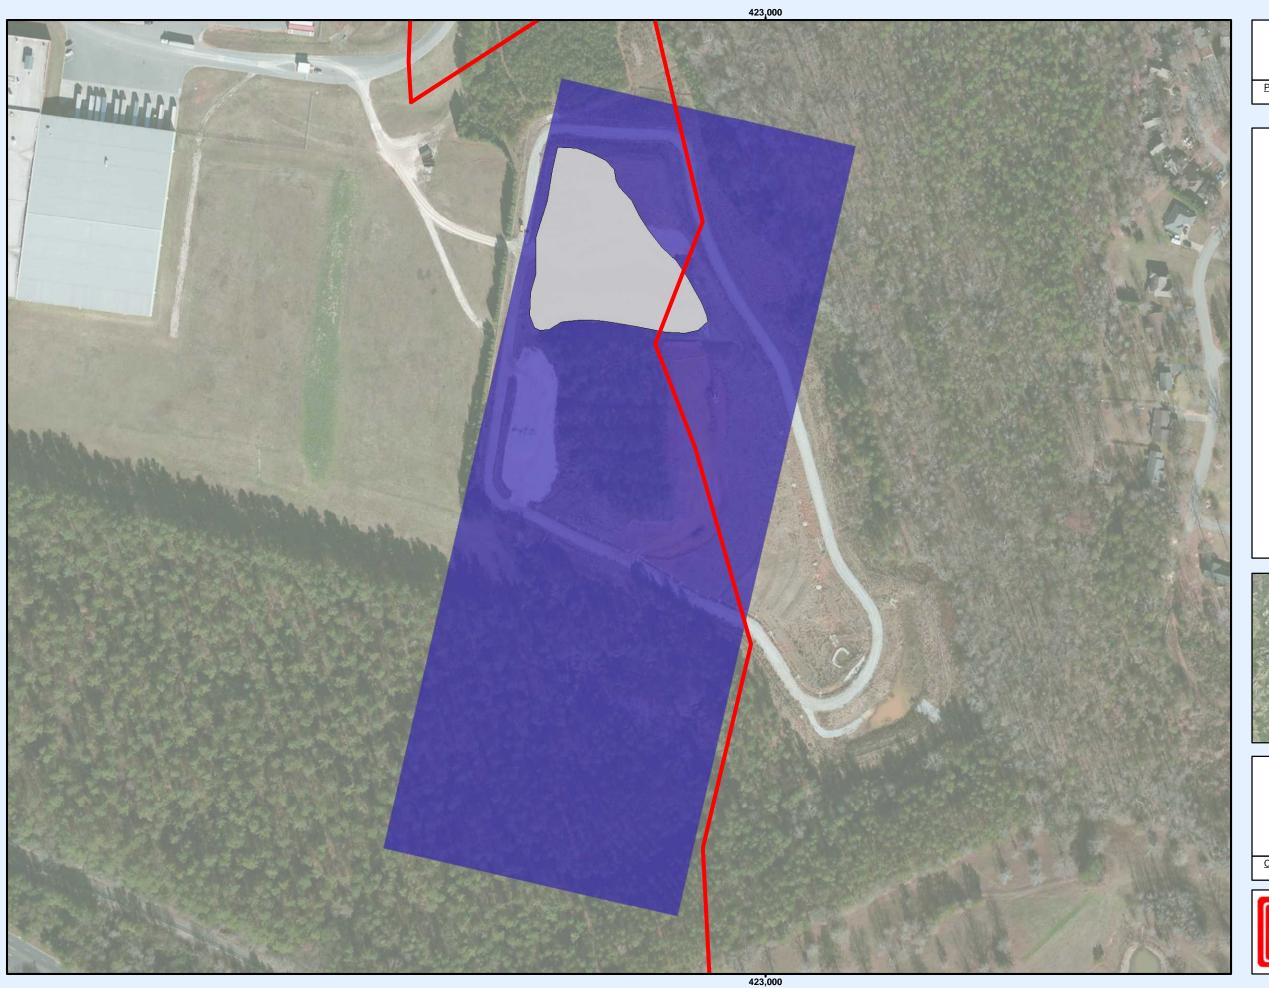
Project Number <u>Date</u> 00017 SEPTEMBER 2015 Exhibit 8-1

Remedial Investigation Report Proposed Boundary Realignment Former Camp Croft, Spartanburg, SC Proposed MRS 1 Revision 2

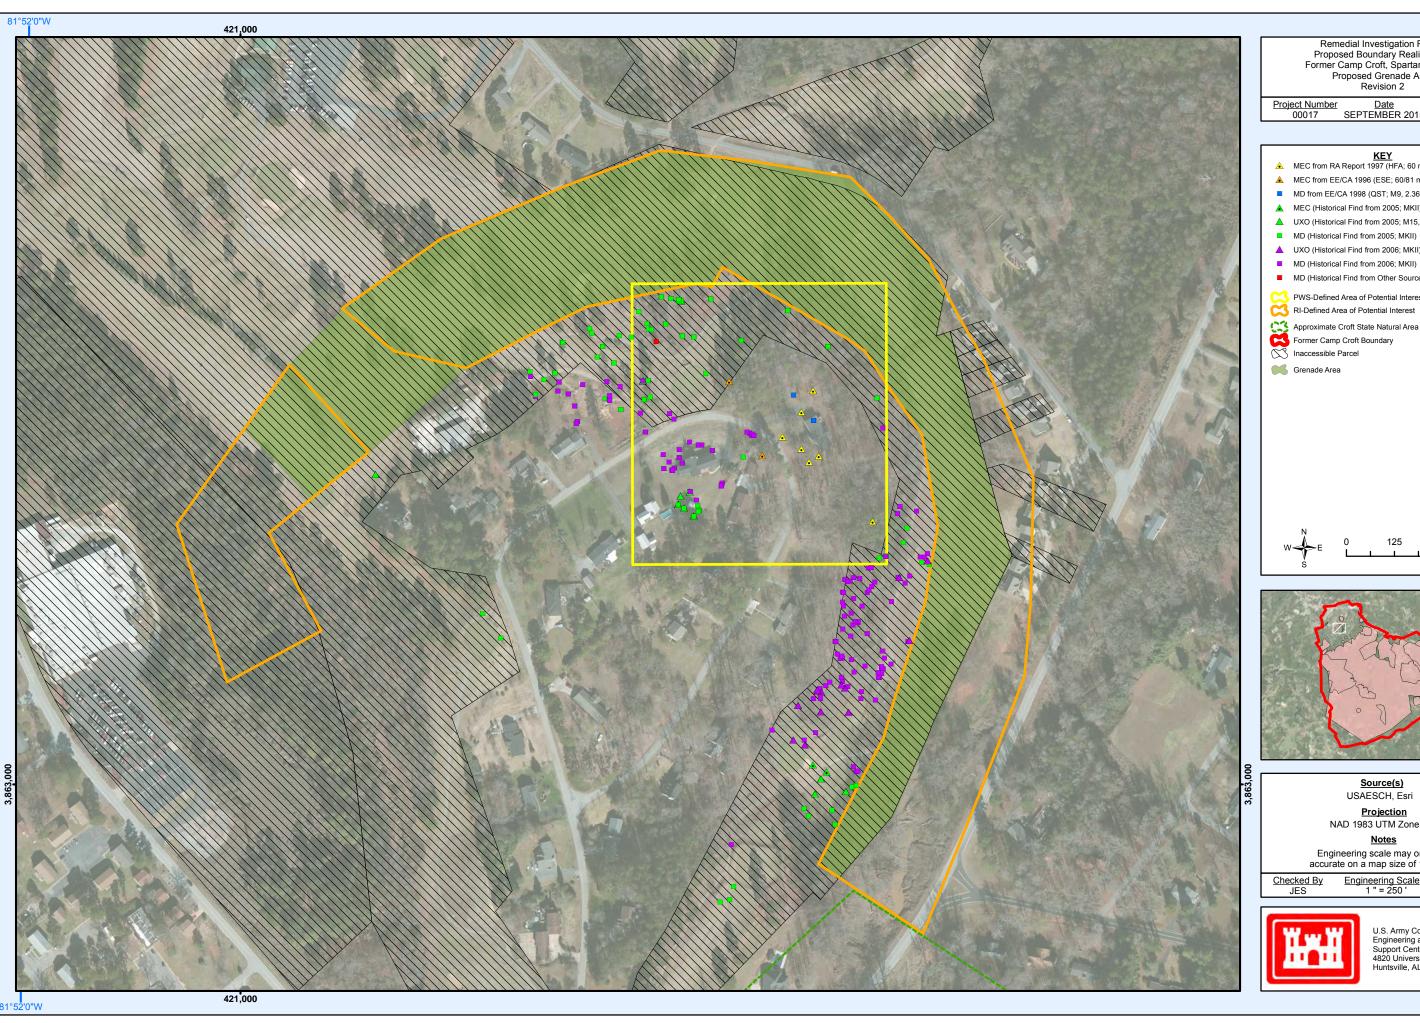
Remedial Investigation Report Proposed Boundary Realignment Former Camp Croft, Spartanburg, SC Proposed Grenade Area Revision 2

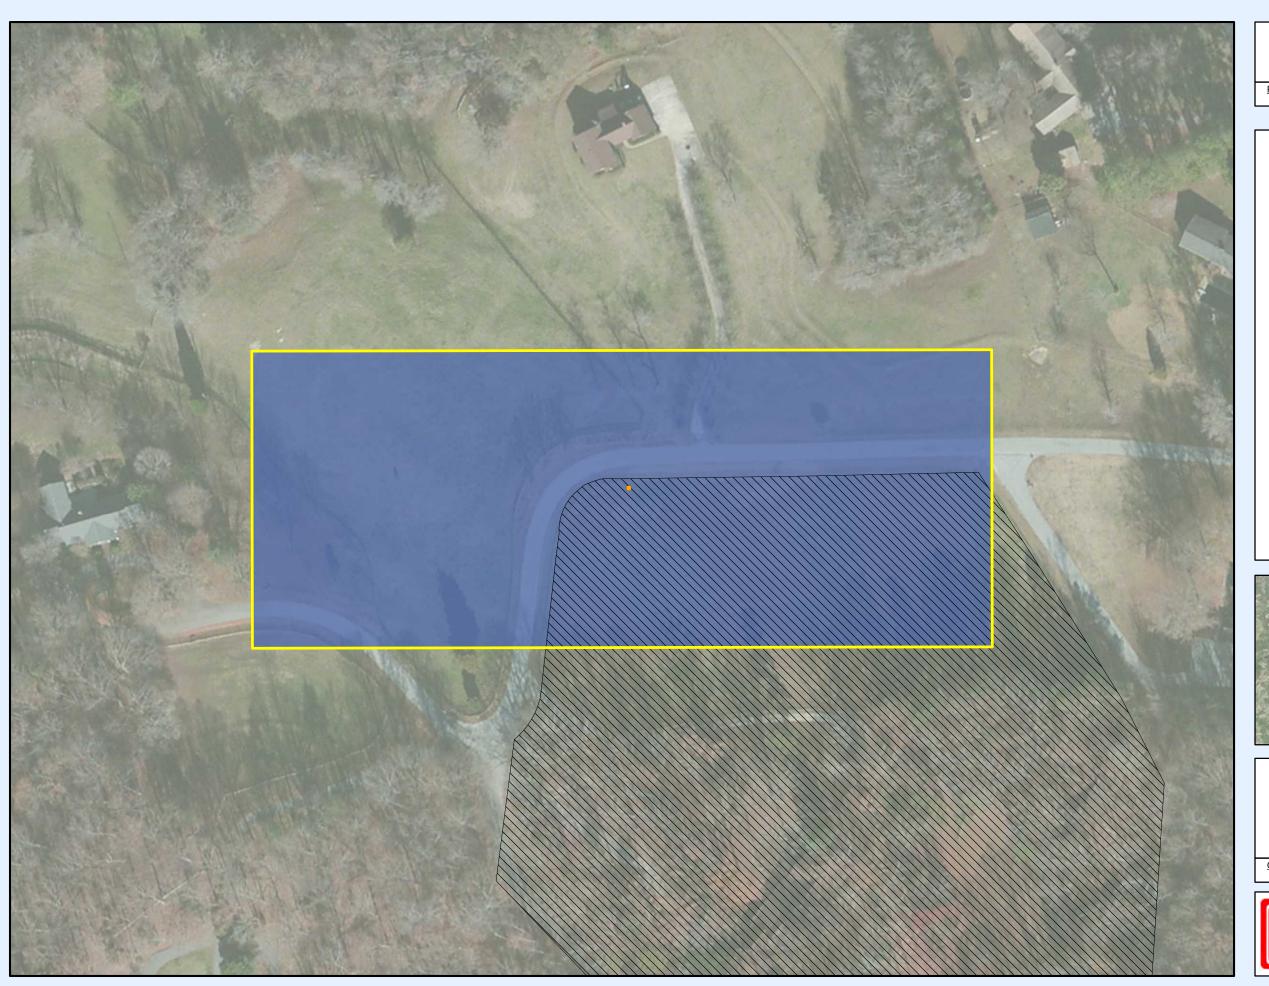
Project Number Date
00017 SEPTEMBER 2015 Exhibit 8-11

Remedial Investigation Report Proposed Boundary Realignment Former Camp Croft, Spartanburg, SC Proposed AoPI 5 Revision 2

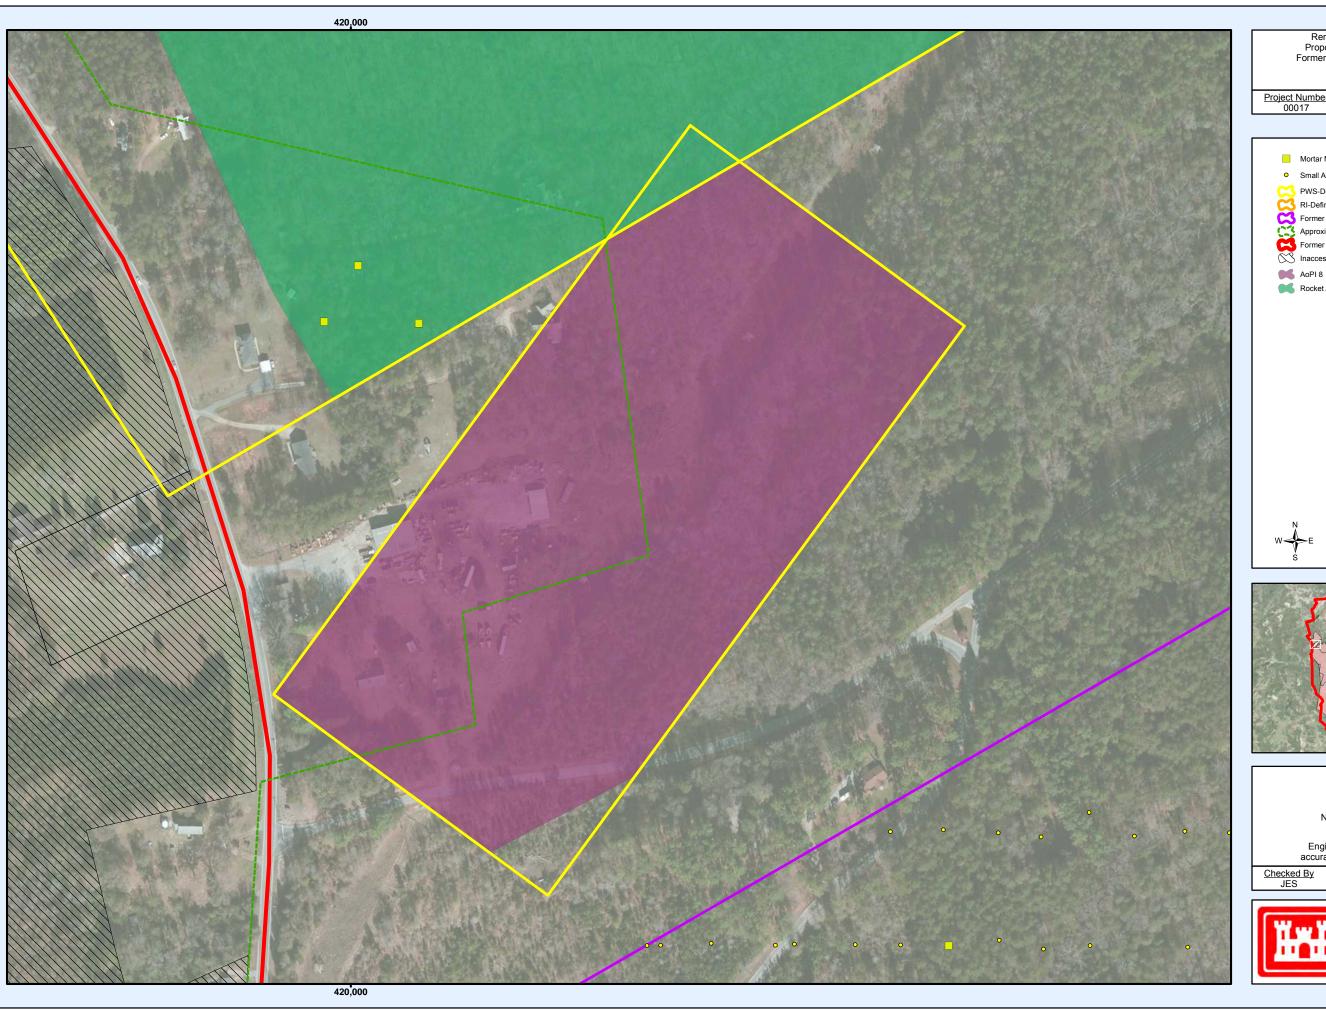
Project Number Date
00017 SEPTEMBER 2015 Exhibit 8-12

Remedial Investigation Report Proposed Boundary Realignment Former Camp Croft, Spartanburg, SC Proposed AoPI 8 Revision 2

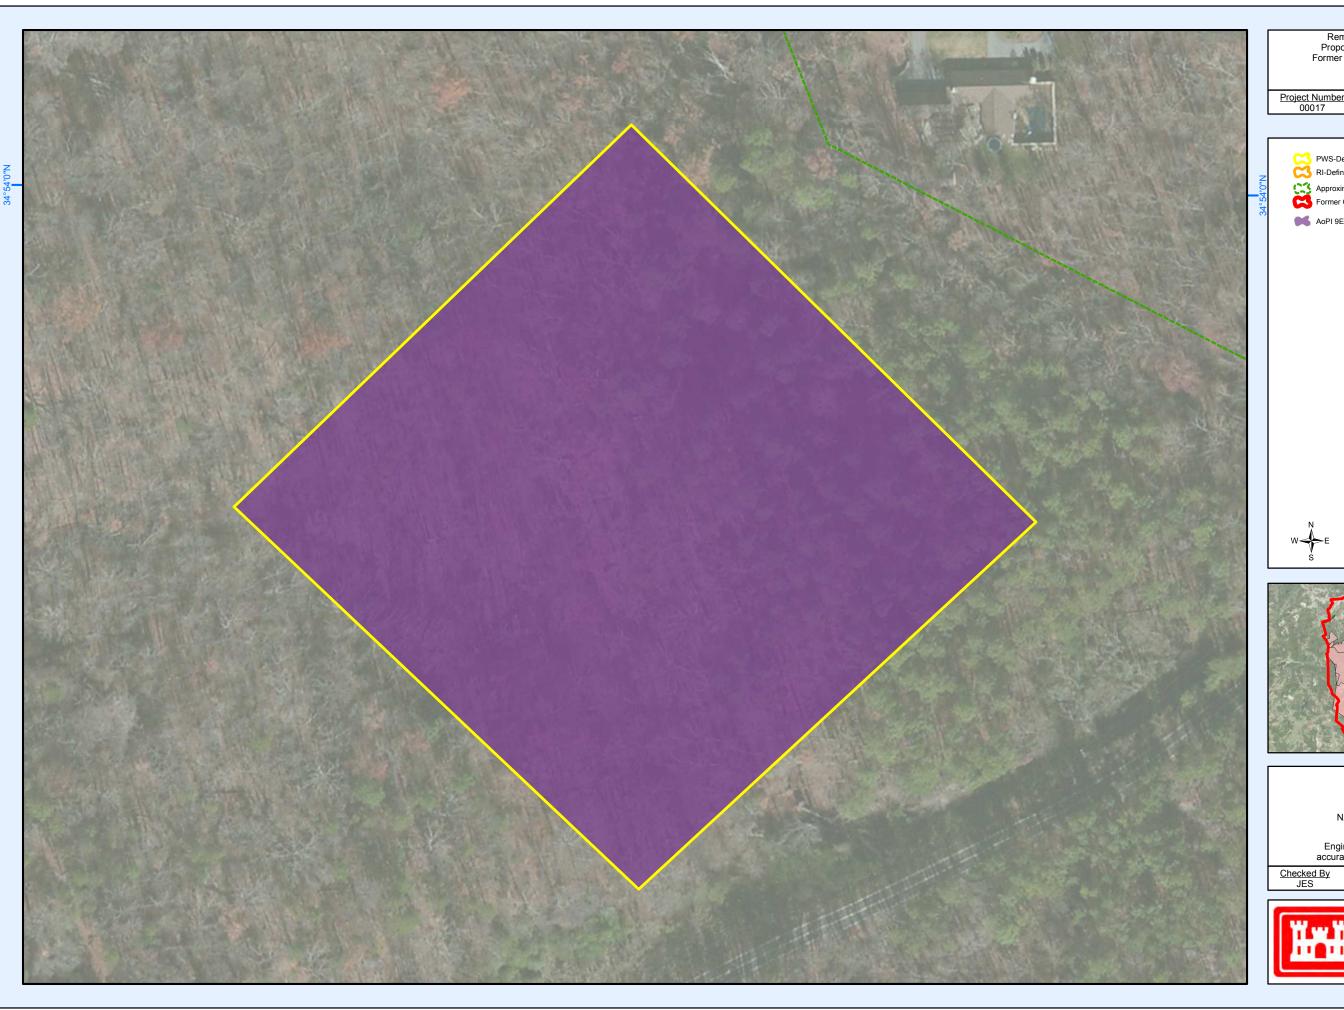
Project Number Date
00017 SEPTEMBER 2015 Exhibit 8-13

Remedial Investigation Report Proposed Boundary Realignment Former Camp Croft, Spartanburg, SC Proposed AoPI 9E Revision 2

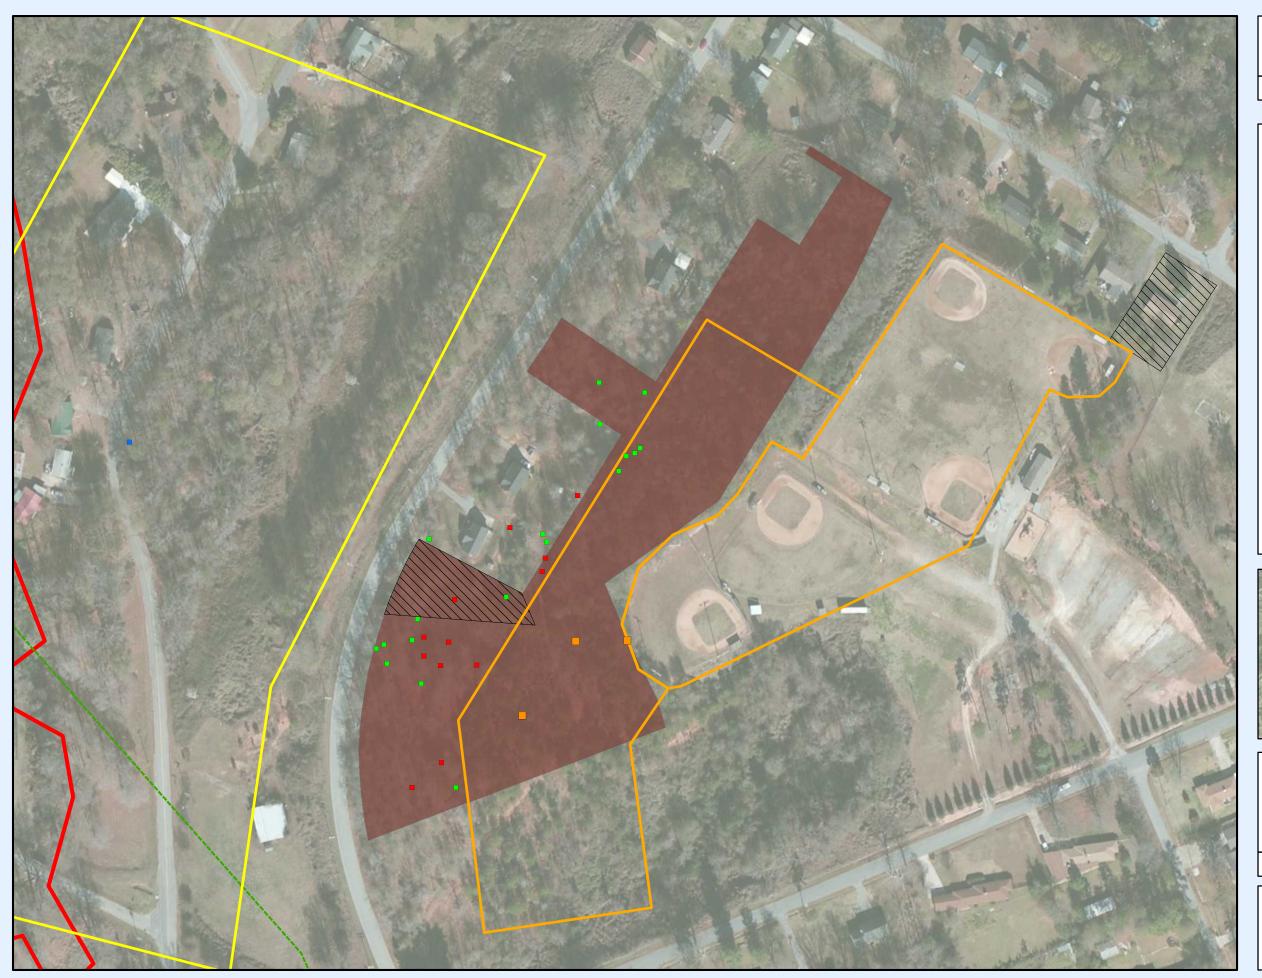
Remedial Investigation Report Proposed Boundary Realignment Former Camp Croft, Spartanburg, SC Proposed Practice Grenade Area Revision 2
