STRATEGIC OPTIMIZATION TECHNICAL MEMORANDUM

**Buxton Naval Facility
Buxton, North Carolina
FUDS Numbers I04NC000101 and I04NC000103**

U.S. Army Corps of Engineers
Huntsville Center
Environmental and Munitions Center of Expertise
1616 Capitol Avenue
Omaha, Nebraska 68102

May 2024

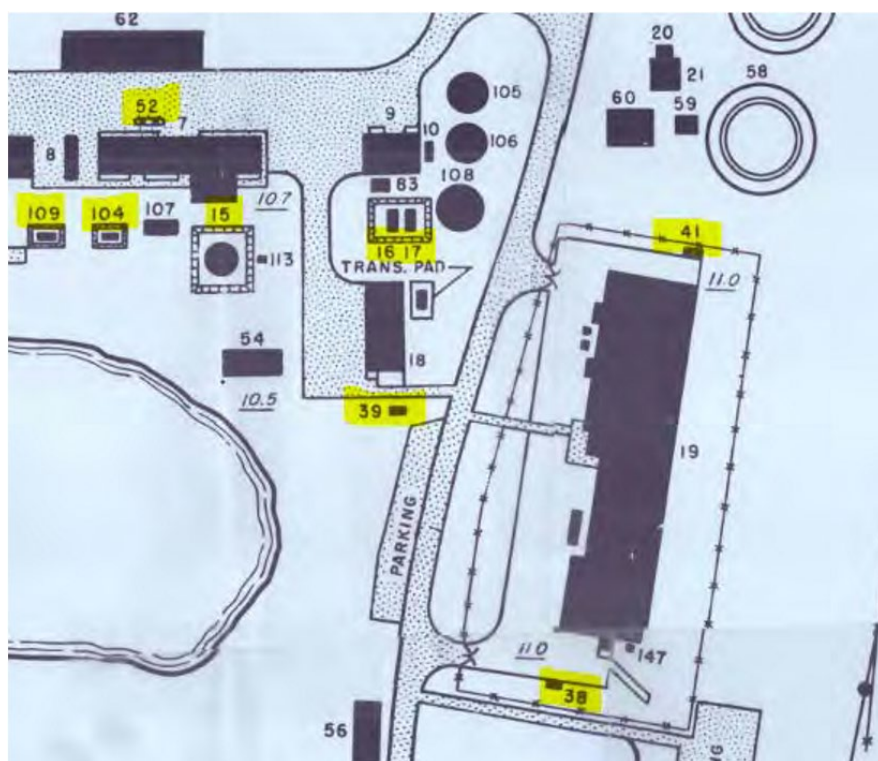
Figure from 2013 Preliminary Assessment (Section 4.2.2.2):

The petroleum, oil, and lubricants (POL) storage tanks and distribution operations at Buxton Naval Facility included a 540 BBL Diesel Oil Tank (#15), two 5,000 gallon fuel oil tanks (#16 and #17), a 1,000 gallon diesel oil tank (#38), two 2,000 gallon diesel oil tanks (#39 and #41), two motor gasoline (MOGAS) pumps (#52) at the service station, a 3,000 gallon MOGAS tank (#104), and a 1,500 gallon MOGAS tank (#109)

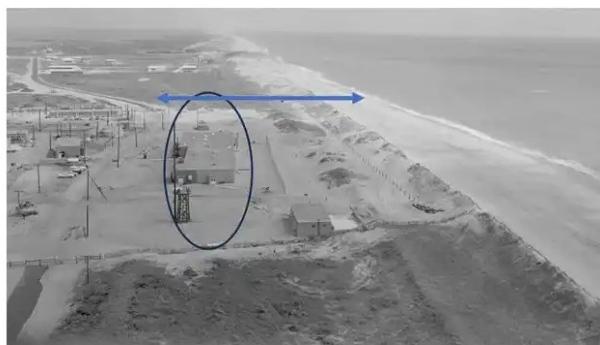
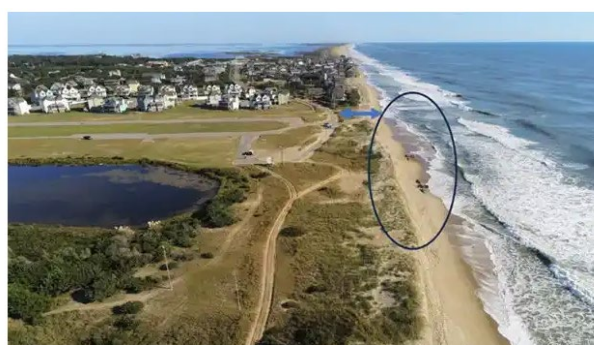
NPS Photos Showing Erosion at Buxton Beach

Photos from presentation by the National Park Service on March 27, 2024 show dramatic erosion. The location of buildings in the Navy Base and the current position of the tide line. Courtesy NPS

Buxton Beach erosion rates average 10 feet per year horizontally; the Buxton shoreline is now much further inland than when the Navy facilities were built, as shown in arial photos excerpted in the attachments below. The area of exposed infrastructure was buried under beach sand and sand dunes until September 2023 when a storm caused a major erosional event. Since then, the area has been exposed and reburied several times. During an erosional event, the vertical loss of sand can be 10 feet, and this may only last several days before additional sand is deposited. The buried infrastructure appears to be remnants of Building 19 (terminal building), which formerly housed the terminus of listening cables that were used to detect enemy warships off the coast. Building 19 was demolished in 1986. The building was originally located on the west side of the dunes, but remnants are now underneath the dunes and beach.

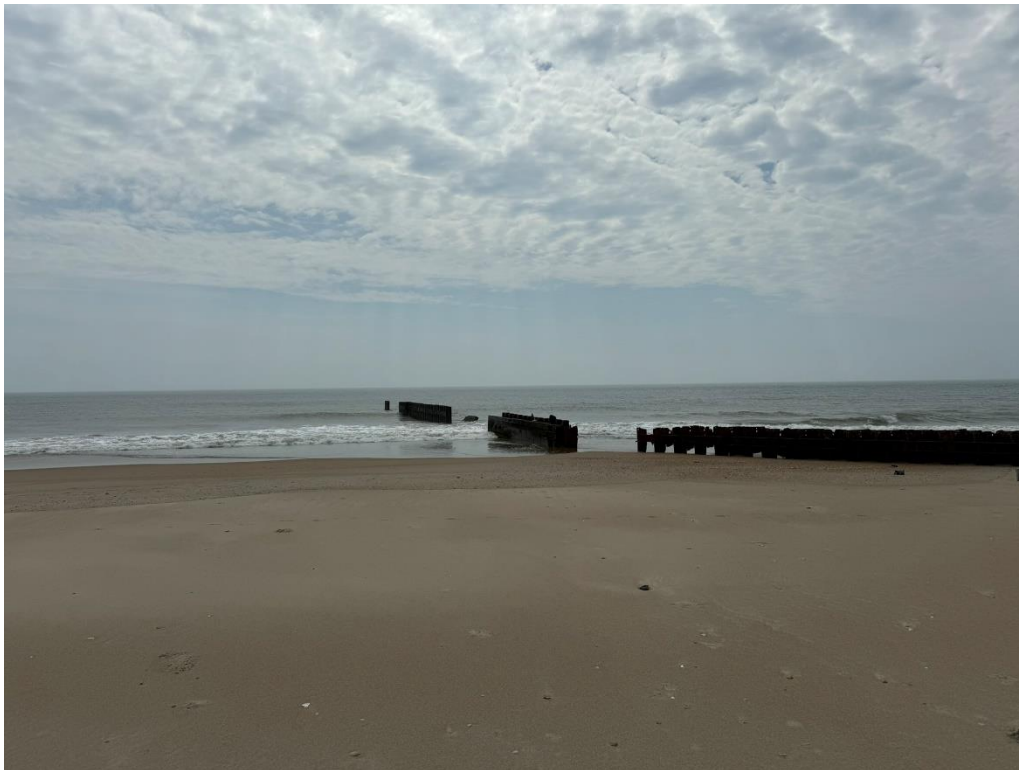
Photo 4 - Southern "groin" structure installed south of FUDS site by Navy

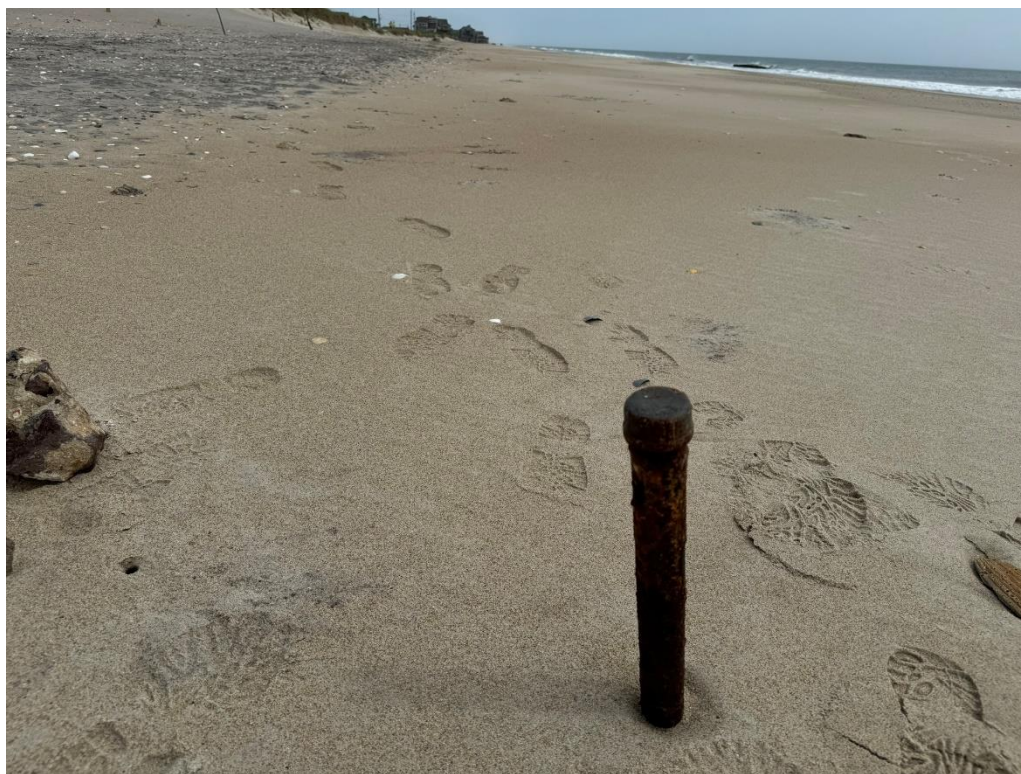
Photo 5 - Small capped metal pipe located south of FUDS site along beach

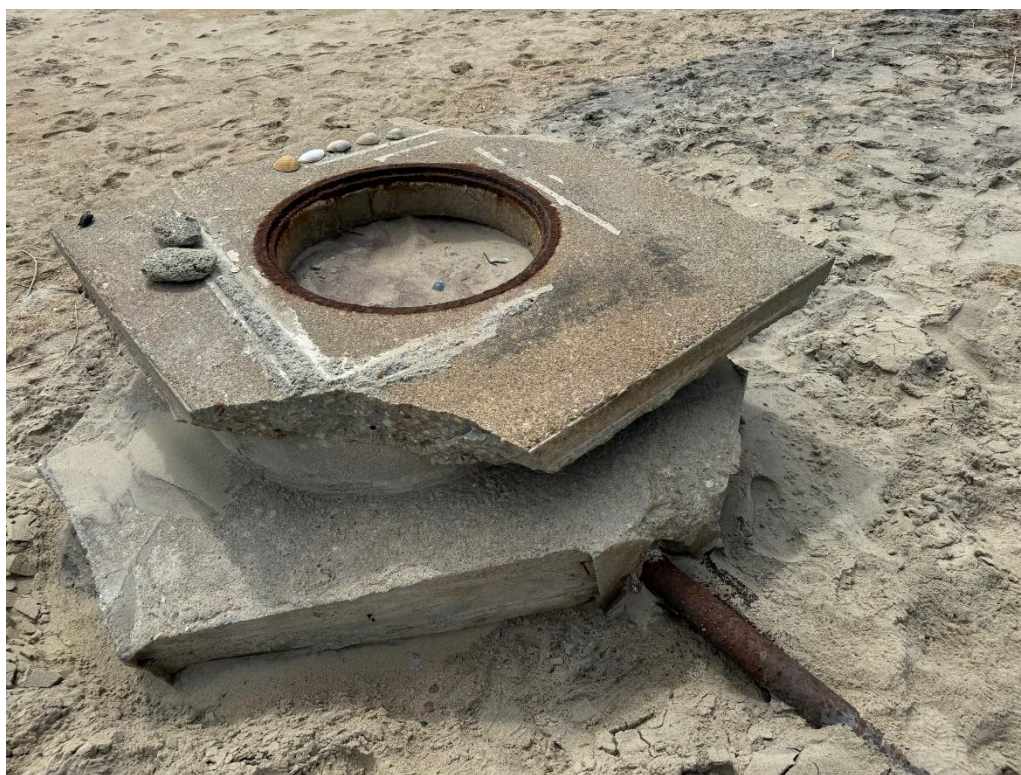
Photo 6 - Manhole structure located near southern part of former Building 19. Note two metal pipes going west from manhole.

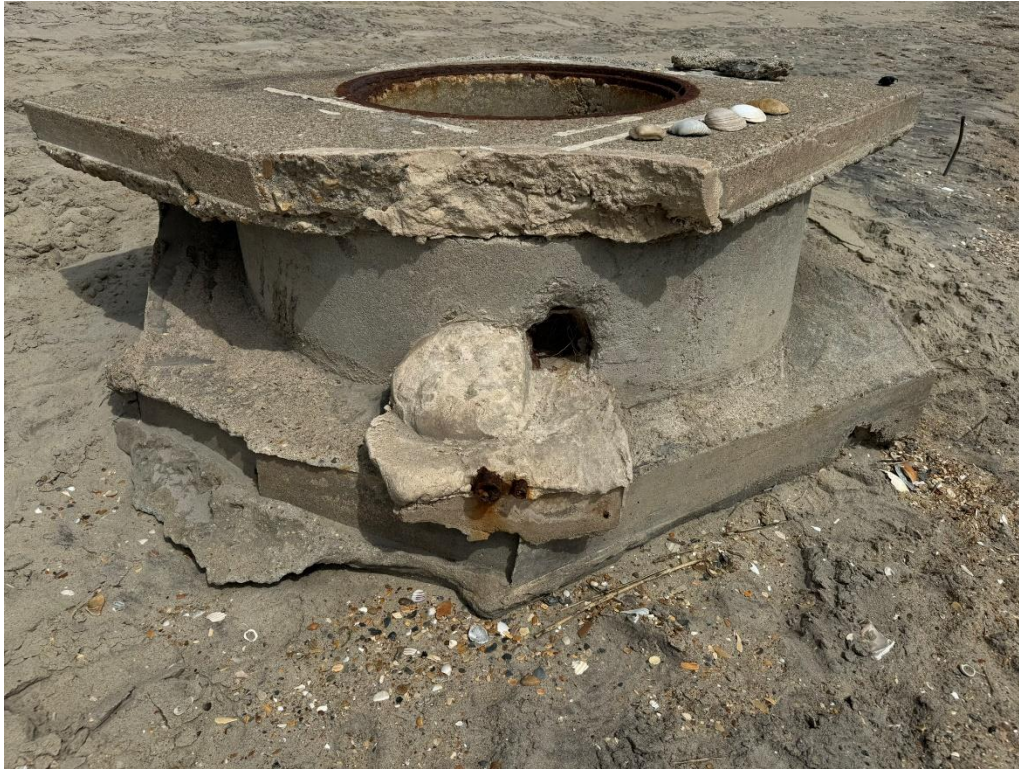
Photo 7 - Additional view of manhole structure. Two smaller pipes/conduits protruding to southeast. Smaller conduit appears to have metal cable inside.

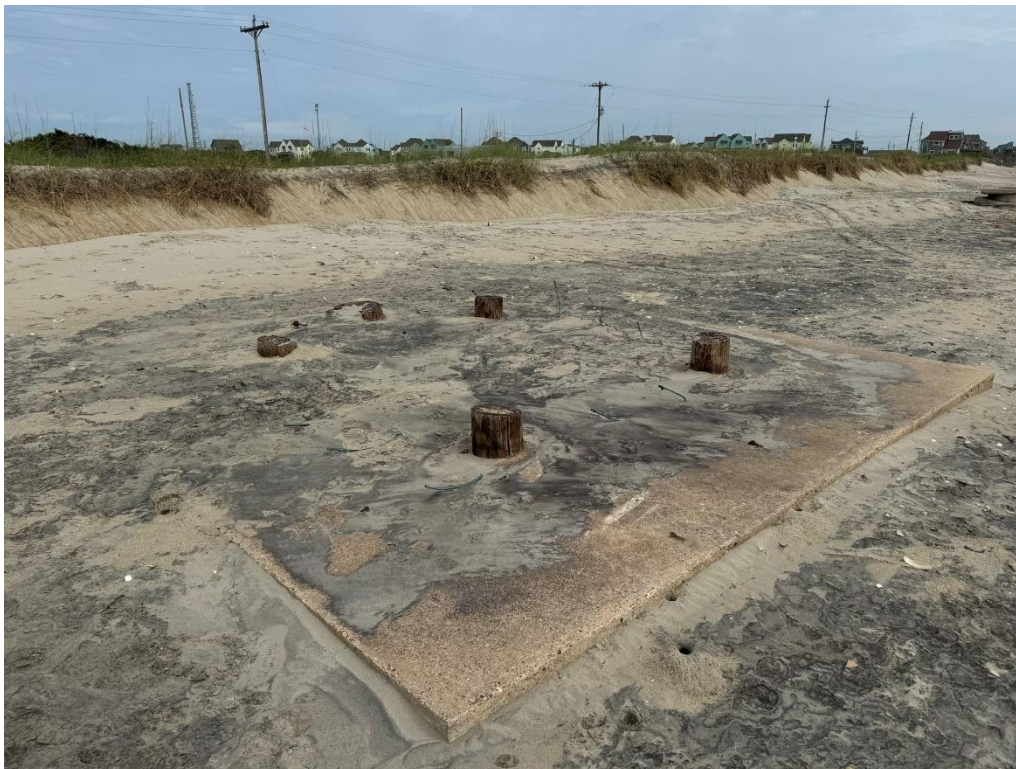
Photo 8 - Concrete pad with timber piers located south of former Building 19 and manhole structure.

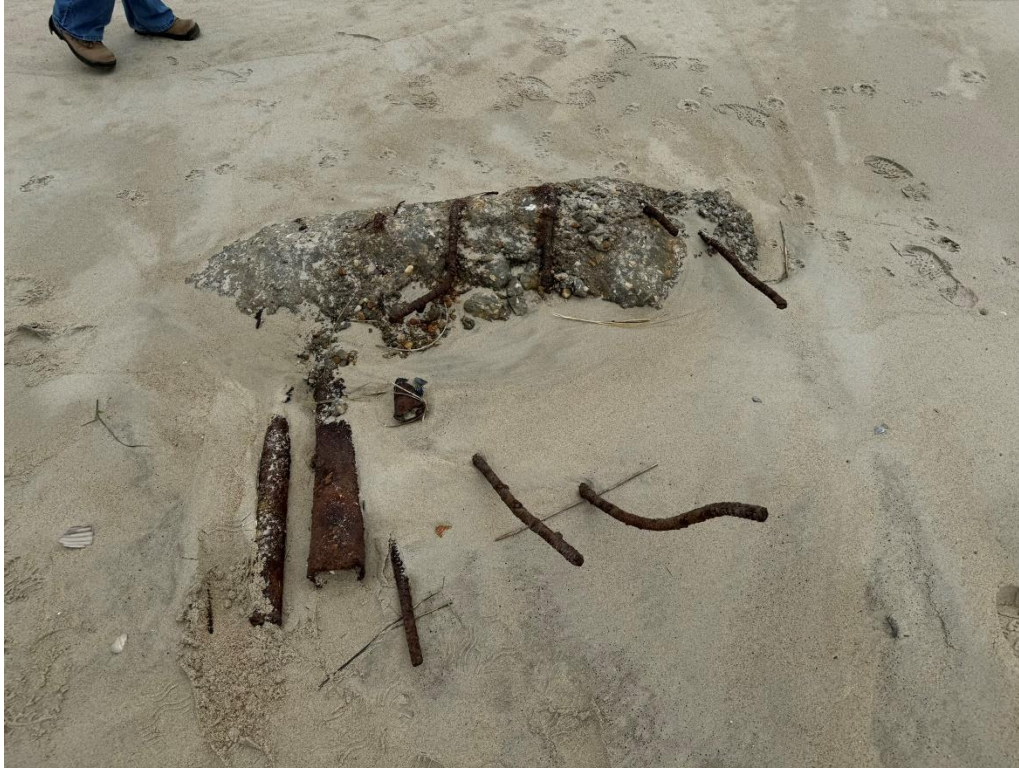
Photo 9 - One of two reinforced concrete structures located in footprint of former Building 19. Believed to be access point for submarine listening equipment to exit building toward beach/water

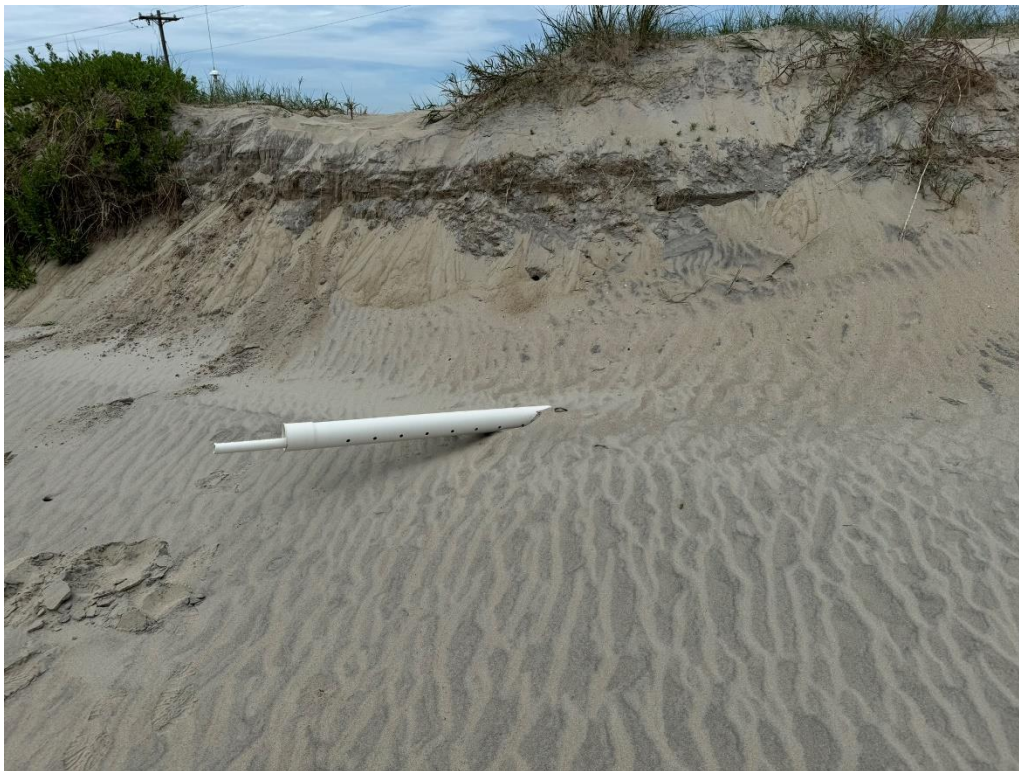
Photo 10 - Assumed sanitary leach field drain pipe located north of former Building 19.

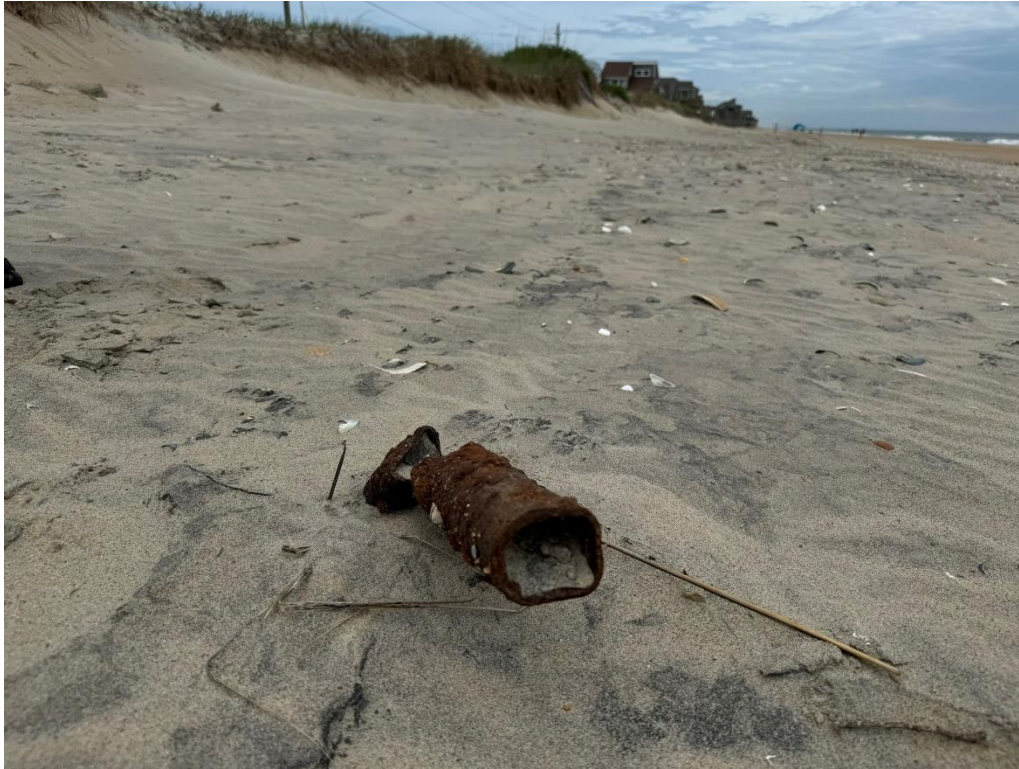
Photo 11 - Small metal pipe located on beach, north of former Building 19

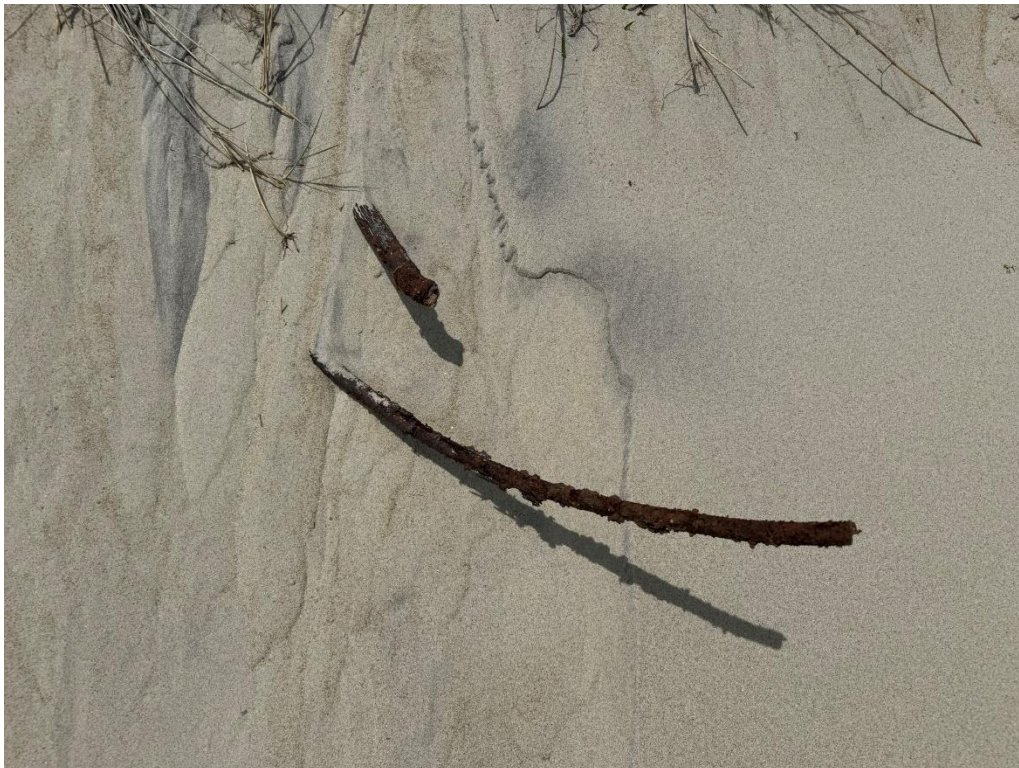
Photo 12 - Two small metal cables/conduits protruding from dune face, near north end of FUDS

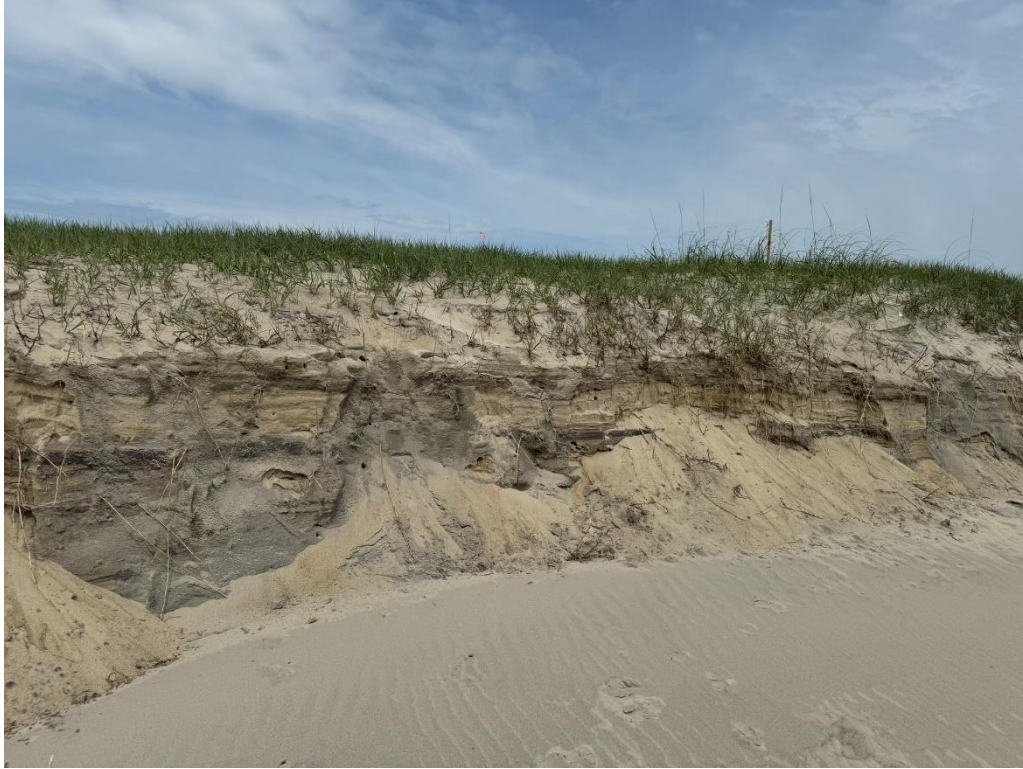
Photo 13 - Exposed dune face showing different soil layers

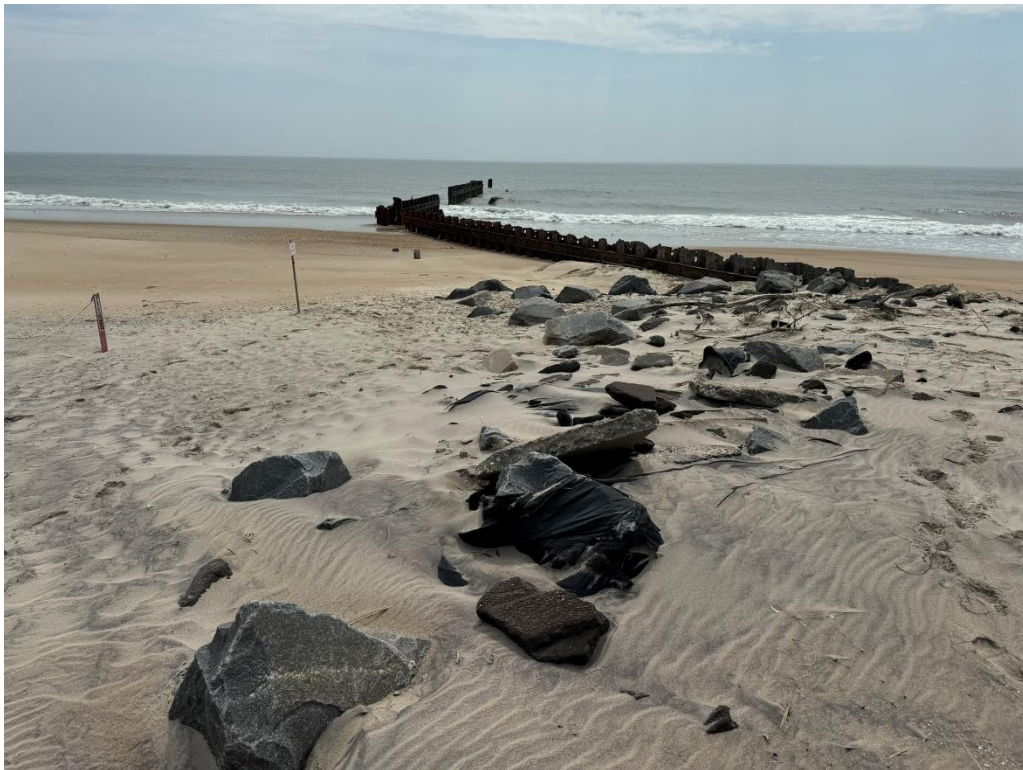
Photo 14 - Boulders and likely asphalt chunks placed on beach near southern "groin" south of FUDS

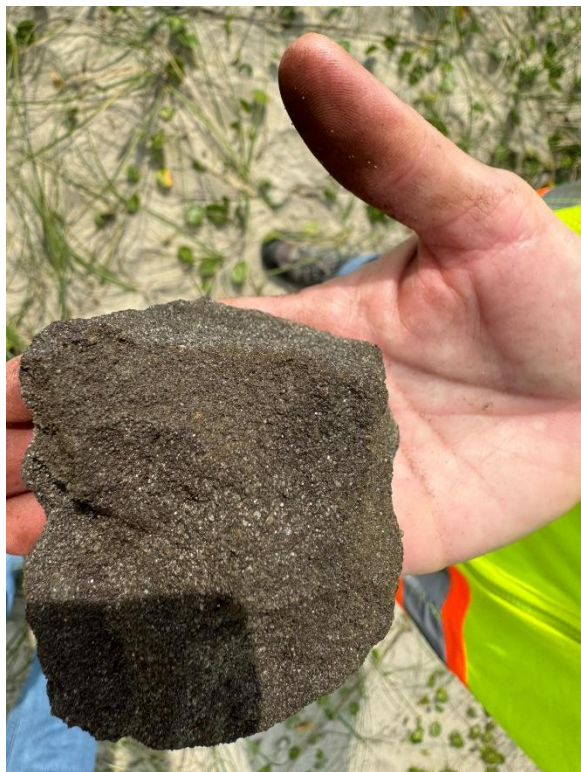
Photo 15 - Example of soil that could be considered "peat-like". This fragment found on dunes, moderately cohesive, no odor, no evidence of organics

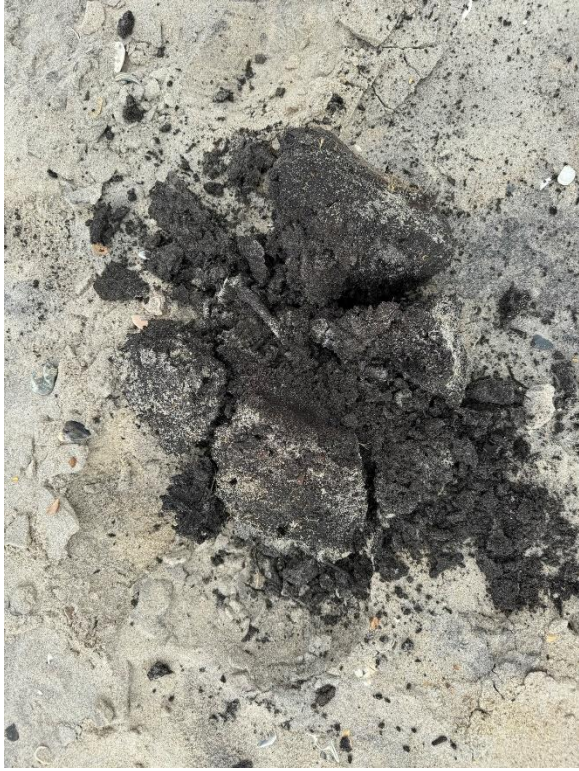
Photo 16 - Example of larger chunk of "peat-like" material found on beach near southern leach field. Material was light, friable, had visible organic material and organic odor.

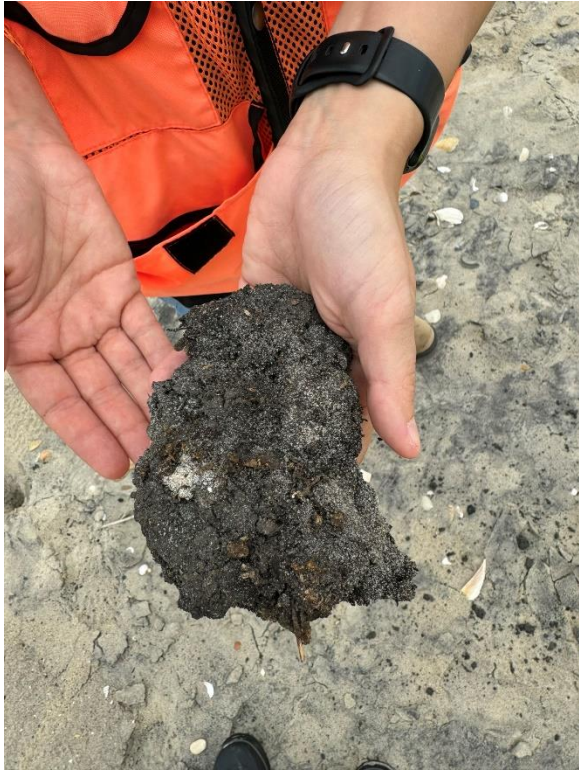
Photo 17 - Additional example of "peat-like" material on beach. Light, friable, visible organic material (wood, leaves), organic odor and possibly fuel-related odor. Some gray discoloration noted.

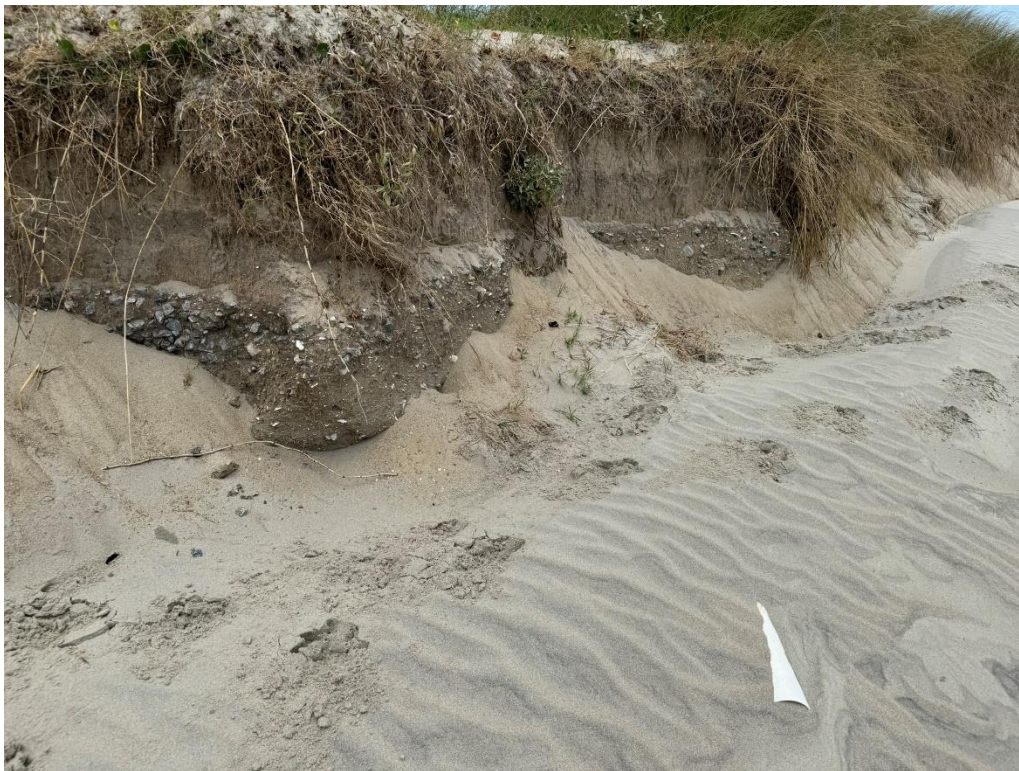
Photo 18 - Additional exposed septic leach field pipe and evidence of backfill (gravel in dune face)

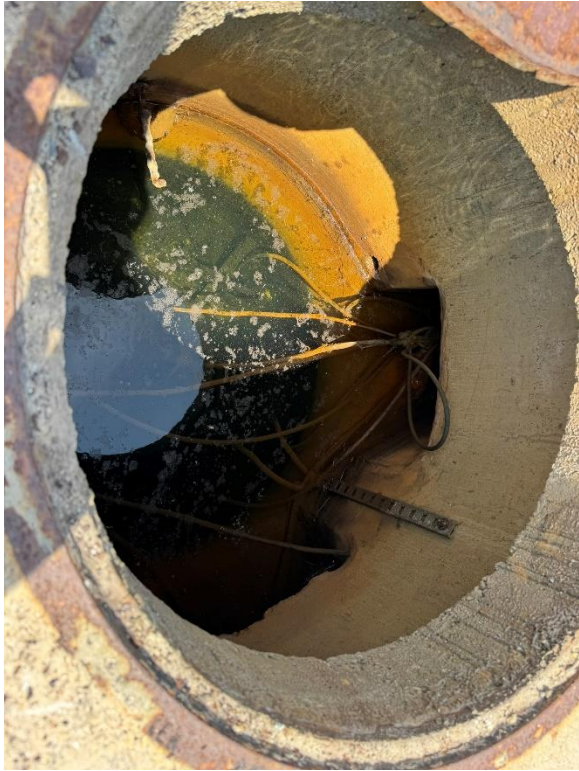
Photo 19 - One of two manholes located west of dunes, eastern/southern part of FUDS. Both contained water, no odor/sheen. Cable conduits going north-south and east-west. Assumed communication cables observed, cut-off metal pipes observed.

- The dune-side portion of the FUDS included very little remnant infrastructure, limited mainly to manholes for utilities. Two manholes believed to be communications-related were located and opened. Both manholes were partially filled with water (no sheen or odor). The manholes had cable conduits/chases running in two directions from the manholes. Several sanitary sewer manholes were present. Two were opened and inspected. No odors were noted. A small amount of baseflow was noted in one manhole.

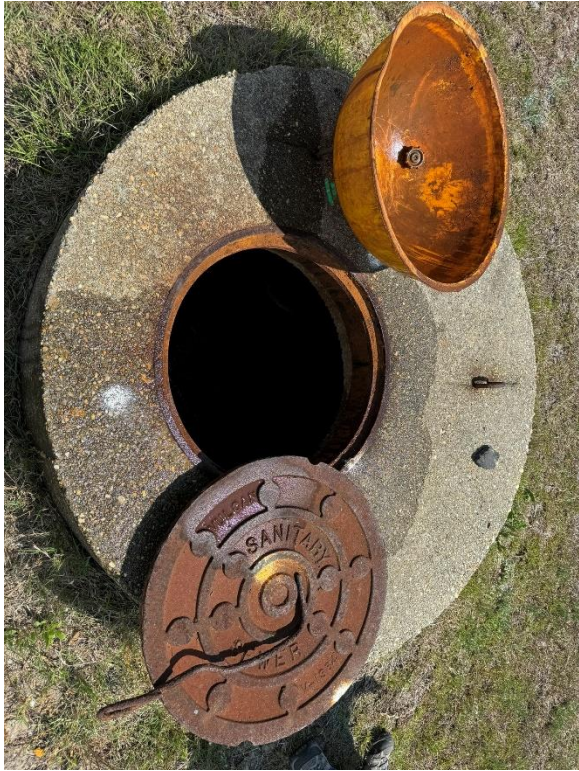
Photo 20 - One of several sanitary sewer manholes noted. Two manholes opened. No odors or sheen. One manhole had small amount of assumed groundwater baseflow

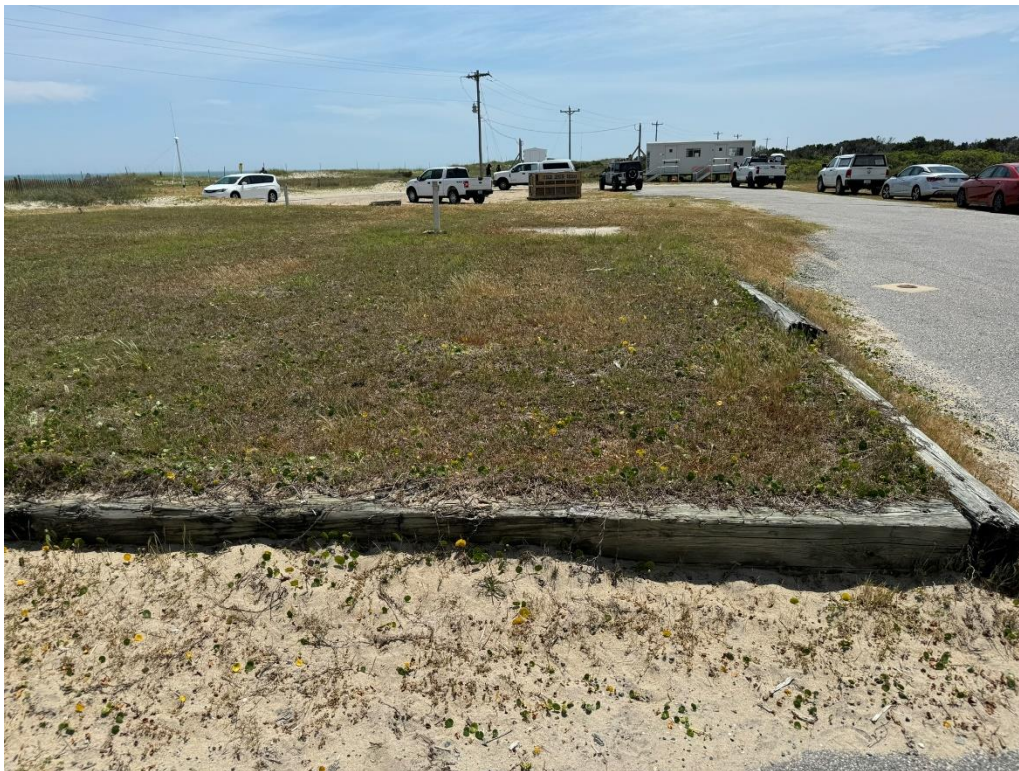
Photo 21 - Former location of Building 9 (identified as Heating Plant/Water Pumping Station)

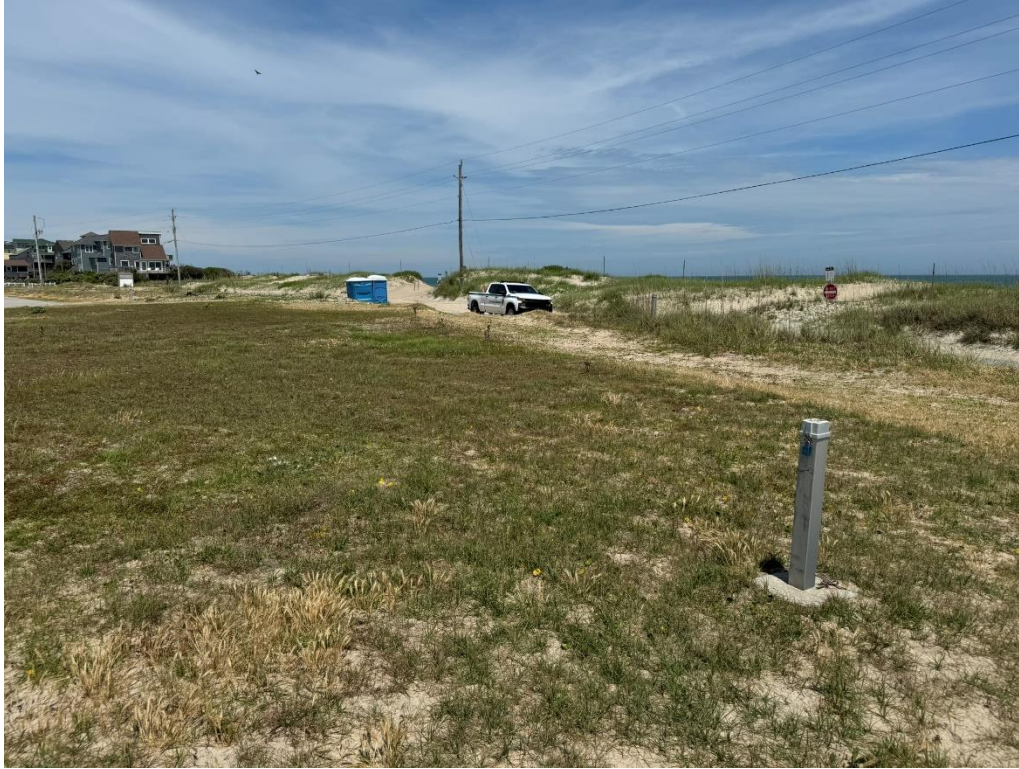
Photo 22 - Representative photo of monitoring well

- Monitoring wells were noted on the dunes and further inland. Wells were both flush-mount and stickup type. The monitoring wells were all closed, locked, and in good condition.
