Brunswick Harbor Deepening Project

Mitigation Closeout Report

**US Army Corps
of Engineers**
Savannah District

Brunswick Harbor Deepening Project Mitigation Closeout Report

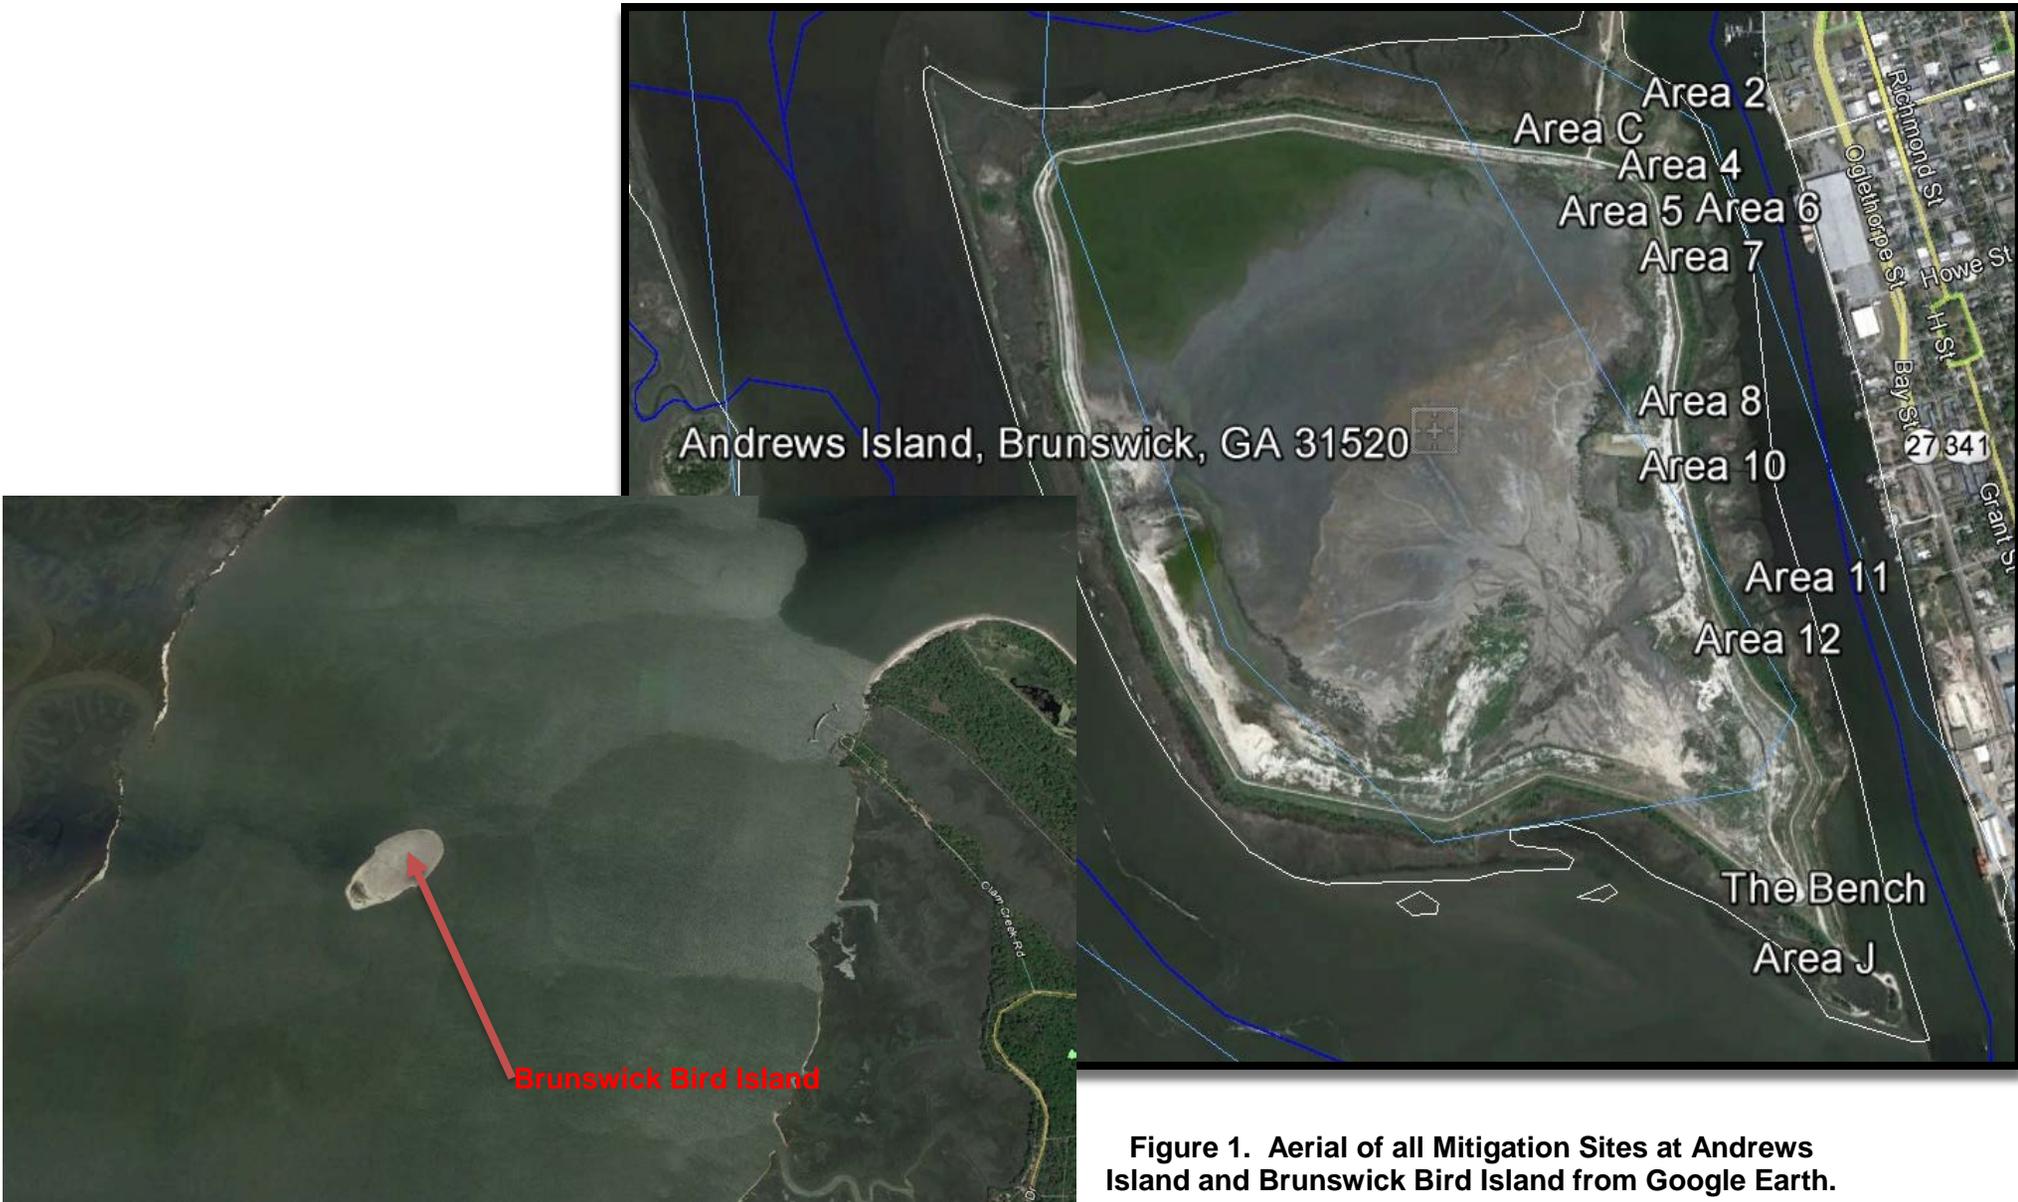
Figure 1. Aerial of all Mitigation Sites at Andrews Island and Brunswick Bird Island from Google Earth.

Along with restoring salt marsh habitat to mitigate for expanding the East River Turning Basin, Savannah District placed dredged material within the Brunswick Sound to create a bird island. That beneficial use feature was completed in 2008 and provides additional environmental benefits. A map of the overall mitigation areas is shown in Figure 1.

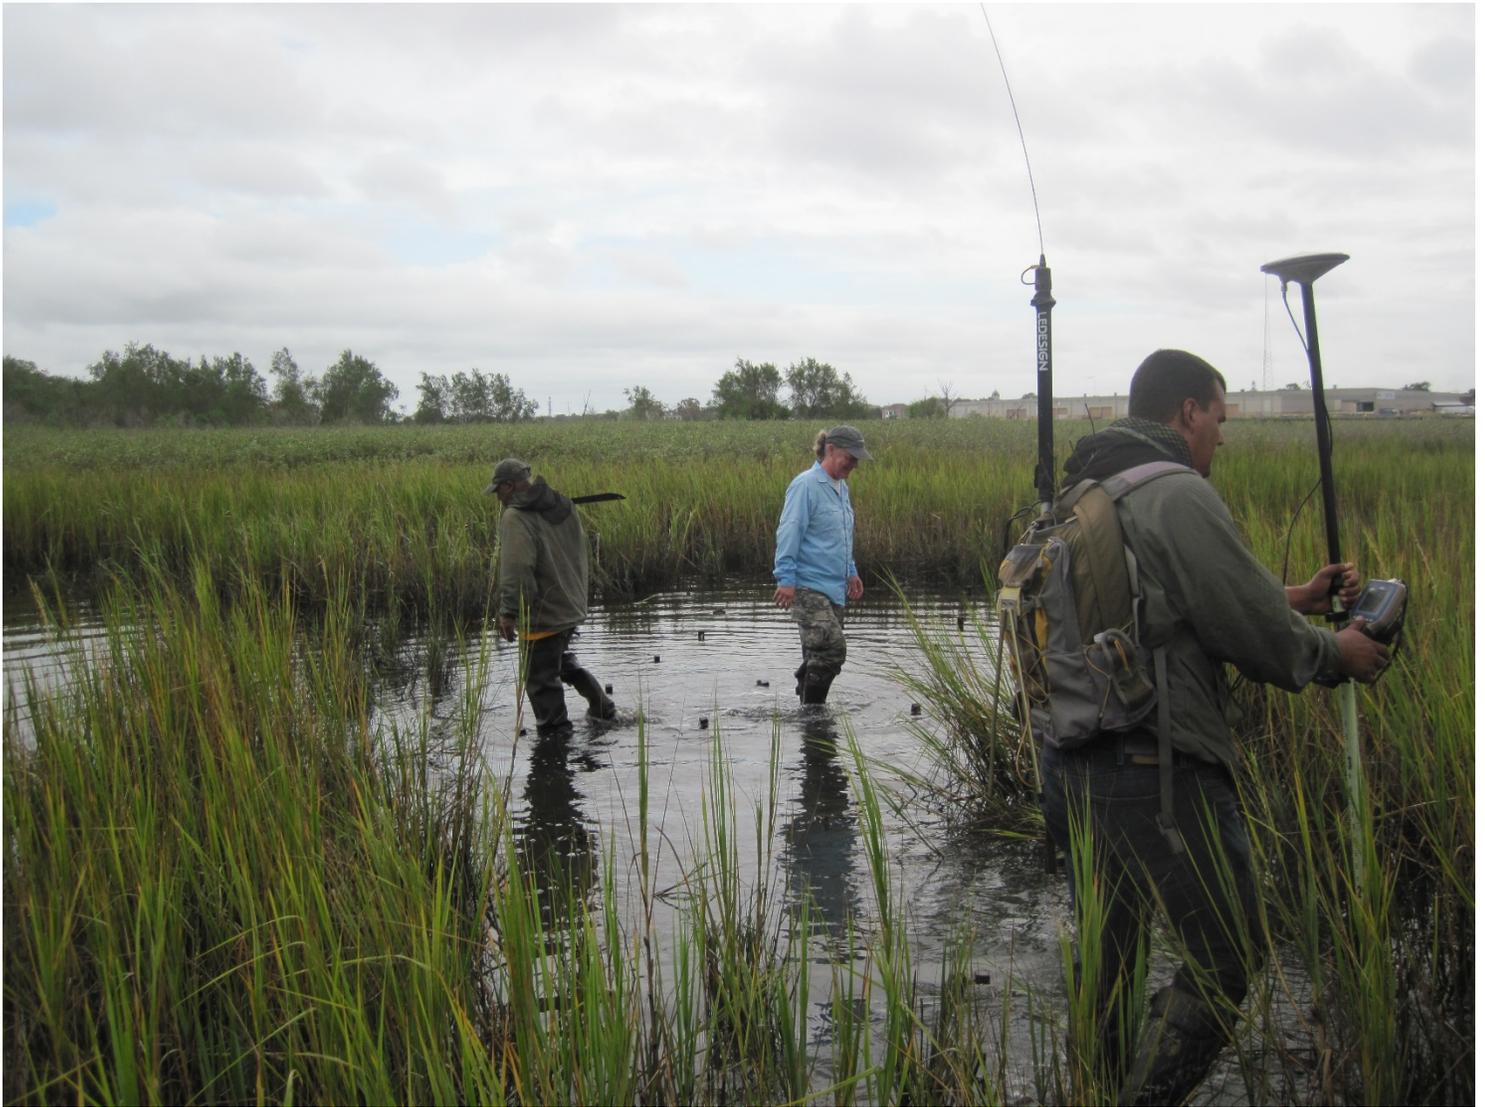
Figure 2. Survey Efforts in Area 10.

A comprehensive topographic and vegetative survey was conducted on September 12 and 13, 2016. A Savannah District survey crew using Ashtech ProFlex 500 land surveying equipment measured the bare, open water areas to develop a detailed analysis of vegetative coverage at each of the restoration sites. Savannah District environmental staff were also on site to assist with the comprehensive survey. During the final year of monitoring in 2016, the percent of vegetative coverage was over 100% of the mitigation requirement (17.79 acres out of the 16.82 required). Table 1 summarizes the mitigation commitments and the extent of the revegetation from the September 2016 comprehensive survey. Table 2 summarizes the mitigation commitments and extent of attainment from the aerial imagery taken in 2016 by GADNR.

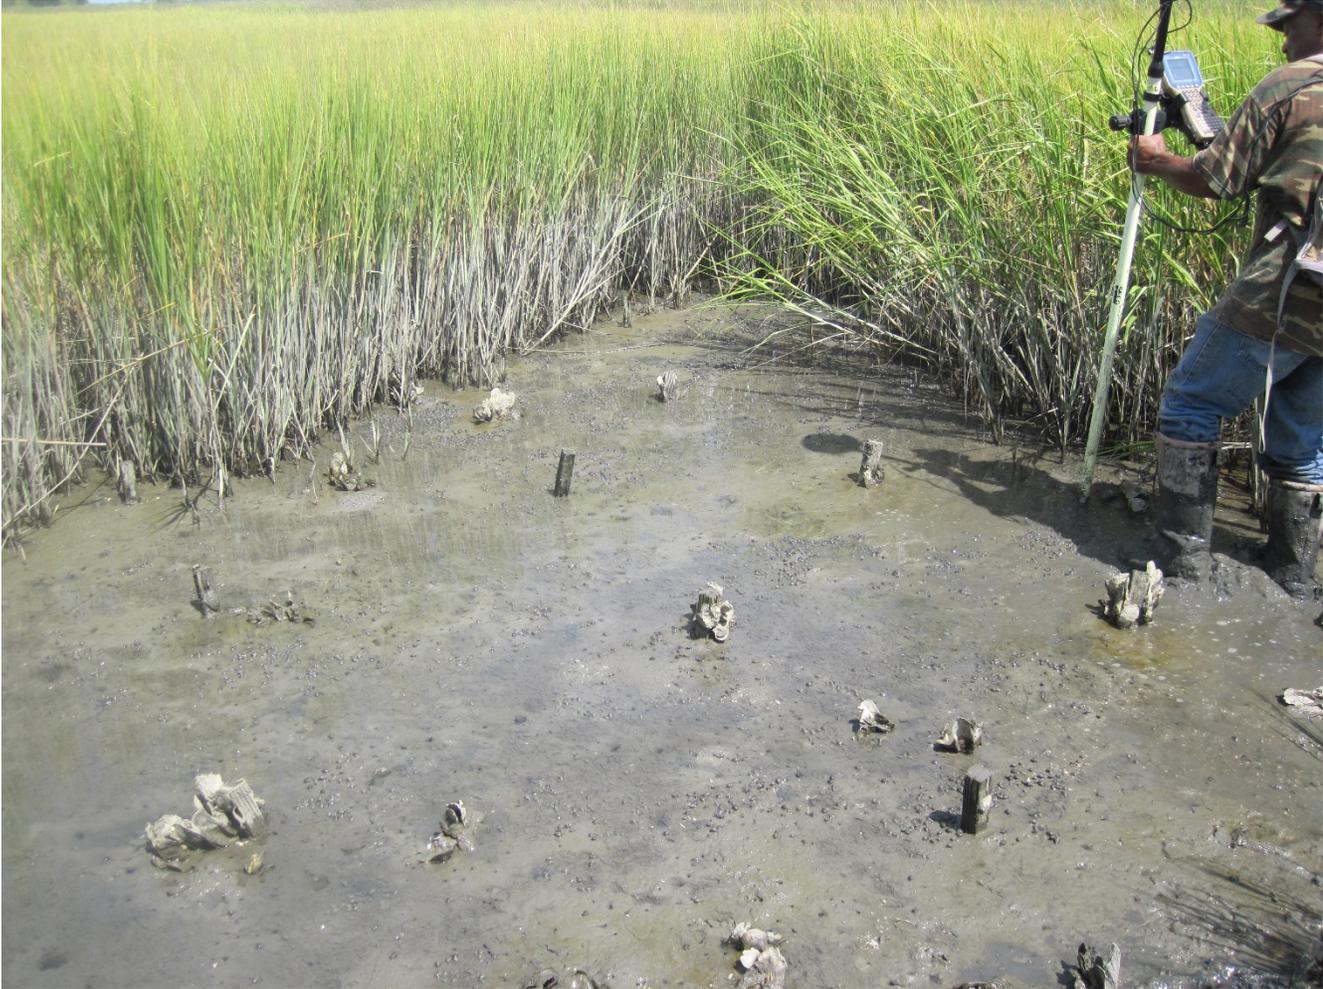
Figure 3 (above). Survey Efforts in Area 12.

While oyster habitat was not part of the original Brunswick Harbor Deepening Project wetland mitigation plan, during the first few years of the project, Savannah District counted some oyster beds that developed within the restoration sites toward the project's EFH habitat commitment. Over time, those areas silted in and are slowly being replaced with *Spartina*, which also fulfill the project's EFH commitment. As seen in Figure 3, oyster habitat still exists in several planting stakes in the area.

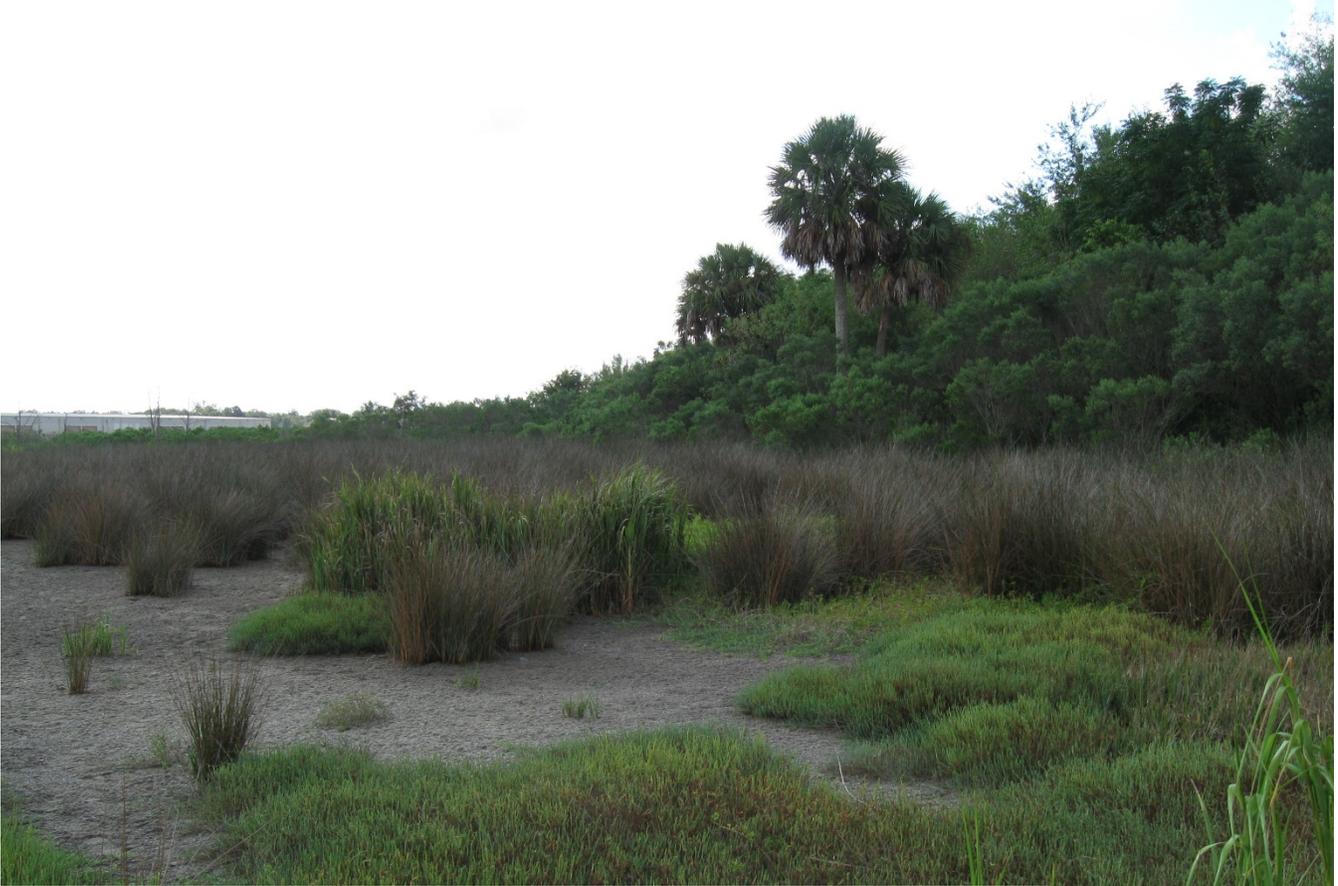
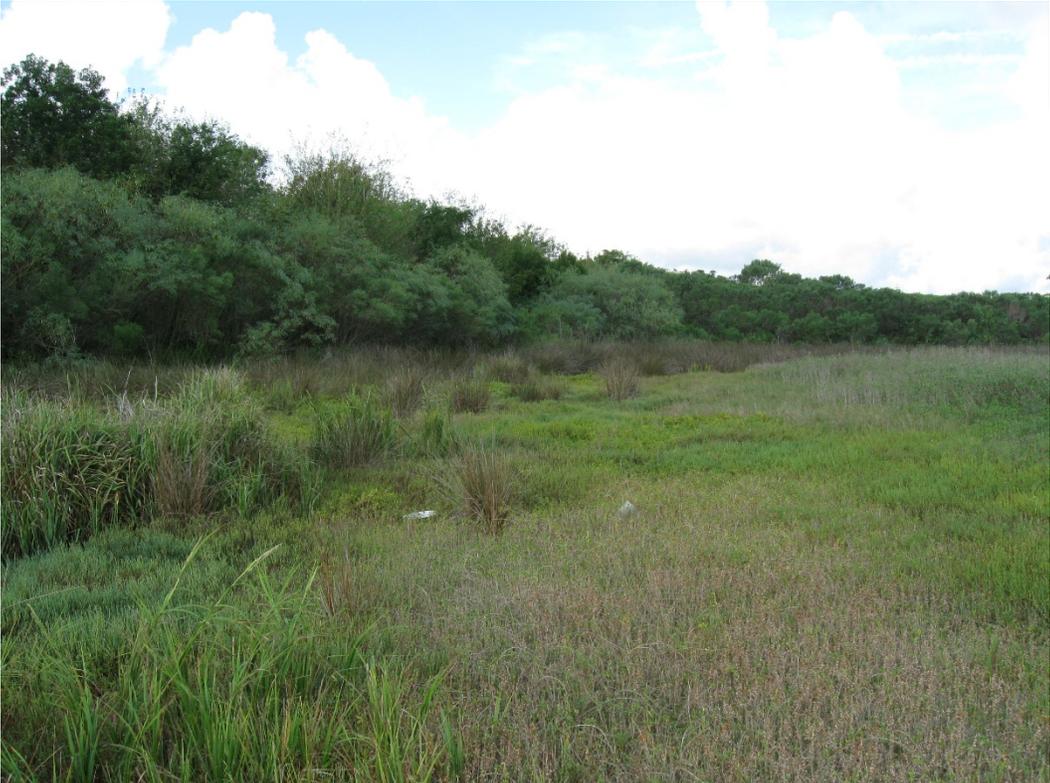
**Figures 5 and 6.
Area C
Vegetation
Coverage.**

The group walked Area C and agreed that there was more vegetation present than depicted in the aerial image. They agreed that images may better represent the vegetative percent coverage if taken during or immediately after the growing season (sometime in August), rather than in February while most vegetation may still be dormant. GADNR volunteered to retake the images later in the year around August.
