Appendix J

Hazardous, Toxic and Radioactive Waste

ENVIRONMENTAL CONDITION of PROPERTY/ PHASE I

NEW SAVANNAH BLUFF LOCK and DAM

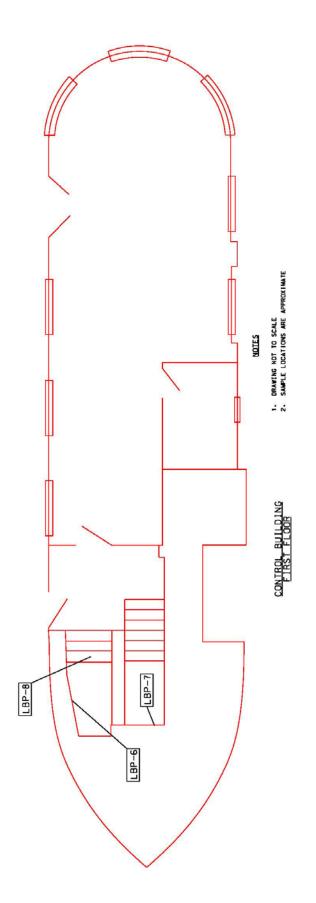
FIGURE 1

Sample Number	Description	Location	Analytical Result
NSB-LBP-1	Off white on concrete wall, damaged	Second floor, above outside door	0.021%
NSB-LBP-2	Green on concrete, damaged	Second floor, above window	1.0%
NSB-LBP-3	Off white on concrete ceiling deck, damaged	Second floor ceiling	0.12%
NSB-LBP-4	Off white on concrete wall, damaged	Second floor, stairwell	None Detected
NSB-LBP-5	Off white and green on concrete wall, damaged	Second floor, by door to stairwell	0.078%
NSB-LBP-6	Green on concrete wall, damaged	First floor, stairwell	0.013%
NSB-LBP-7	Green on concrete wall, damaged	First floor, stairwell	None Detected
NSB-LBP-8	Gray on concrete stairs, damaged	First floor, stairwell	0.22%

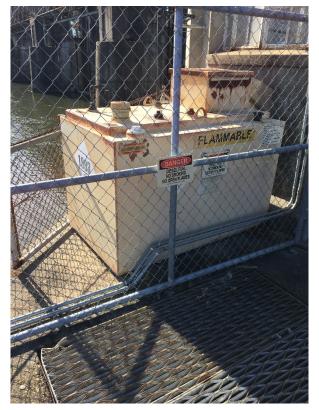
Photo 1: AST located outside Lock Control Room

An AST containing diesel fuel is located outside the lock control room. The AST contains approximately 275 gallons of diesel, and is used to power the emergency generator in the event of a power loss (**Photo 1**).

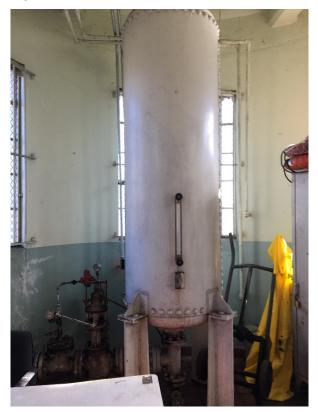
Photo 3: New Hydraulic Oil Tank located inside Lock and Dam Control Room

The original hydraulic oil tank is still located inside the lock and dam control room. It is believed that the tank has been emptied and cleaned of residual fluid. A new hydraulic fluid tank is located in the control room. The new tank contains approximately 85 gallons of hydraulic fluid (**Photos 2 & 3**).
