Fish Passage at NSBL&D
Engineering Appendix – Attachment 4

Fixed Weir Pool Simulation - After Action
Review

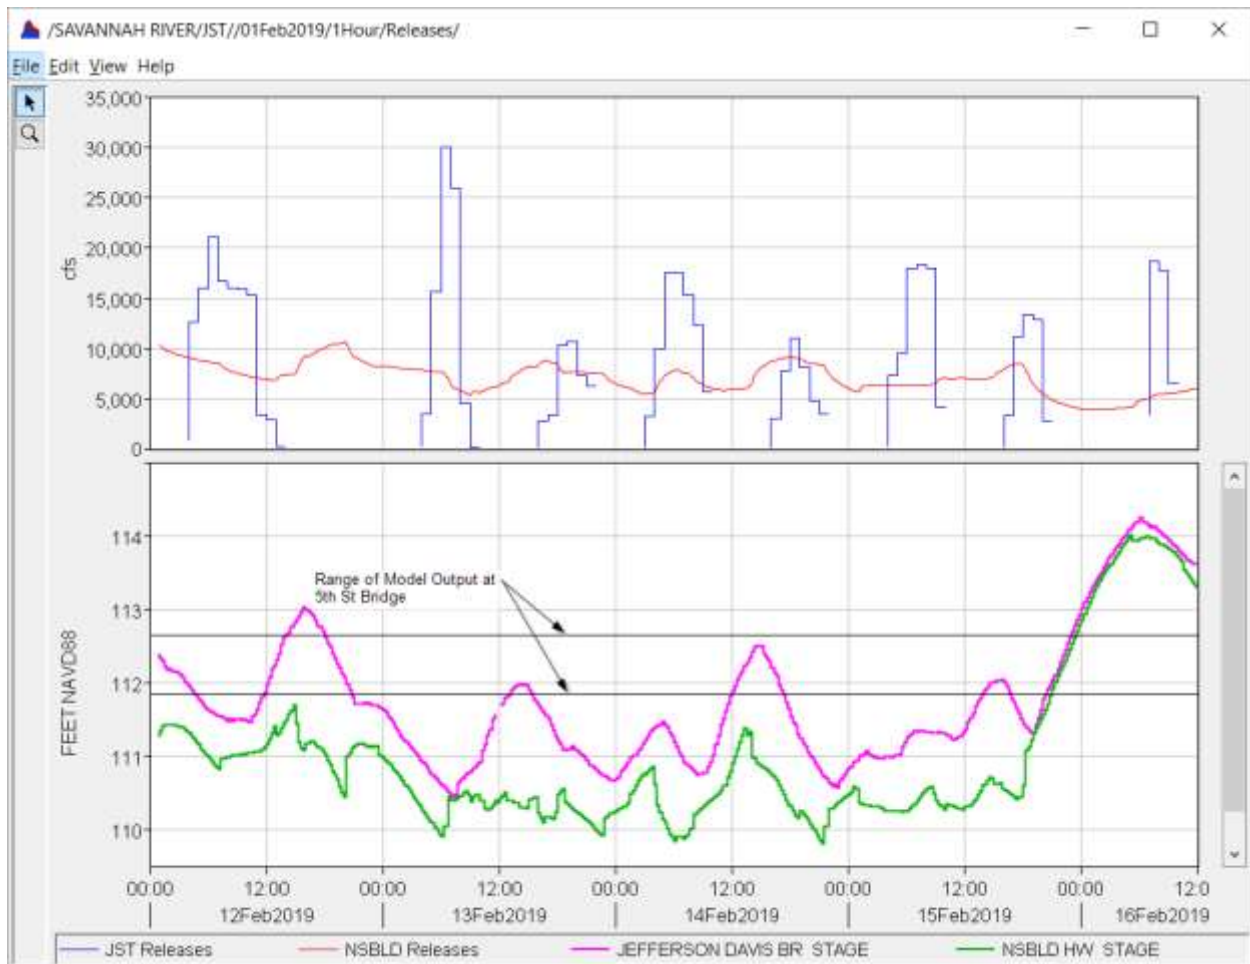
The figure below shows pertinent information regarding river levels and flows measured during the simulation. Releases from JST are seen in blue, and flows measured below NSBLD in red. The pool elevation at 5th Street Bridge is shown in pink and the elevation at NSBLD is in green. The range of

expected pool elevations for the with-project condition for normal flow conditions is also highlighted. A range of values is presented because there is some natural amount of uncertainty in the model used to predict water elevations; model uncertainty is discussed later in this document.

Pool elevations seen during the simulation are lower than those listed in the main report and Engineering Appendix for the recommended plan. However, pool elevations for the recommended plan as reported in the main report assume that the flashboards at Steven Creek are in place to reregulate Thurmond discharges for hydropower generation (see Object 1 discussion above). After the simulation the hydraulic model was used to simulate releases from Thurmond without reregulation from Stevens Creek. The model was able to reproduce some of the effects seen during the simulation, such as the exposed training wall, mudflats, and shoreline retreat during periods when Thurmond was not generating hydropower and flows in the river dropped to near zero. This validated the model’s performance from normal and extremely low flows, and given the uncertainty discussed above no modifications to the model were deemed necessary.

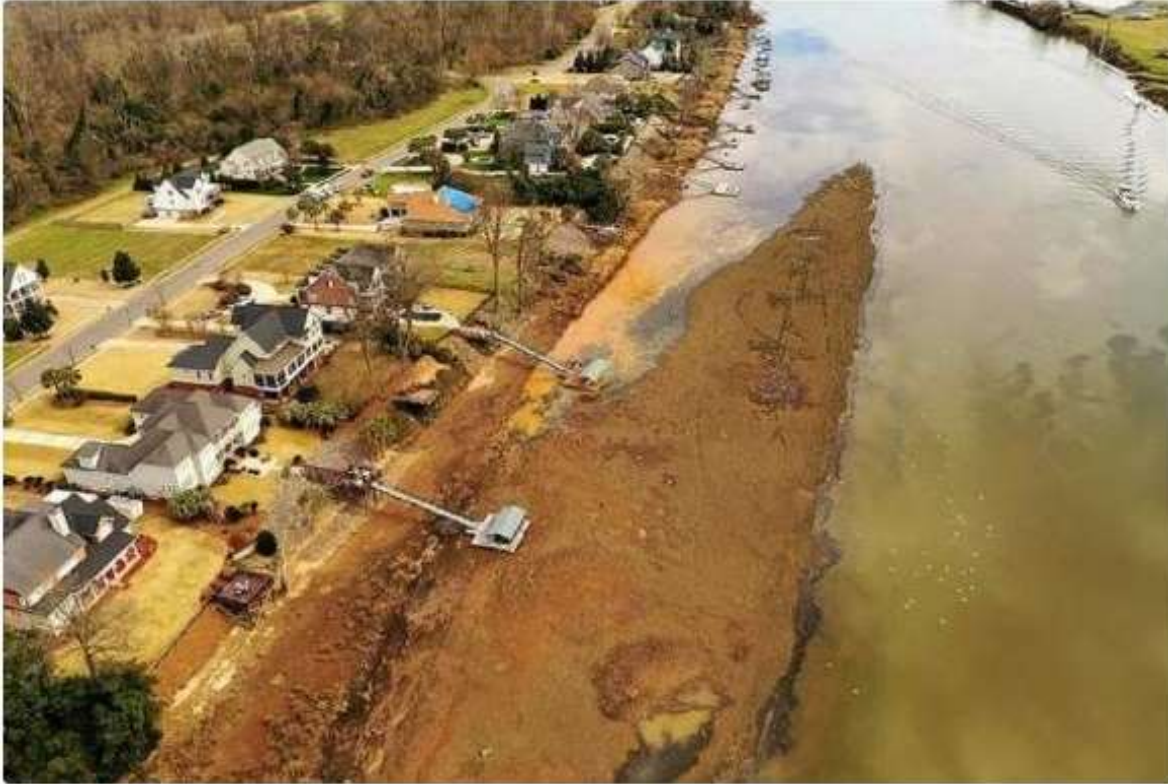
Numerous comments regarding the simulation and exposed “mudflats” were received during the public comment period (see photo below). Conditions seen during the simulation were more dramatic than should be expected for the recommended plan, and many of the areas that were exposed during low flows will not be exposed under the recommended plan. However, some areas will see shoreline retreat and additional exposed “mudflats”. These area will likely see vegetation colonize the exposed areas relatively quickly after construction of the fish passage project is completed.

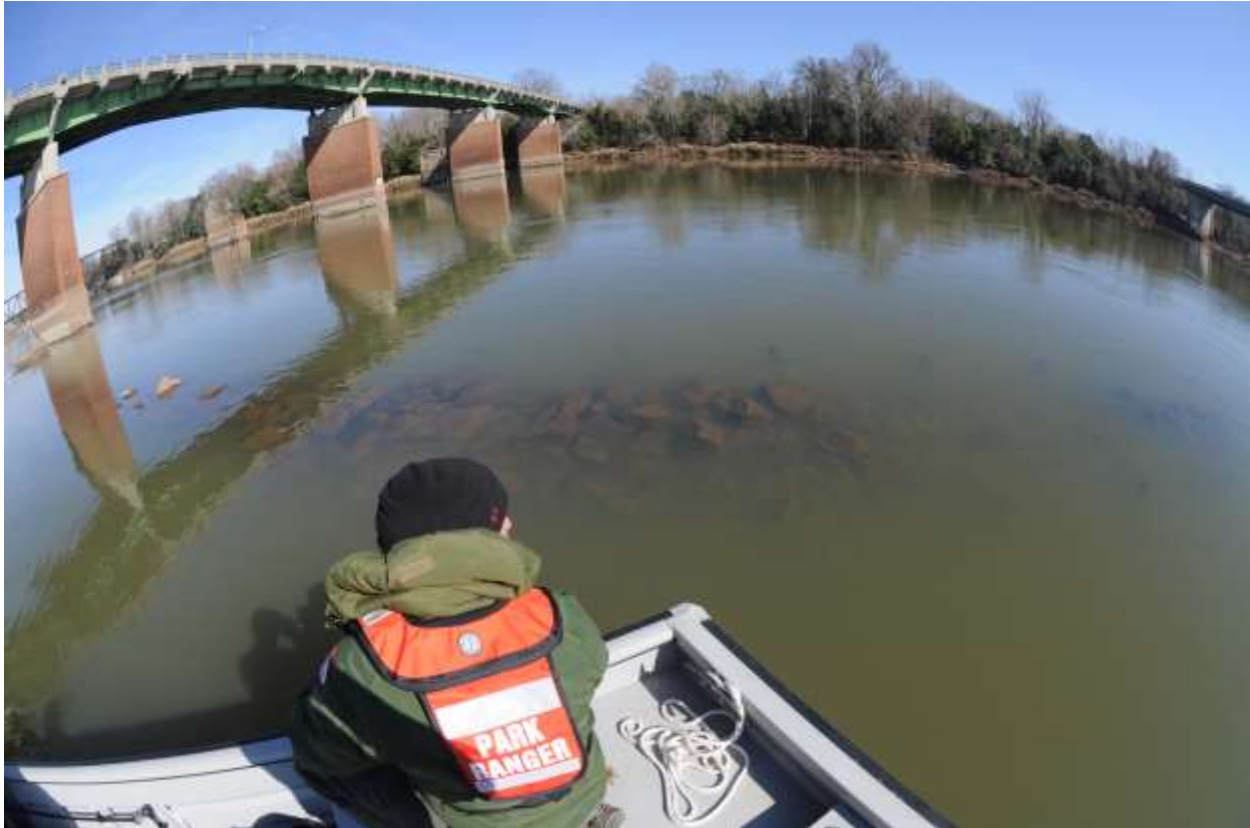
The depth of water over the training wall varied throughout the simulation, due to the fluctuations in flow and resulting pool level as discussed above. This made measuring depths difficult as there wasn’t a steady pool level against which to measure depths. However, it was clear from the simulation that parts of the training wall were exposed during the simulation and other portions were visible just below the water’s surface. The photo below shows the cribbing and rock fill used to construct the training wall, near 5th Street Bridge.

The low flow levels discussed in Objective 1 above exposed more of the training wall than would be expected during normal conditions for the recommended plan, and the impacts discussed in the main report are still valid. The training wall is a feature of the Savannah River Below Augusta navigation project constructed c. 1910 and is a known navigational hazard for recreational boating. The training wall will be marked with buoys as part of the fish passage construction. The Savannah District has requested approval to study removal of the training wall separate from the fish passage analysis.

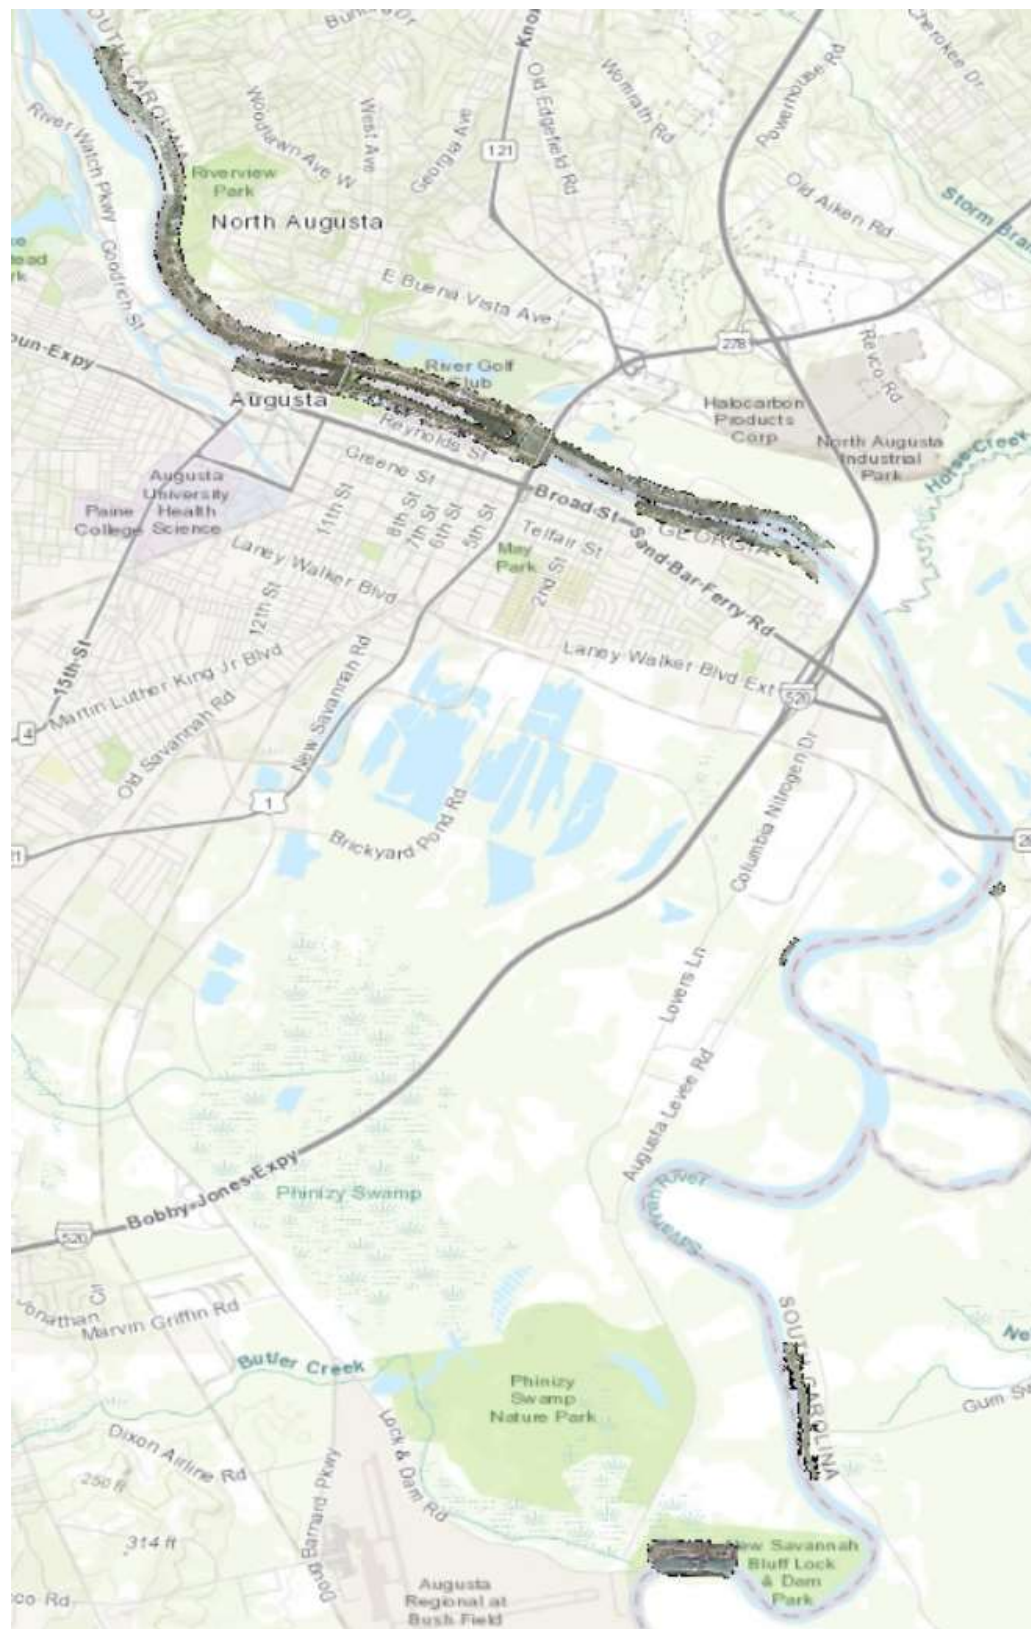
An unmanned aerial vehicle was used to acquire aerial imagery of the shoreline and any exposed features during the simulation. Areas of interest for which imagery was acquired are shown in the figure below:

The imagery was collected over the course of several days during the simulation, during which time flow and pool levels fluctuated on an hourly basis. This made mapping the impacts on flow levels to shoreline retreat and exposed mudflats difficult. If the aerial vehicle was not flying over an exposed area during low flows, we were unable to get imagery of that feature during the extreme low flows we saw during the simulation.

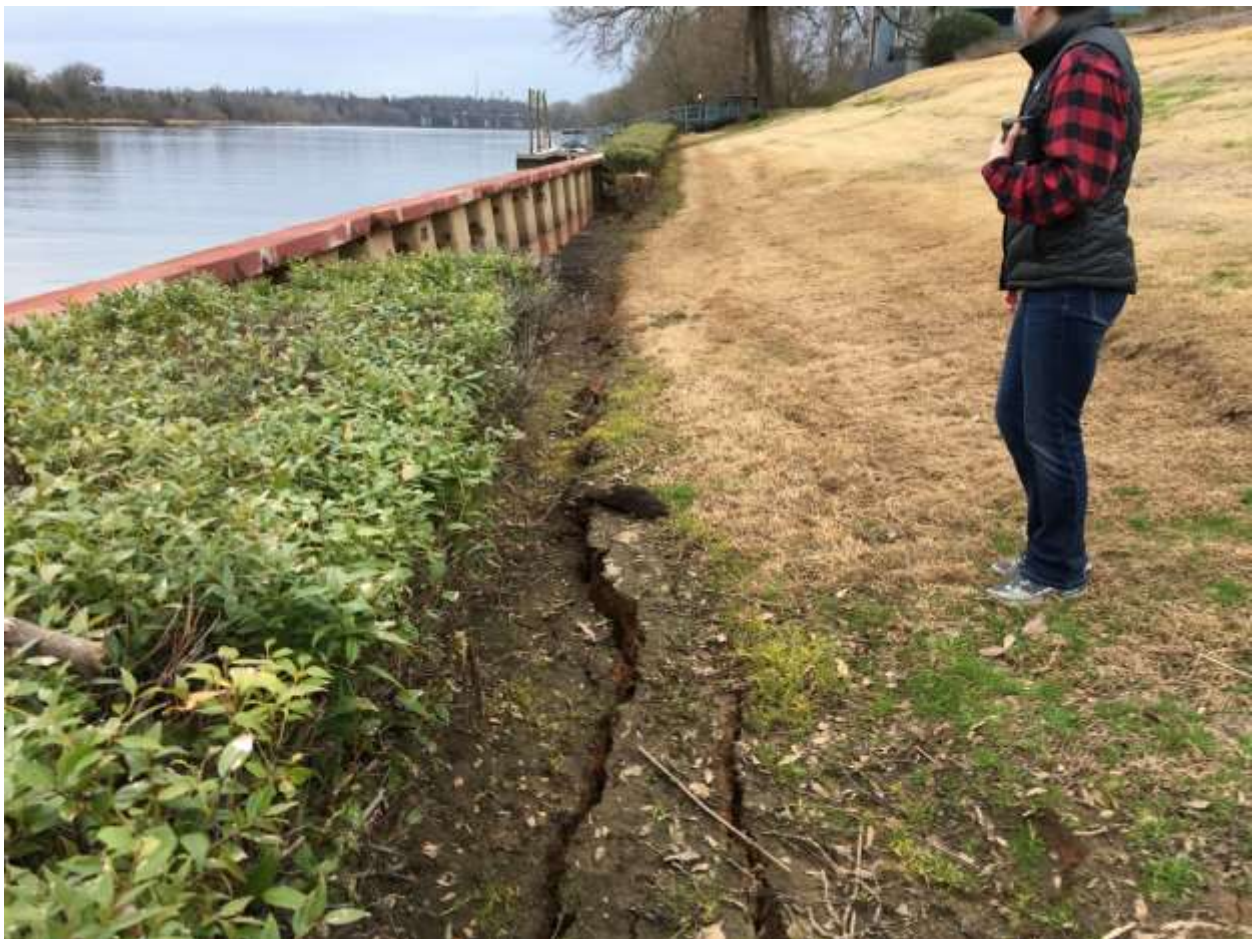
On February 15th a homeowner in the Goodale Landing community contacted USACE with concerns regarding a retaining wall that was experiencing sloughing. USACE dispatched a team of engineers varying in specialties to evaluate the situation noted several areas where the wall was deformed and sloughing in the backfilled area landside of the wall. The team noted a lack of drainage system in the wall, and the ground behind the wall appeared to be very saturated and not draining well. The pool was lowered incrementally over a number of days to avoid impacts like this, but the lack of a proper drainage system for the retaining wall likely contributed to the sloughing and deformation.

As a result of this evaluation USACE made the decision to cancel the remainder of the simulation to alleviate some of the pressure on the retaining wall. Operators at Thurmond Dam immediately began bringing the pool back up to normal operations.
