Testing
of
CSS Georgia
Casement Rail
Preliminary Report

U. S. Army Corp. of Engineers
Savannah District
Savannah, Georgia

November 2014

Peter B. Keating, Ph.D., P.E.
Structural and Materials Testing Laboratory
Zachry Department of Civil Engineering
Texas A&M University
College Station, Texas 77843

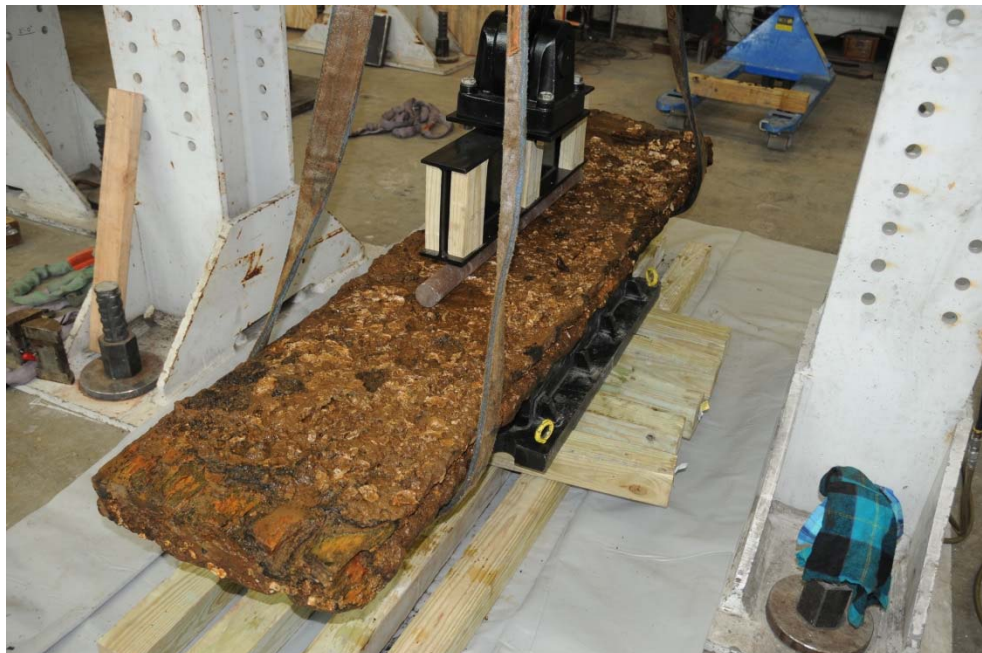
Figure 1: View of rail casement split test setup.

A test was performed to determine the magnitude of force required to separate or split a group of rails apart. The test setup involved supporting the casement section in the long direction and applying a force from a 50-kip actuator at the middle of the short span (14-3/8"). The setup for the test is shown in Figure 1. The force required to split the rails apart was 15.1 kips. The casement section separated in two parts with each half containing five rails.

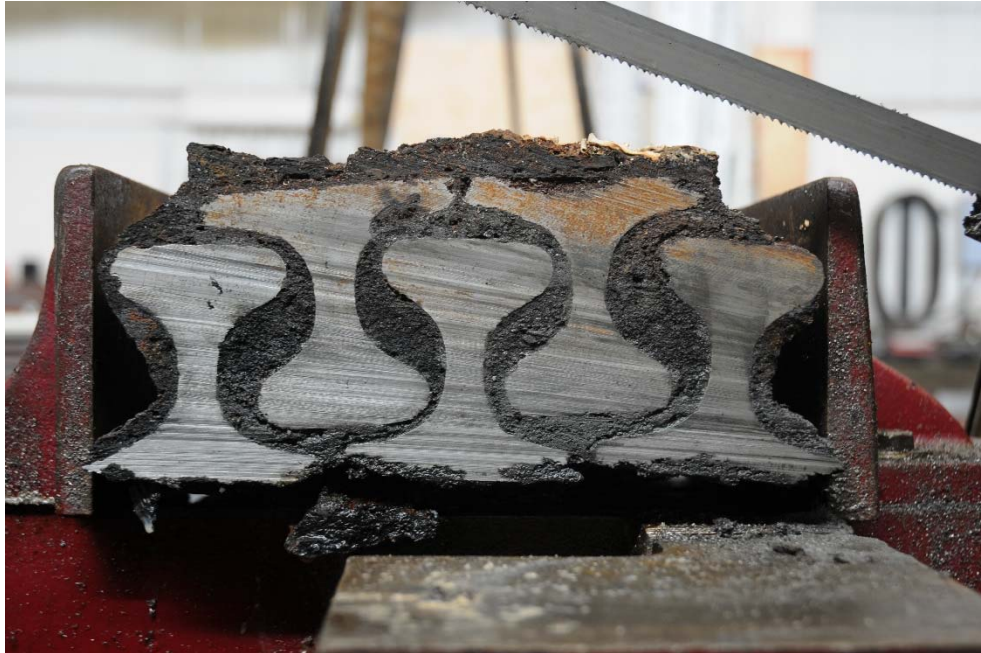
Figure 2: Cross-sectional view of five rails after cutting.

The relatively high force required to separate the rail group can be attributed to the mixture of corrosion product and river sediment located in the gaps between the rails. This mixture had bonded the rails together and can be seen in a cross sectional view of one group of five rails in Figure 2. From this group of 5 rails, a 3-inch long section and an 8-inch long section were cut to be utilized for test specimens.

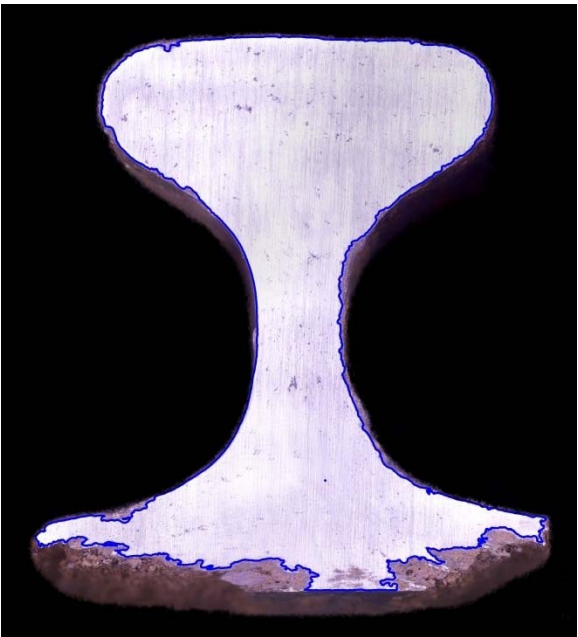
Figure 5: Cross-sectional area of Rail 3.

The grouping of 3-inch length rails were separated from each other, cleaned, and then ground smooth on one end by hand to provide a more uniform cross-sectional surface. This allowed for a measurement of the cross-sectional area using a digital microscope, which also provided high-resolution images of the cross-sectional surface. The cross-sectional areas are given in Table 1. The cross-sectional images of the five rails are given in Figures 3 through 7.

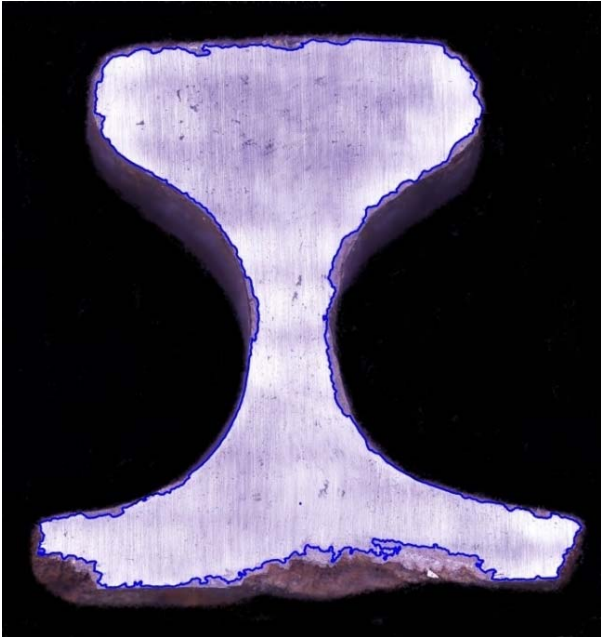
Figure 6: Cross-sectional area of Rail 4.

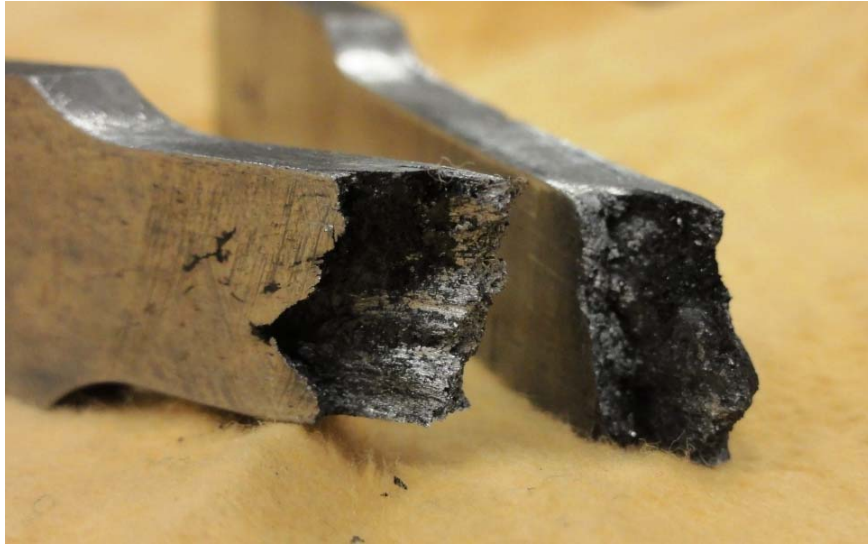
Figure 9: Failure location view of axial tensile specimen (4-1).

Axial tensile tests were performed on one 8-inch section of rail (Rail No. 4). This section of rail was cut up to produce six tensile specimens, one of which is shown in Figure 8. All of the tensile specimens tested failed with respect to the relatively large impurity inclusions. This is evidenced by the darker regions being the impurities versus light grey of the iron, as shown in Figure 9.

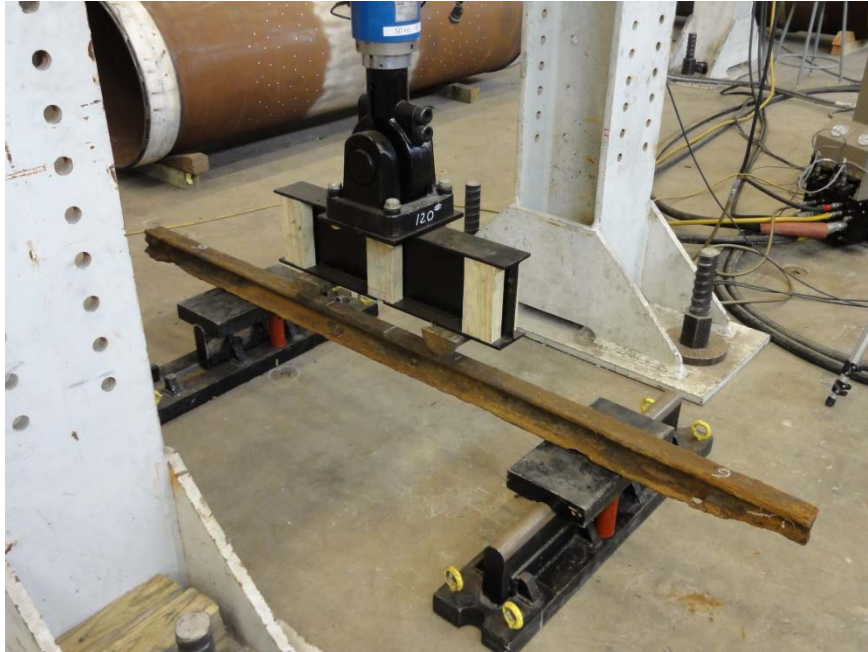
Figure 10: Test setup for rail flexural test.

Bend tests were performed on four of the rails. The length of these rails was the as-received length of 7'-3". The test setup is shown in Figure 10. The span length between the simple supports was four feet while the distance between the two load points was 18 inches. Three of the rails were tested with the rail head up (in compression) while one rail was tested upside-down to place the rail head in tension. Table 4 summarizes the results of the flexural tests.
