# REQUEST FOR JURISDICTIONAL DETERMINATION FOR PROPERTY LOCATED WITHIN THE STATE OF GEORGIA

# **INVESTIGATION OF JURISDICTIONAL WETLANDS AND WATERS OF THE U.S. FOR THE RIVERVIEW SUBDIVISION APARTMENTS PROJECT SITE CITY OF SAVANNAH, CHATHAM COUNTY, GEORGIA**

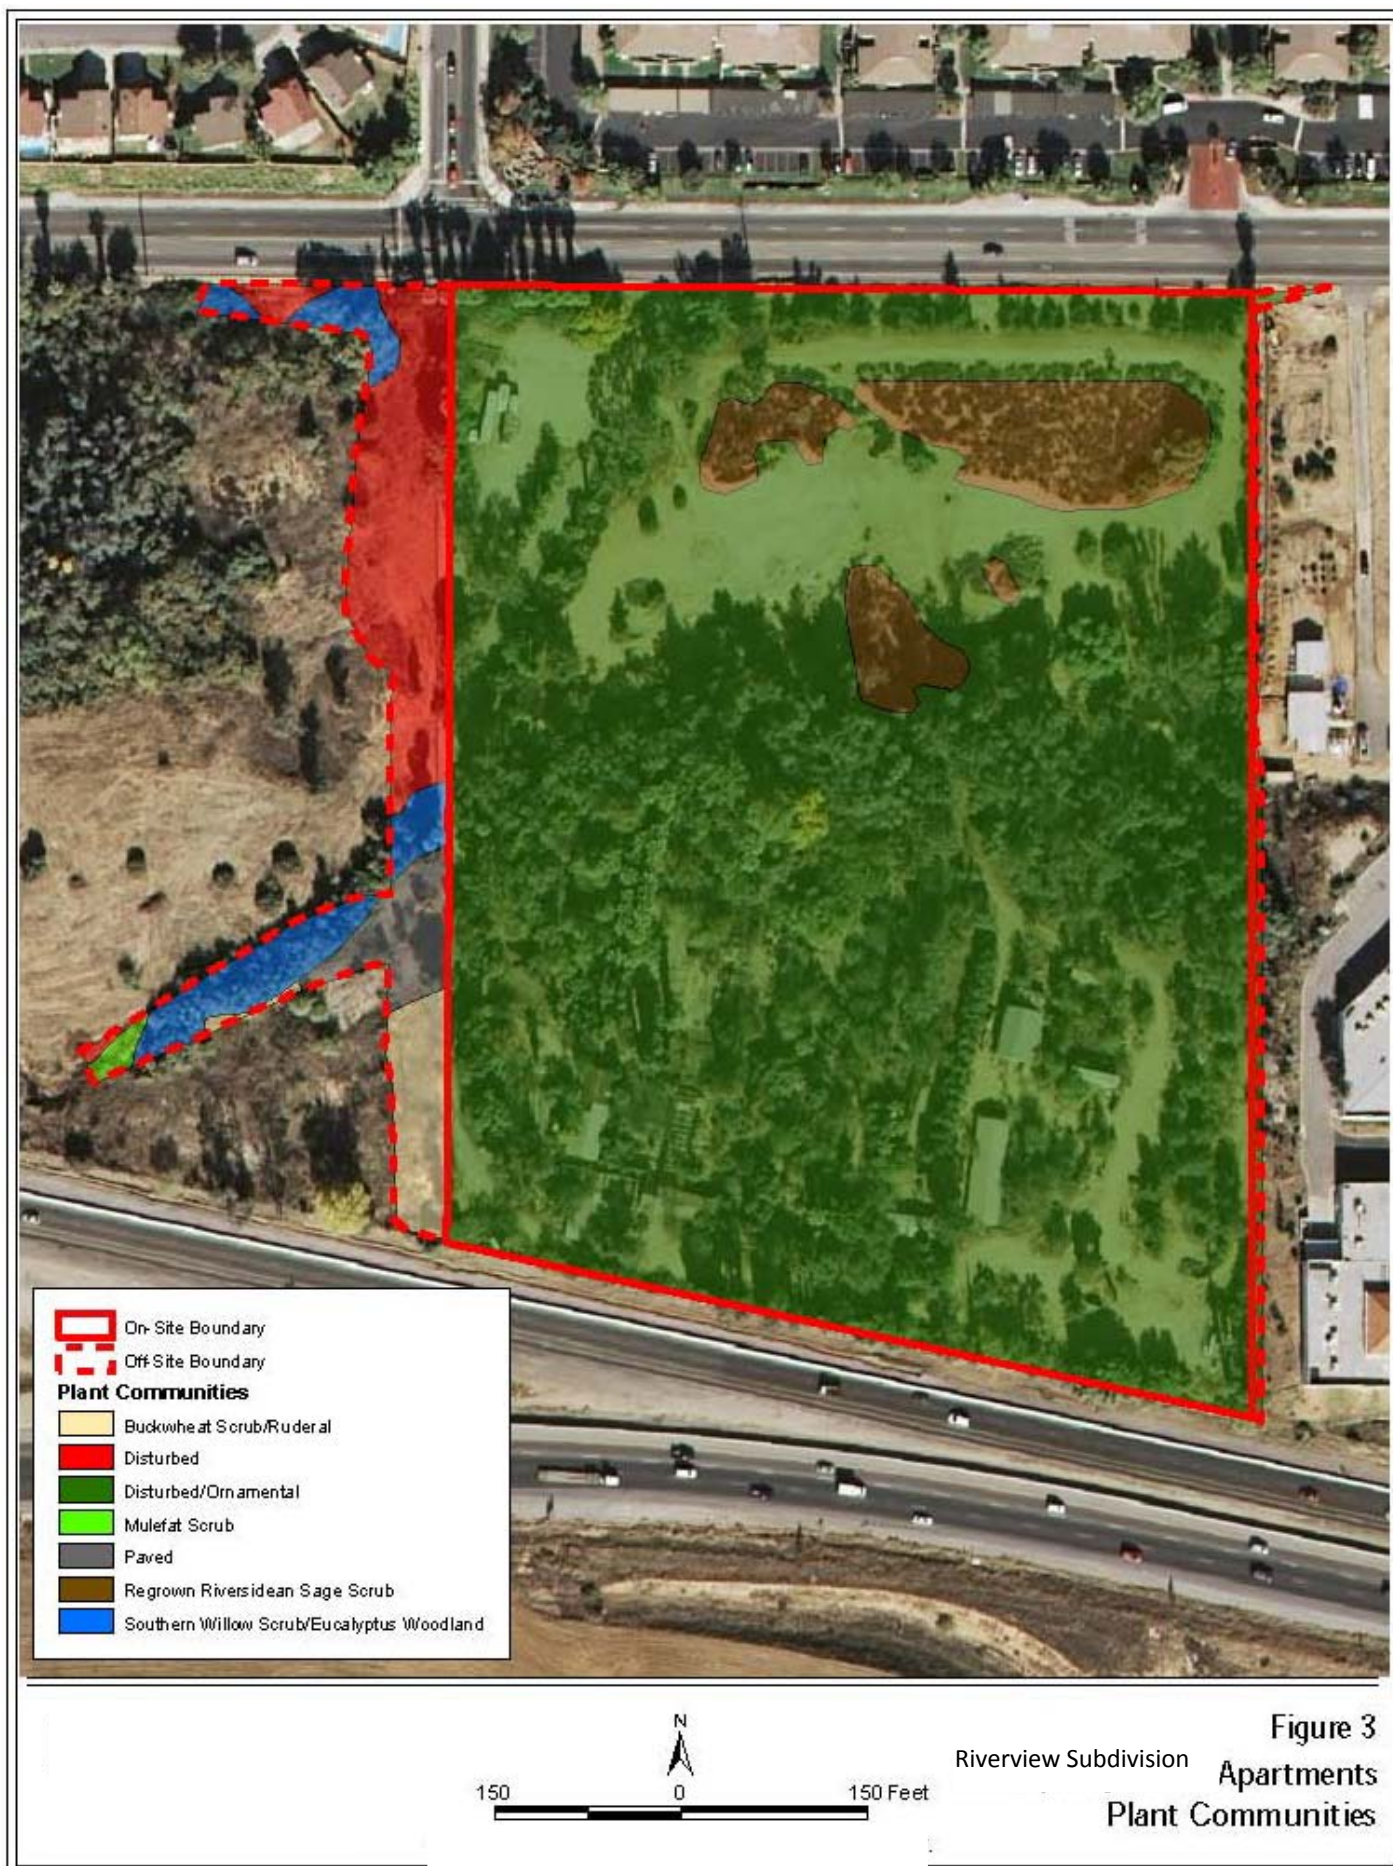
Figure 4  
Riverview Subdivision Apartments  
Soils Map

The Soil Survey for Chatham County (Knecht 1971) was consulted and five soil types within four soil series were identified within the study area (Figure 4, *Soils Map*). The soils series mapped on-site include Fallbrook, Greenfield, Hanford, and Monserate. The soil types mapped within the study area are described in detail below. The soils map and underlying aerial photograph were analyzed for indicators of streams and location of wetlands, seeps, springs, or hydric soils. Drainage A appears on the 1971 soils map as an “intermittent” aquatic feature that begins at the foot of the Riverview Mountains and flows into the Ogeechee River west of the study area. No other aquatic resources appear on the soils map within the study area.

The study area contains one drainage feature (referred to in this report as Drainage A), one tributary (referred to in this report as Tributary A1), and an adjacent wetland (referred to in this report as Wetland 1). Both of the non-wetland water features are perennial features and are generally dominated by native tree species. Neither feature was mapped as “blue-line” stream features on the USGS topographic map (USGS 1967, photorevised 1980). However, Drainage A appears on the U.S. Department of Agriculture (USDA) soils map as an “intermittent” aquatic feature (Knecht 1971) (Figure 4, *Soils Map*, on page 6).

None of the soils found within the Site boundaries are included in the *Field Office Official List of Hydric Soil Map Units for Chatham County, Georgia* (USDA 1992). Therefore, the soils mapped on-site are not classified as hydric soils.

Tributary A1 is an intermittent, earthen feature that originates off-site to the east. This feature is not a USGS-designated “blue-line” stream, nor does it show up on the USDA soils map as an aquatic feature (USGS 1967 and Knecht 1971). Tributary A1 enters the study area under a chain link fence along the eastern boundary, approximately 60 feet north of where Drainage A enters the study area. During the investigation, some water was found within Tributary A1. Tributary A1 becomes very shallow, almost indefinable for approximately 10 feet before it meets with Drainage A.

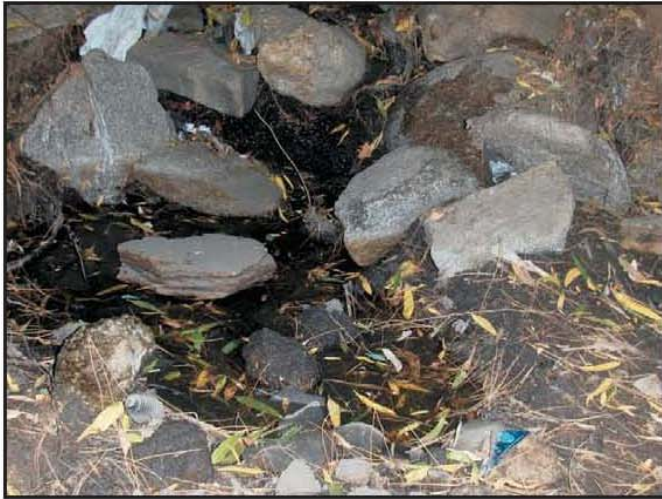
Photograph 1: Pool of water at the start of Drainage A on-site along the eastern boundary of the Site.

Drainage A enters the study area under a barbed wire and chain link fence along the eastern project boundary. At this point, the drainage is approximately 28 feet wide and has three-foot banks. During the investigation, three pool complexes were observed within the easternmost portion of the drainage. The deepest pool was six-inches deep, while the shallowest pool was one to two inches deep. These pools were found in an area that was adjacent to a commercial development off-site to the east and under heavily shaded conditions. Approximately 80 feet downstream, the banks are reduced to one-foot on each side. A six-inch PVC pipe follows the drainage along the northern side for over 100 feet. Approximately 120 feet from the start of Drainage A on-site, the drainage narrows to approximately eight feet. Approximately halfway through the study area, a 15-inch concrete pipe sticks out into the drainage, although it does not appear to convey water into the drainage. The other end of the pipe could not be located, but it appeared to be an abandoned resource that did not show evidence of water. Approximately 300 feet from the eastern study area boundary, Drainage A splits into two distinct channels, one that has shallow banks but is approximately eight feet wide, and the other that has more defined, steep banks but is approximately three feet wide. Approximately 140 feet downstream, the two channels re-join. Approximately 40 feet from the end of the first braid, Drainage A splits again into two separate channels for approximately 41 feet. The western one-fourth of the drainage

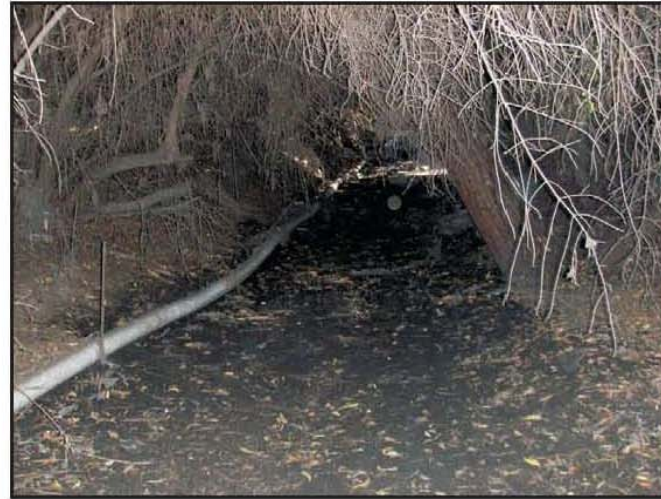
Photograph 2: Drainage A looking upstream within the eastern quarter of the Site.

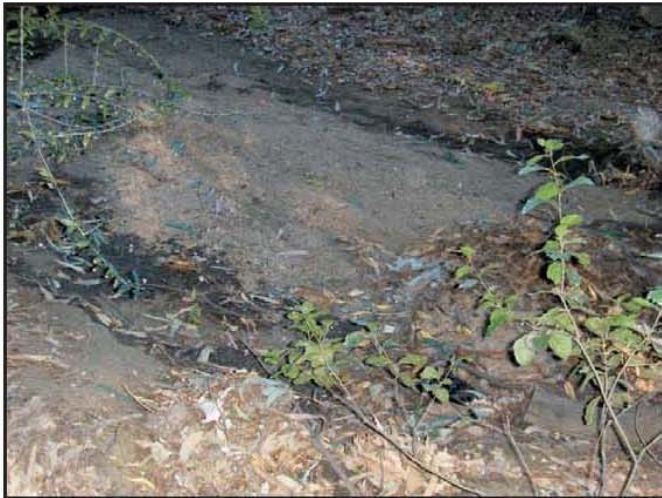
Photograph 3: Drainage A looking downstream at the first braided portion of the channel.

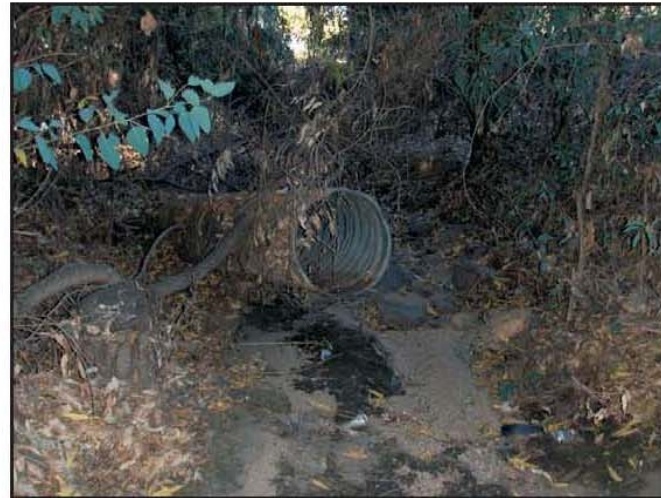
Photograph 4: Drainage A looking downstream where the 15-inch pipe is sticking out into the drainage.

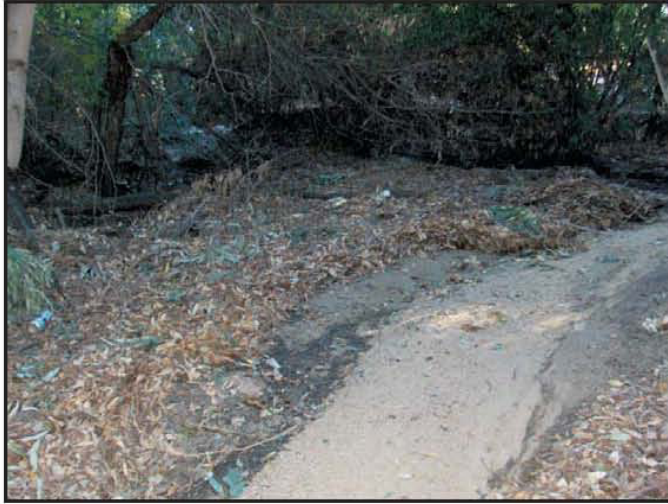
Photograph 5: Drainage A looking upstream at the second braided portion of the channel.

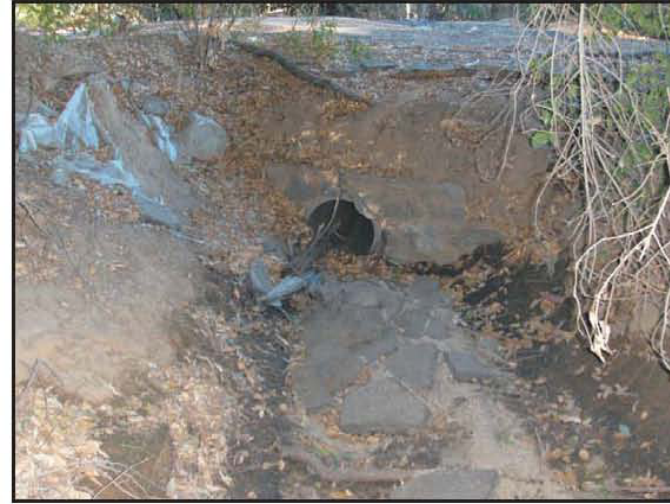
Photograph 6: Drainage A looking downstream at the 15-inch culvert along the western boundary of the Site where the drainage exits the Site.

contains large rocks and pieces of broken asphalt. This area appears more disturbed by the former nursery activities. Drainage A exits the study area along the western boundary under a nursery road through a 15- inch culvert. Representative photographs of Drainage A are presented in Figure 6 and Figure 7, *Site Photographs*.

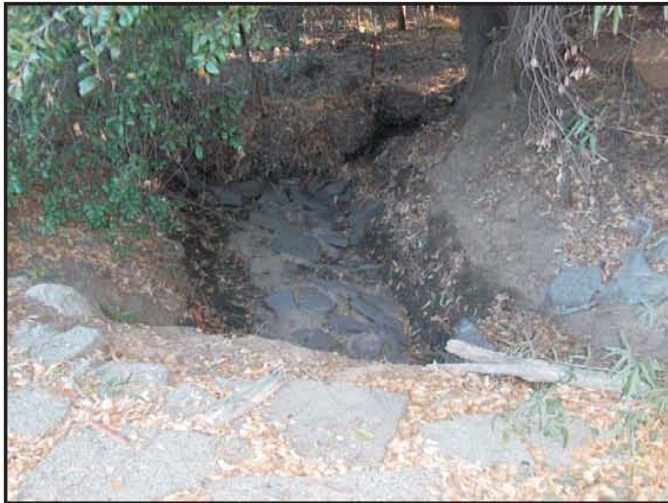
Photograph 7: Drainage A looking upstream from the western boundary of the Site where the drainage exits the Site.

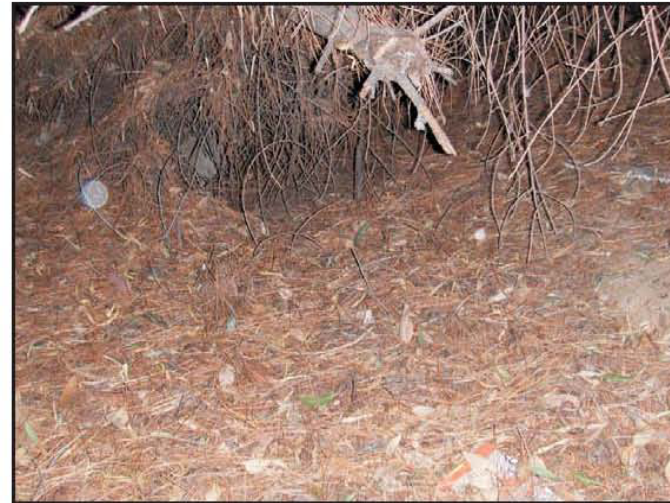
Photograph 8: Tributary A1 looking upstream from the intersection with Drainage A.

Representative photographs of Tributary A1 are presented in Figure 7, *Site Photographs*. On-site, Tributary A1 measures approximately 76 linear feet, with an ACOE jurisdictional width ranging between 1.5 to three feet. Tributary A1 contains less than 0.01 acre of ACOE jurisdictional non-wetland “waters of the U.S.”, as measured by the width and extent of the OHWM found throughout its on-site length,
