DBC Building Inspection Report

Date: 11/28/2007

Location:	Ft Campbell, KY		
Building Name:	CSG Barracks		
Building Address	CSG Barracks Complex		
Building Number	6752, 6756		
Beneficial Occupancy Date	Apr-07		
Local POC:	Miller Moore, USACE		
DBC Inspection Team Lead	Mike Grussing, ERDC-CERL		
DBC Inspection Team Members:			
	1	Mike Grussing	
	2	Sam Hunter	
	3		
Inspection Date Start	11/7/2007	Inspection Date Complete	11/7/2007
Baseline / Pilot	Baseline	Inspection #	1
Inspection Weather:	Sunny, 43 deg Farenheit		
Resulting Initial BCI:	Combined BCI of both buildings = 99 (0-100 scale)		
Inspection Process Discription:	BUILDER Visual Distress Survey Inspection Process. Inspector observed distresses with input from building occupants/users.		
Comments:	<p>The survey encompassed all systems of physical fitness center on site. The initial component inventory for the building was developed previous to the site visit using construction drawings, and inventory was verified and adjusted during site-visit. The assessment scope included all aspects of the building deemed real property, including civil/structural, electrical, mechanical, and roofing. Overall building conditions for the init

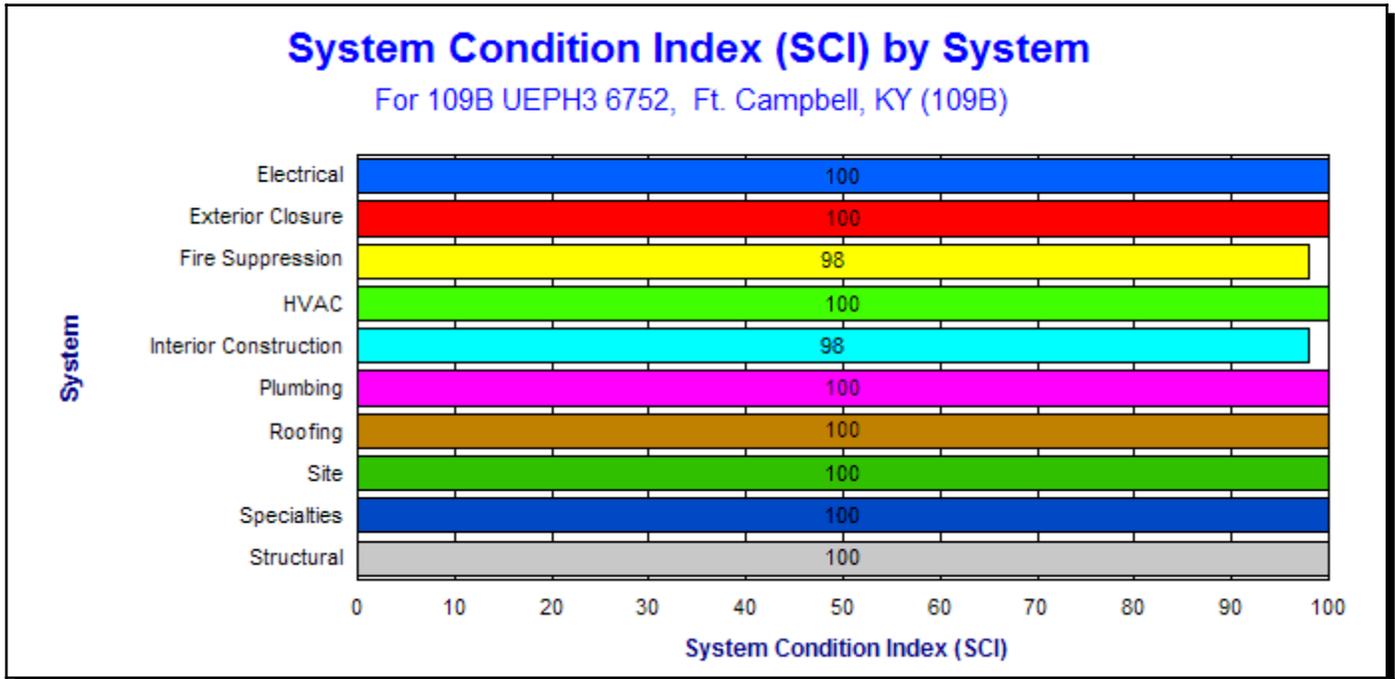
Design-Build-Commissioning Study - Army - 109B
UEPH3 6752

<i>Inspected Systems</i>	<i>SCI</i>
Electrical	100
Exterior Closure	100
Fire Suppression	98
HVAC	100
Interior Construction	98
Plumbing	100
Roofing	100
Site	100
Specialties	100
Structural	100

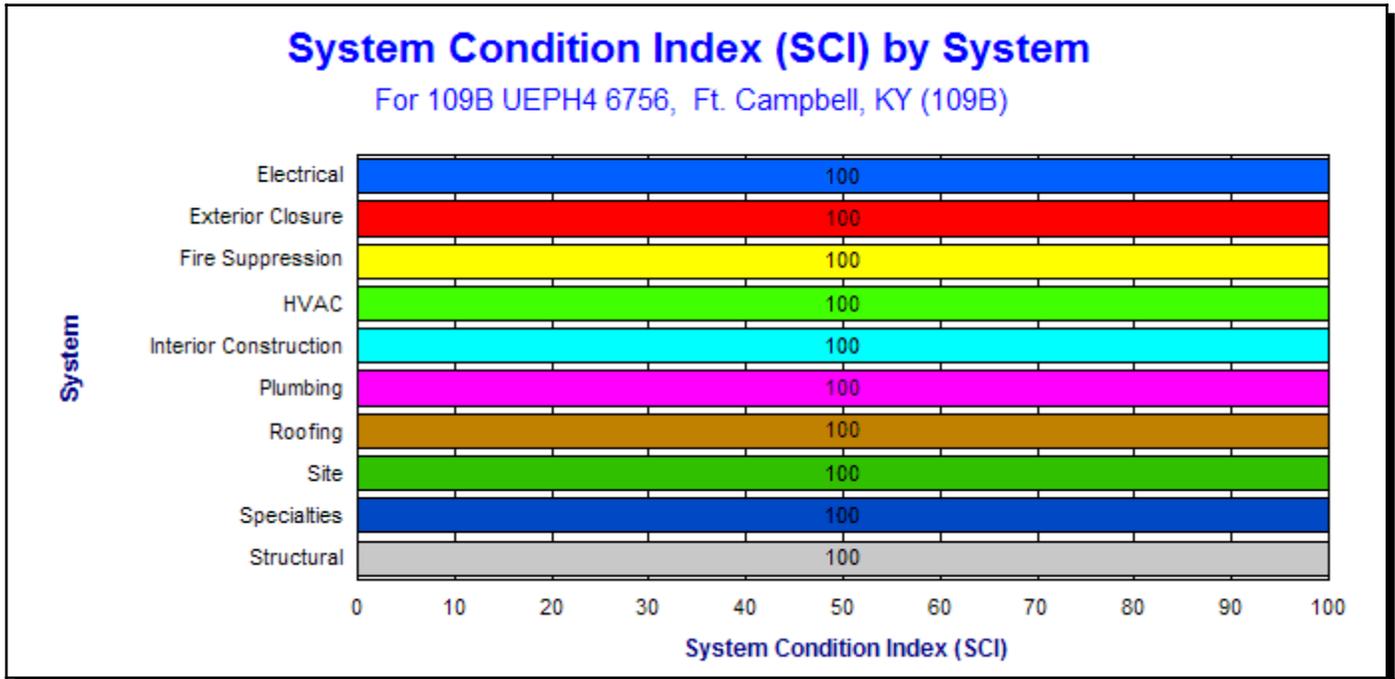
Design-Build-Commissioning Study - Army - 109B
UEPH4 6756

<i>Inspected Systems</i>	<i>SCI</i>
Electrical	100
Exterior Closure	100
Fire Suppression	100
HVAC	100
Interior Construction	100
Plumbing	100
Roofing	100
Site	100
Specialties	100
Structural	100
