DBC Building Inspection Report

Date: 11/28/2007

Location:	Ft Campbell, KY		
Building Name:	SOAR Barracks		
Building Address	SOAR Barracks Complex		
Building Number	2992, 2993		
Beneficial Occupancy Date	Oct-07		
Local POC:	Miller Moore, USACE / Joe Nash, Facility Services Inc (FSI)		
DBC Inspection Team Lead	Mike Grussing, ERDC-CERL		
DBC Inspection Team Members:			
	1	Mike Grussing	
	2	Sam Hunter	
	3		
Inspection Date Start	11/6/2007	Inspection Date Complete	11/6/2007
Baseline / Pilot	Baseline	Inspection #	1
Inspection Weather:	Sunny, 45 deg Farenheit		
Resulting Initial BCI:	Combined BCI of both buildings = 100 (0-100 scale)		
Inspection Process Discription:	BUILDER Visual Distress Survey Inspection Process. Inspector observed distresses with input from building occupants/users.		
Comments:	<p>The survey encompassed all systems of physical fitness center on site. The initial component inventory for the building was developed previous to the site visit using construction drawings, and inventory was verified and adjusted during site-visit. The assessment scope included all aspects of the building deemed real property, including civil/structural, electrical, mechanical, and roofin

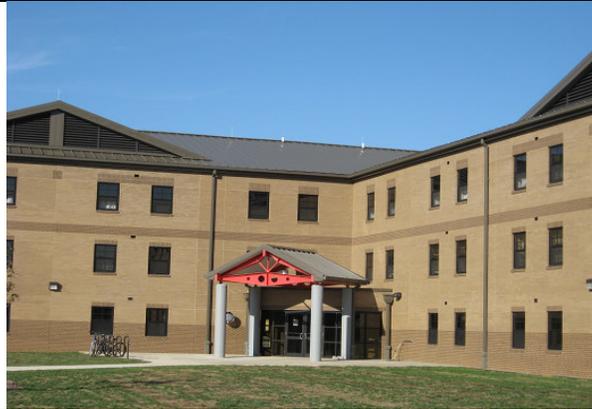
Elevation of Barracks Building

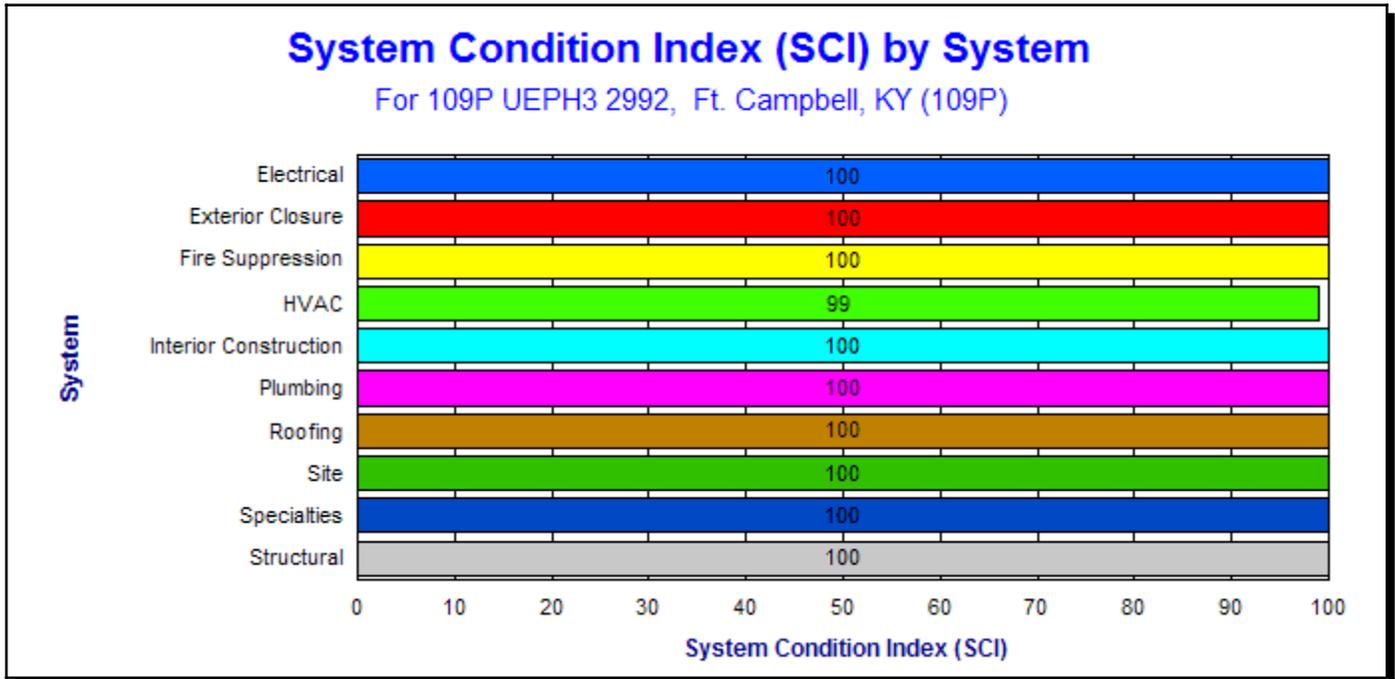
Design-Build-Commissioning Study - Army - 109P
UEPH3 2992

<i>Inspected Systems</i>	<i>SCI</i>
Electrical	100
Exterior Closure	100
Fire Suppression	100
HVAC	99
Interior Construction	100
Plumbing	100
Roofing	100
Site	100
Specialties	100
Structural	100

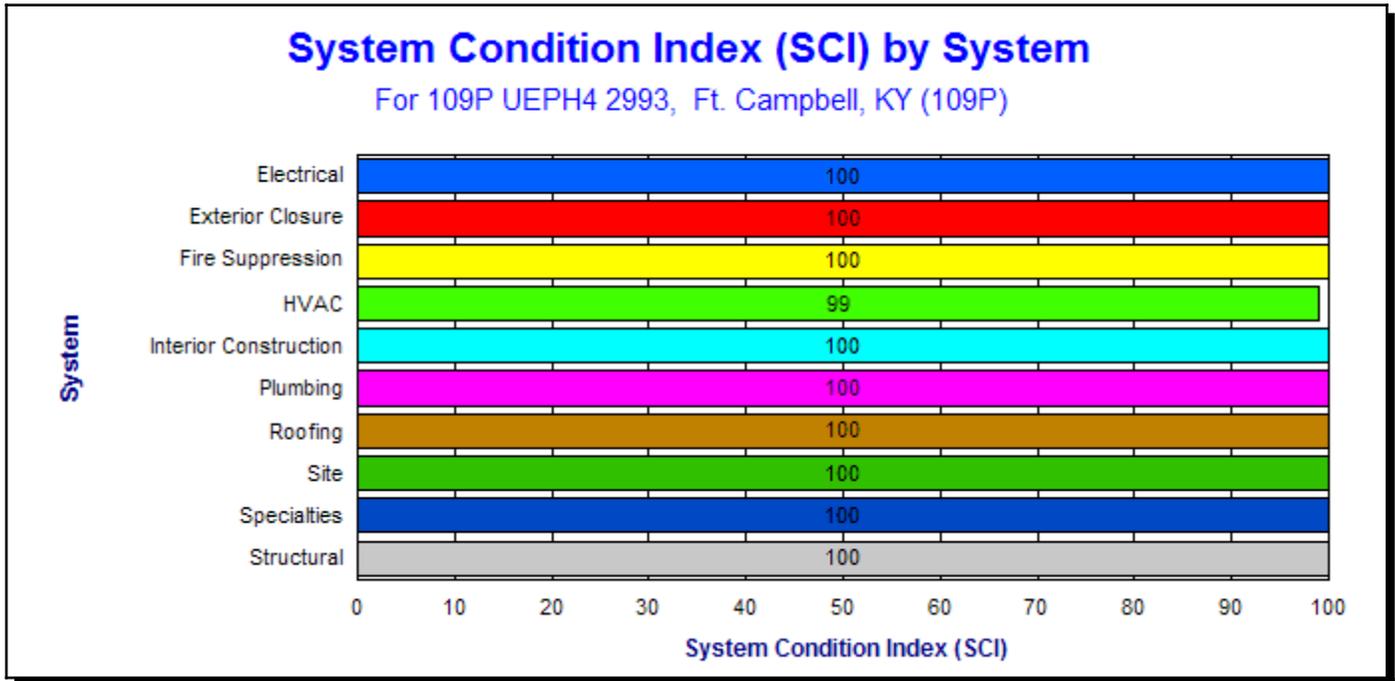
Design-Build-Commissioning Study - Army - 109P
UEPH4 2993

<i>Inspected Systems</i>	<i>SCI</i>
Electrical	100
Exterior Closure	100
Fire Suppression	100
HVAC	99
Interior Construction	100
Plumbing	100
Roofing	100
Site	100
Specialties	100
Structural	100
