**Environmental Condition of Property Update Report
Armed Force Reserve Center (IL027)
7402 W. Roosevelt Road, Forest Park, Illinois 60130**

**Environmental Documentation in Support of
U.S. Army Reserve Facility Disposals**

January 2022

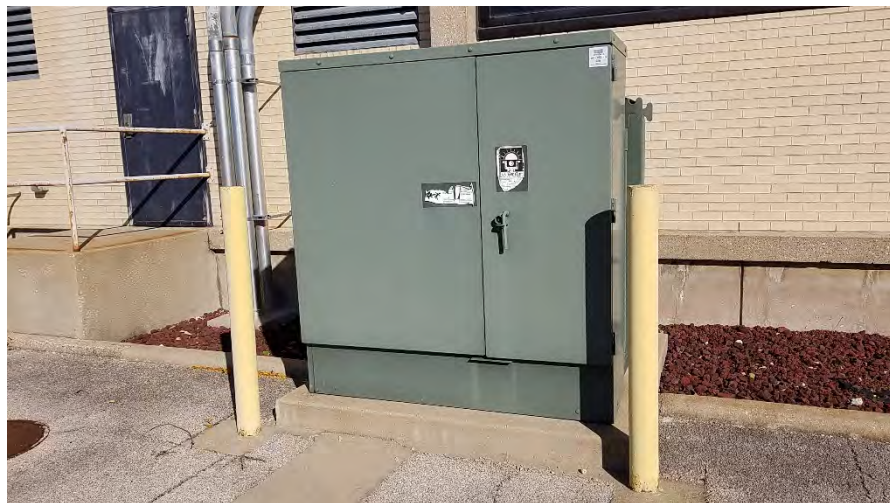
7. Pad mounted transformer – south side of the AFRC Building

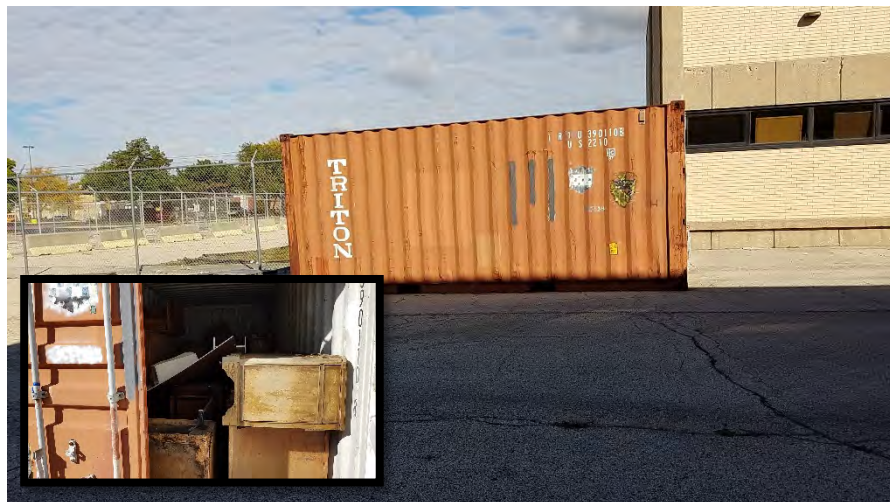
9. Shipping container near the AFRC. Old furniture is being stored in it.

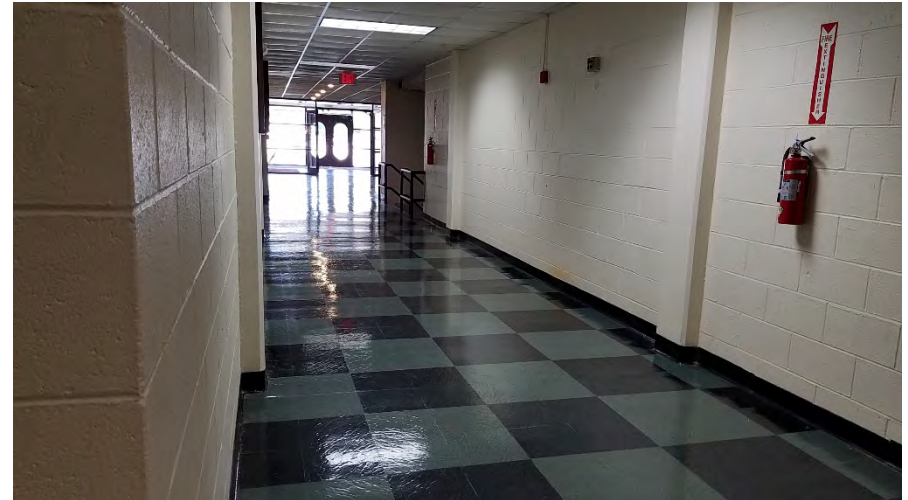
24. Another corridor in the AFRC Building. Green and black colored tiled flooring contains non-friable asbestos containing material (ACM)

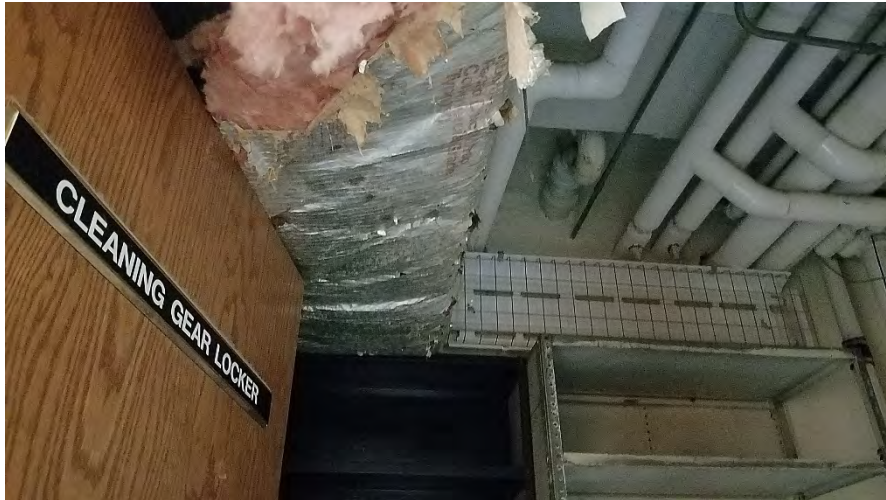
25. Exposed insulation in a HVAC duct and utility pipes in the ceiling of a cleaning supplies storage room

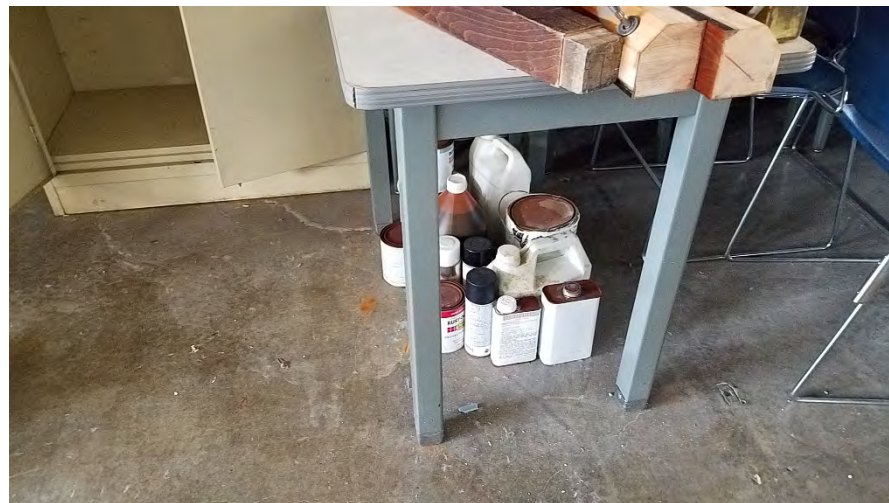
28. Cleaning chemicals and solvents temporarily stored in Room 101 (Navy's deepsea training area) of the Admin Building. AFOS indicated that these items are ready for pickup and disposal

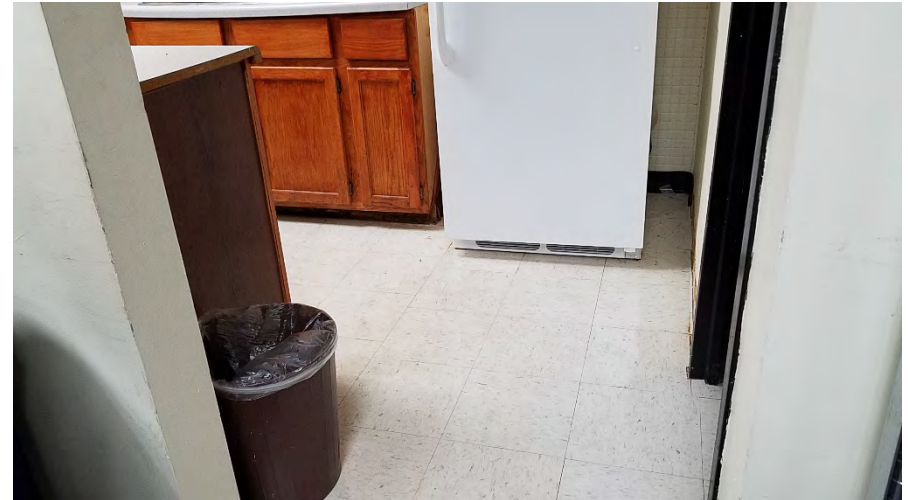
34. 9-inch x 9-inch tile flooring in the kitchen. Mastic contains non-friable ACM (2006 ECP Report)

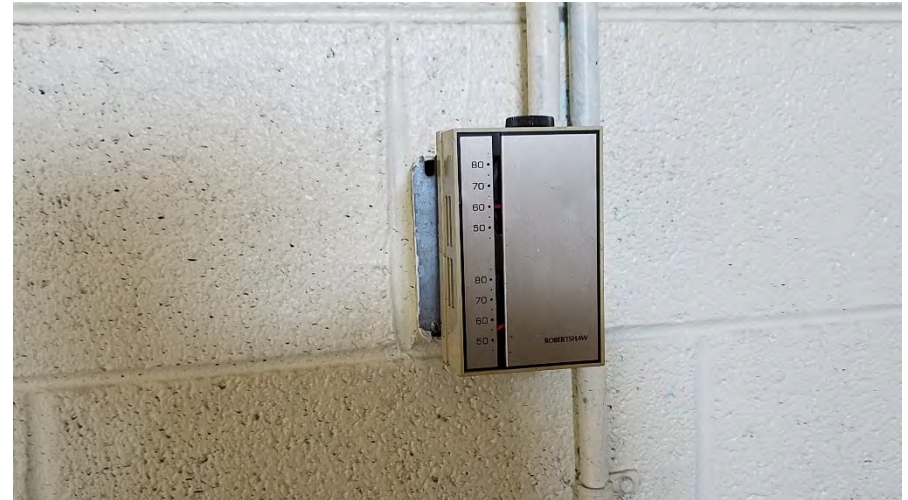
52. Old thermostat containing mercury switch located inside the OMS

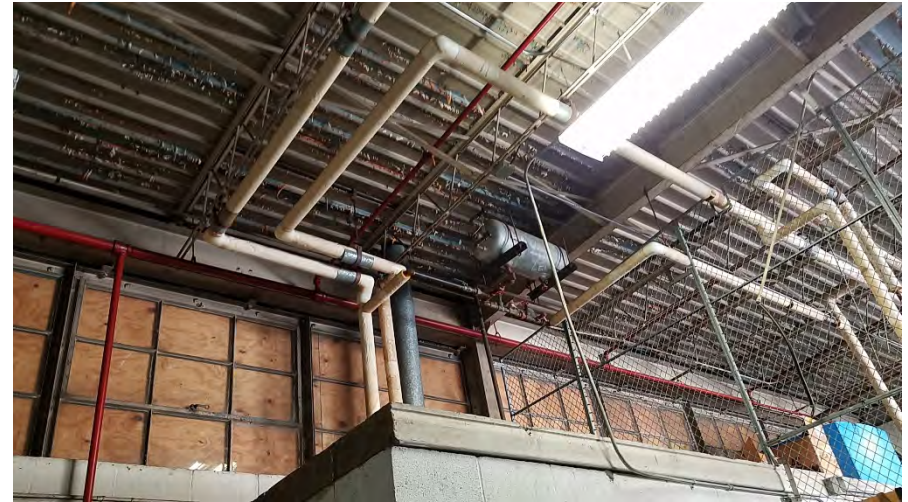
56. Another view of the ceiling with peeling paint. HVAC piping and fluorescent lighting

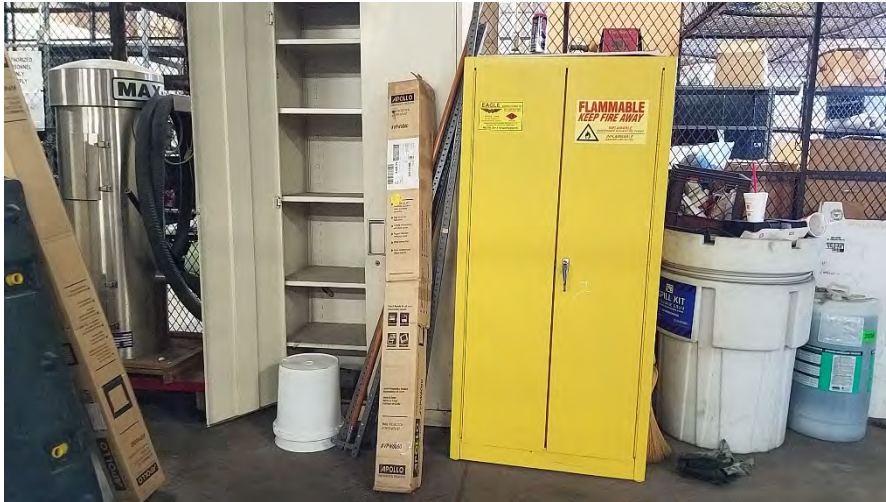
63. Flammable materials storage shelf inside the OMS

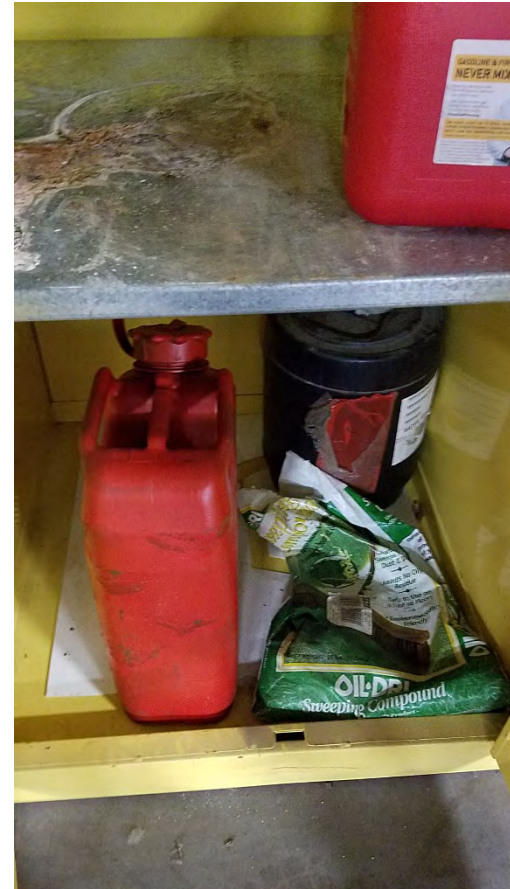
64. Two empty, gasoline containers were present inside the flammable materials storage shelf

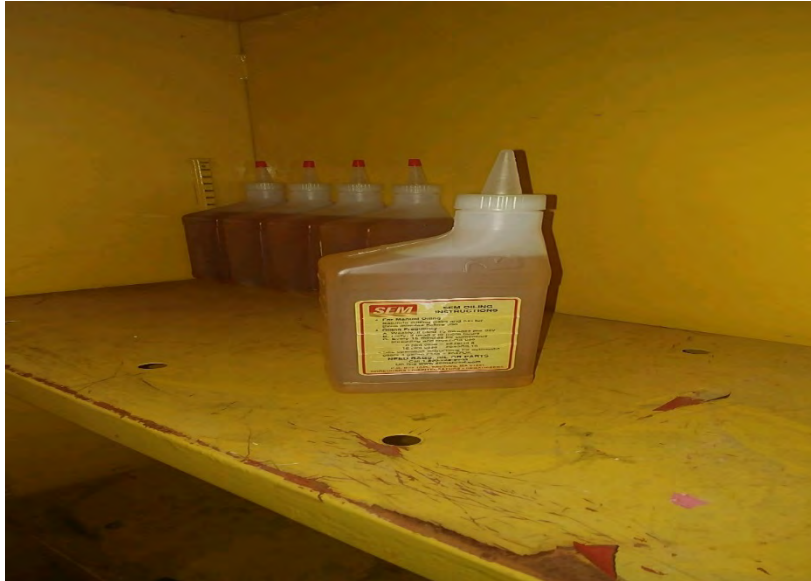
71. Shredder oil in cabinet 2

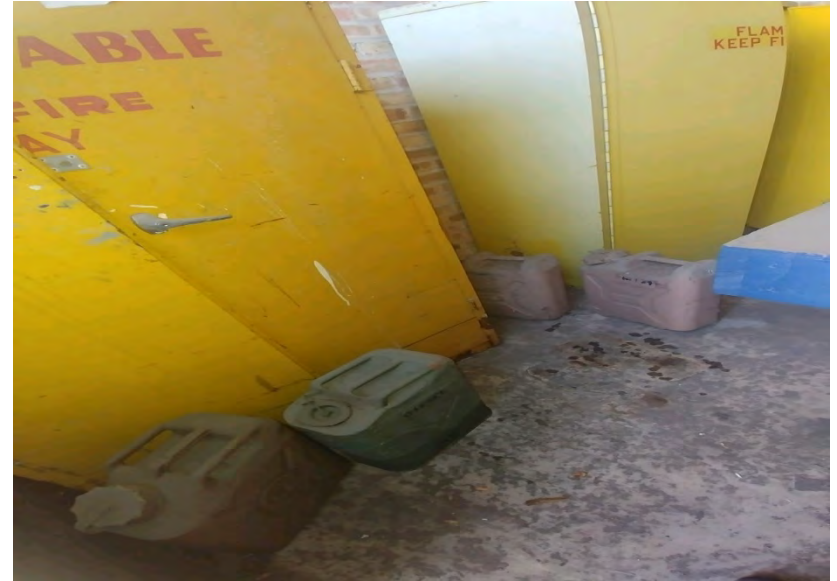
72. Empty fuel containers

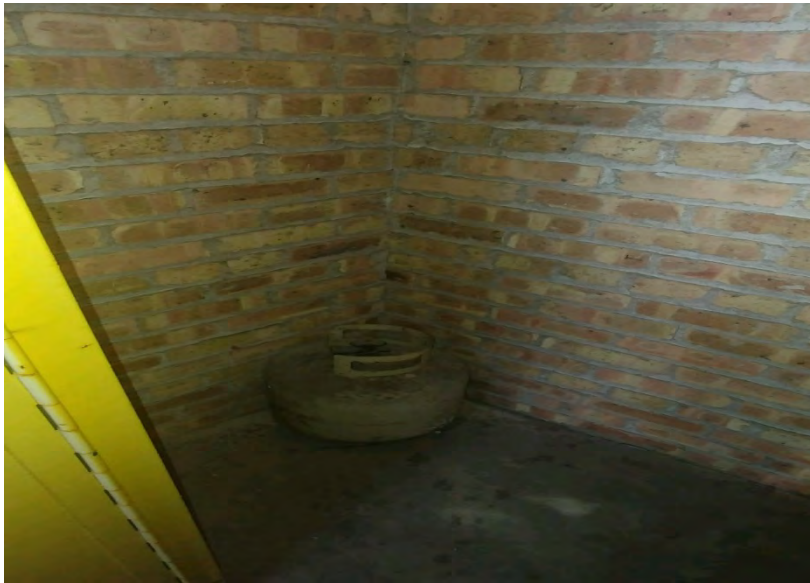
73. Propane tank appears to be empty

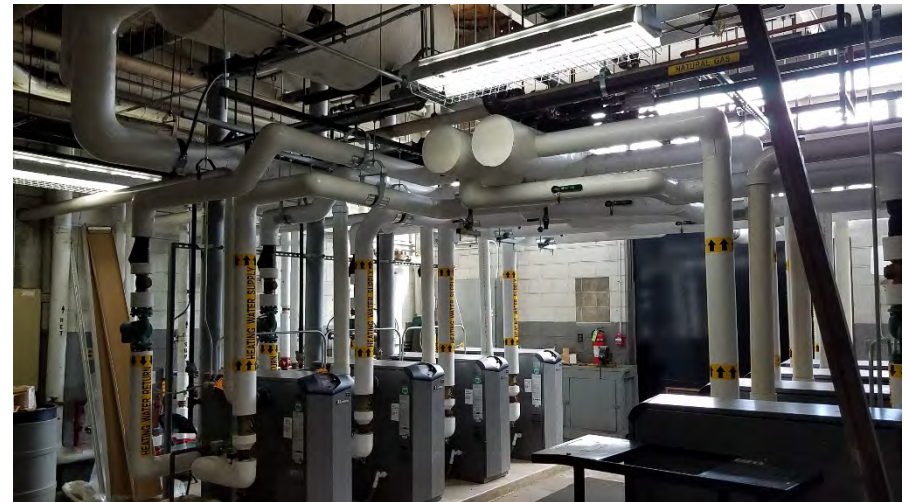
82. Inside boiler room in the Admin Building

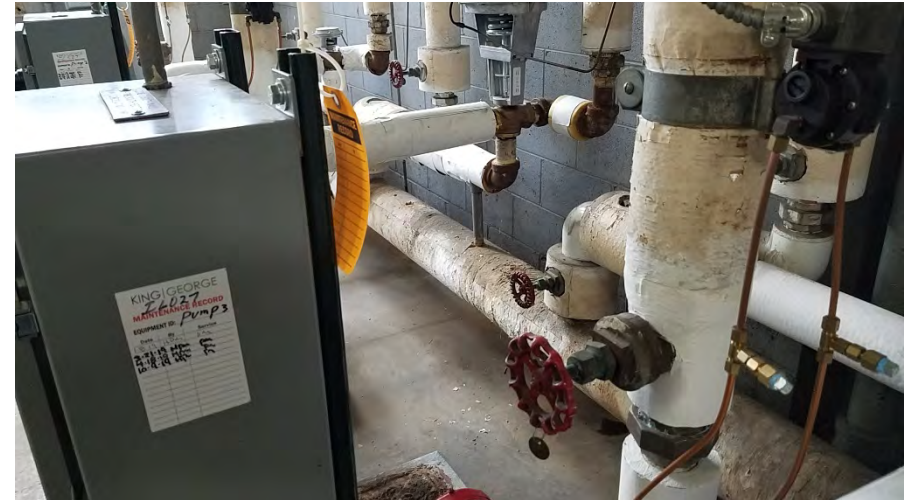
86. TSI on water distribution lines

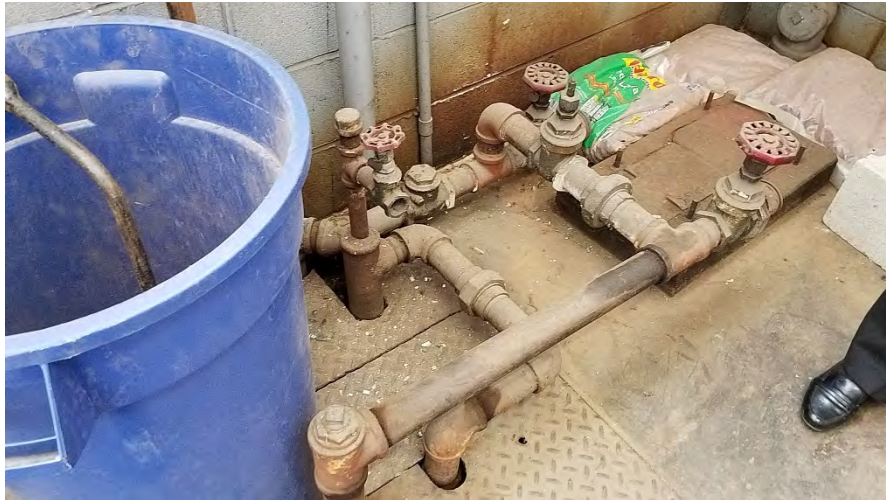
87. Distribution system piping and valves in the boiler room

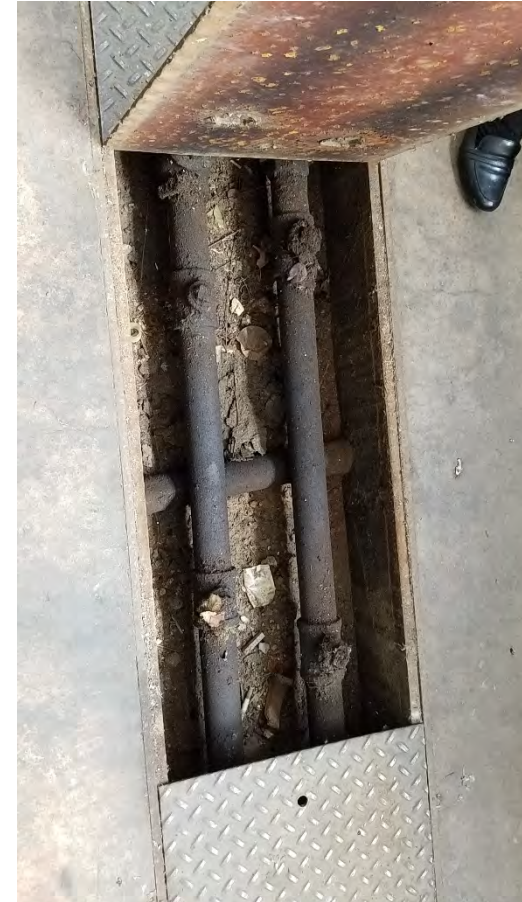
88. Piping in the utility trench inside the boiler room

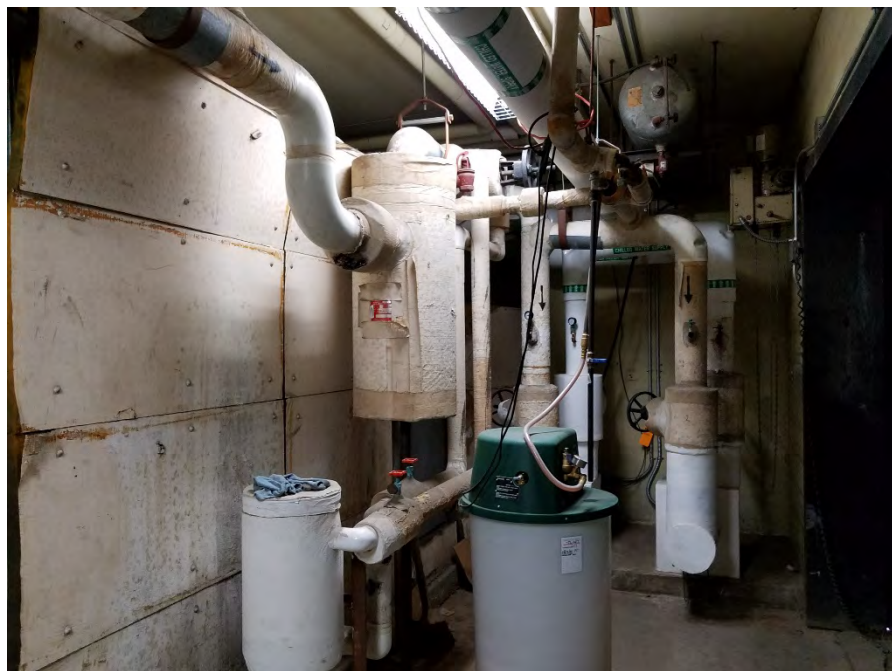
91. Distribution pipes with TSI

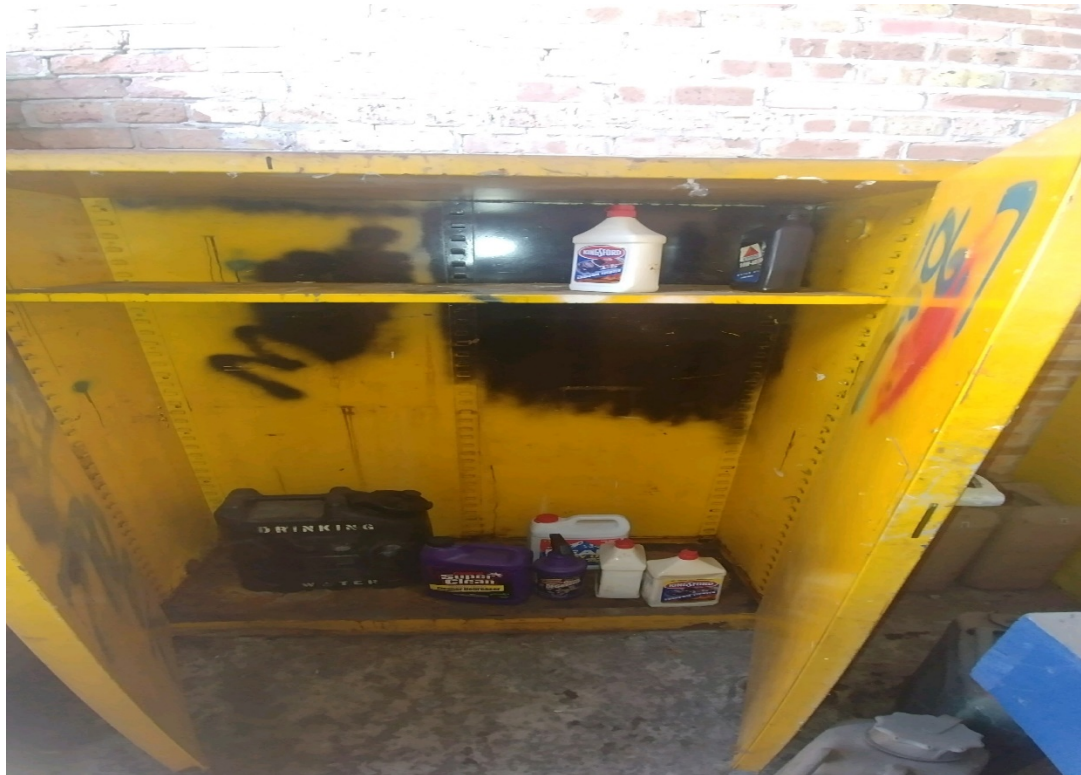
HAZMAT cabinet 1 - Charcoal lighter fluid, motor oil, degreaser, water canister

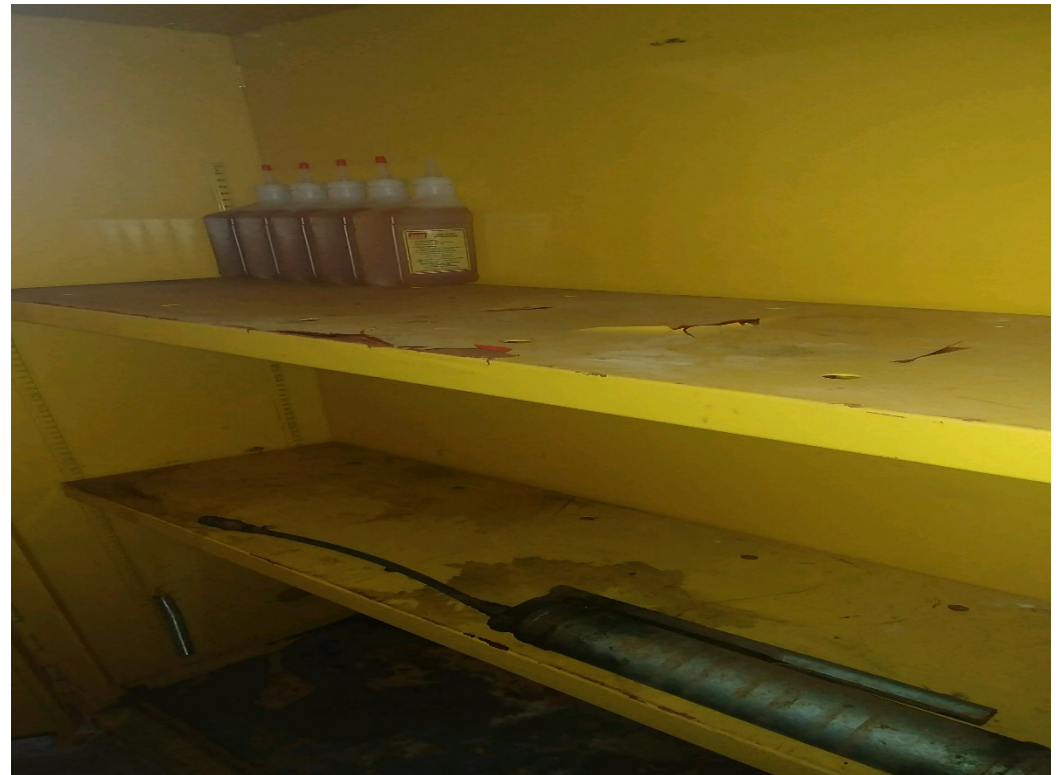
HAZMAT cabinet 2 – Shredder Oil, Tire pump

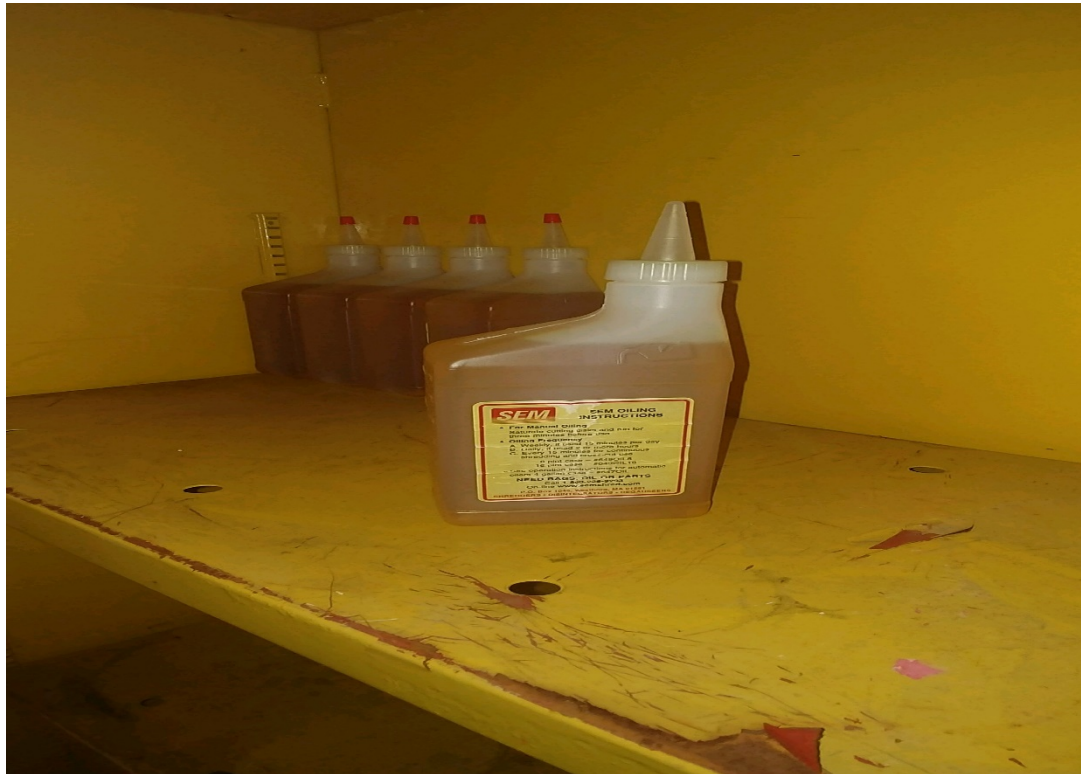
Shredder oil in cabinet 2

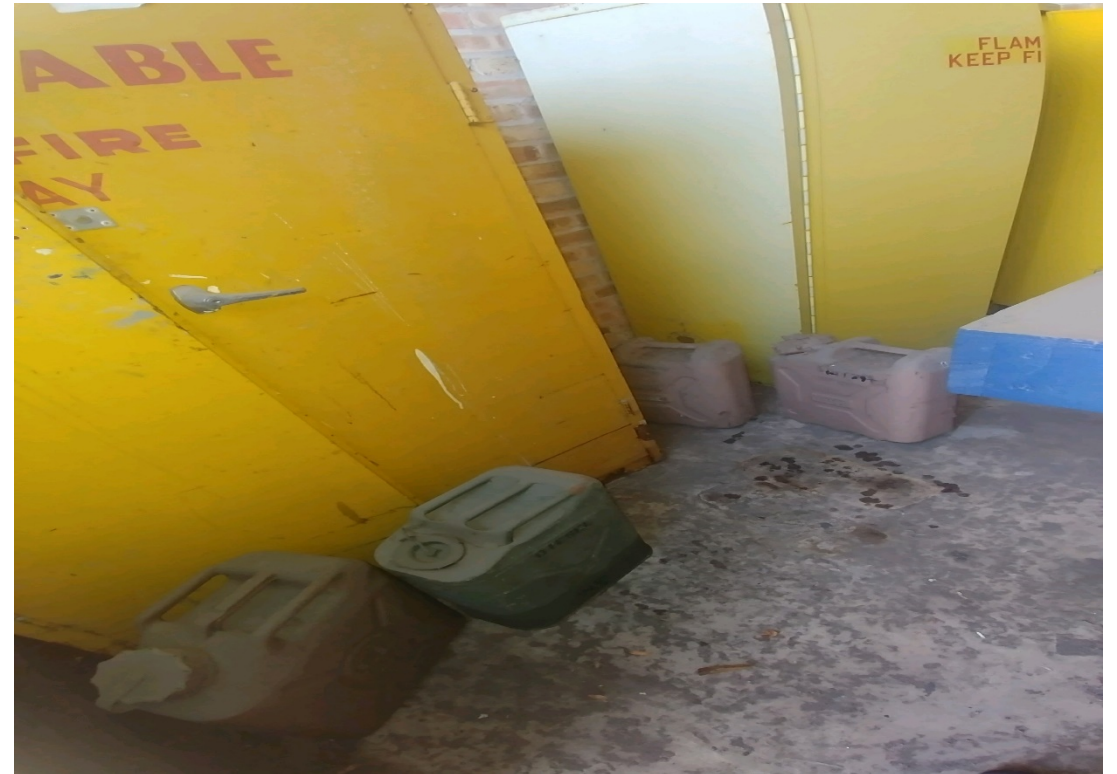
4 Empty fuel containers

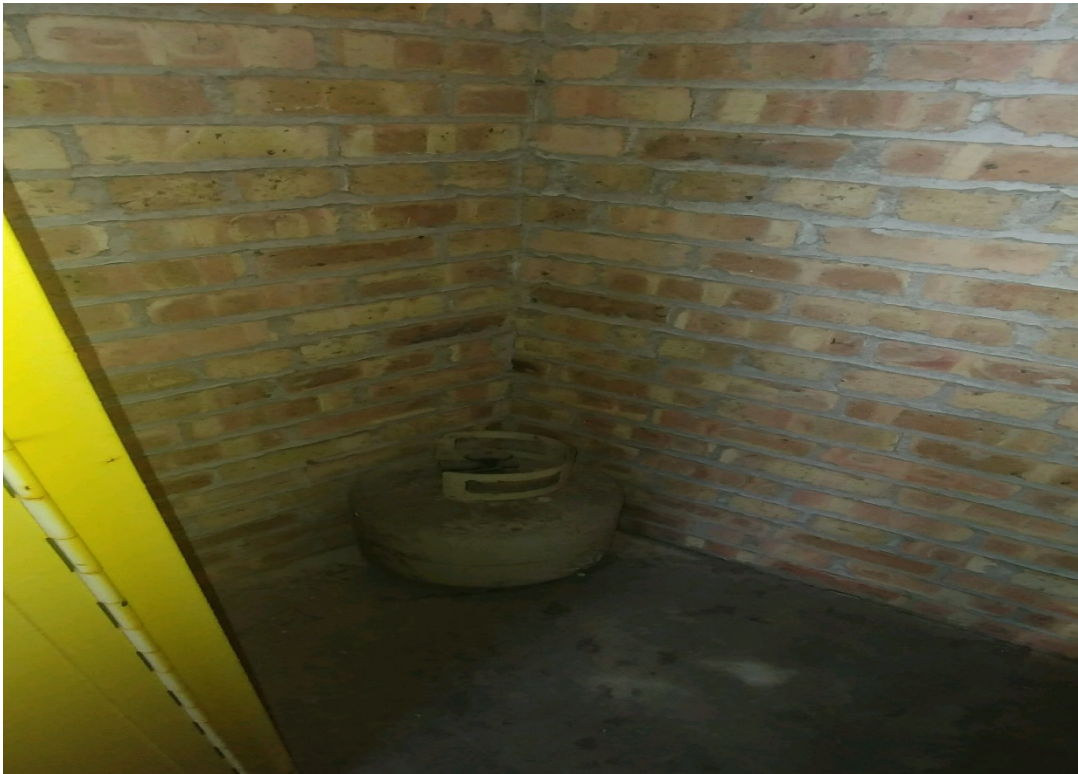
Propane tank appears to be empty

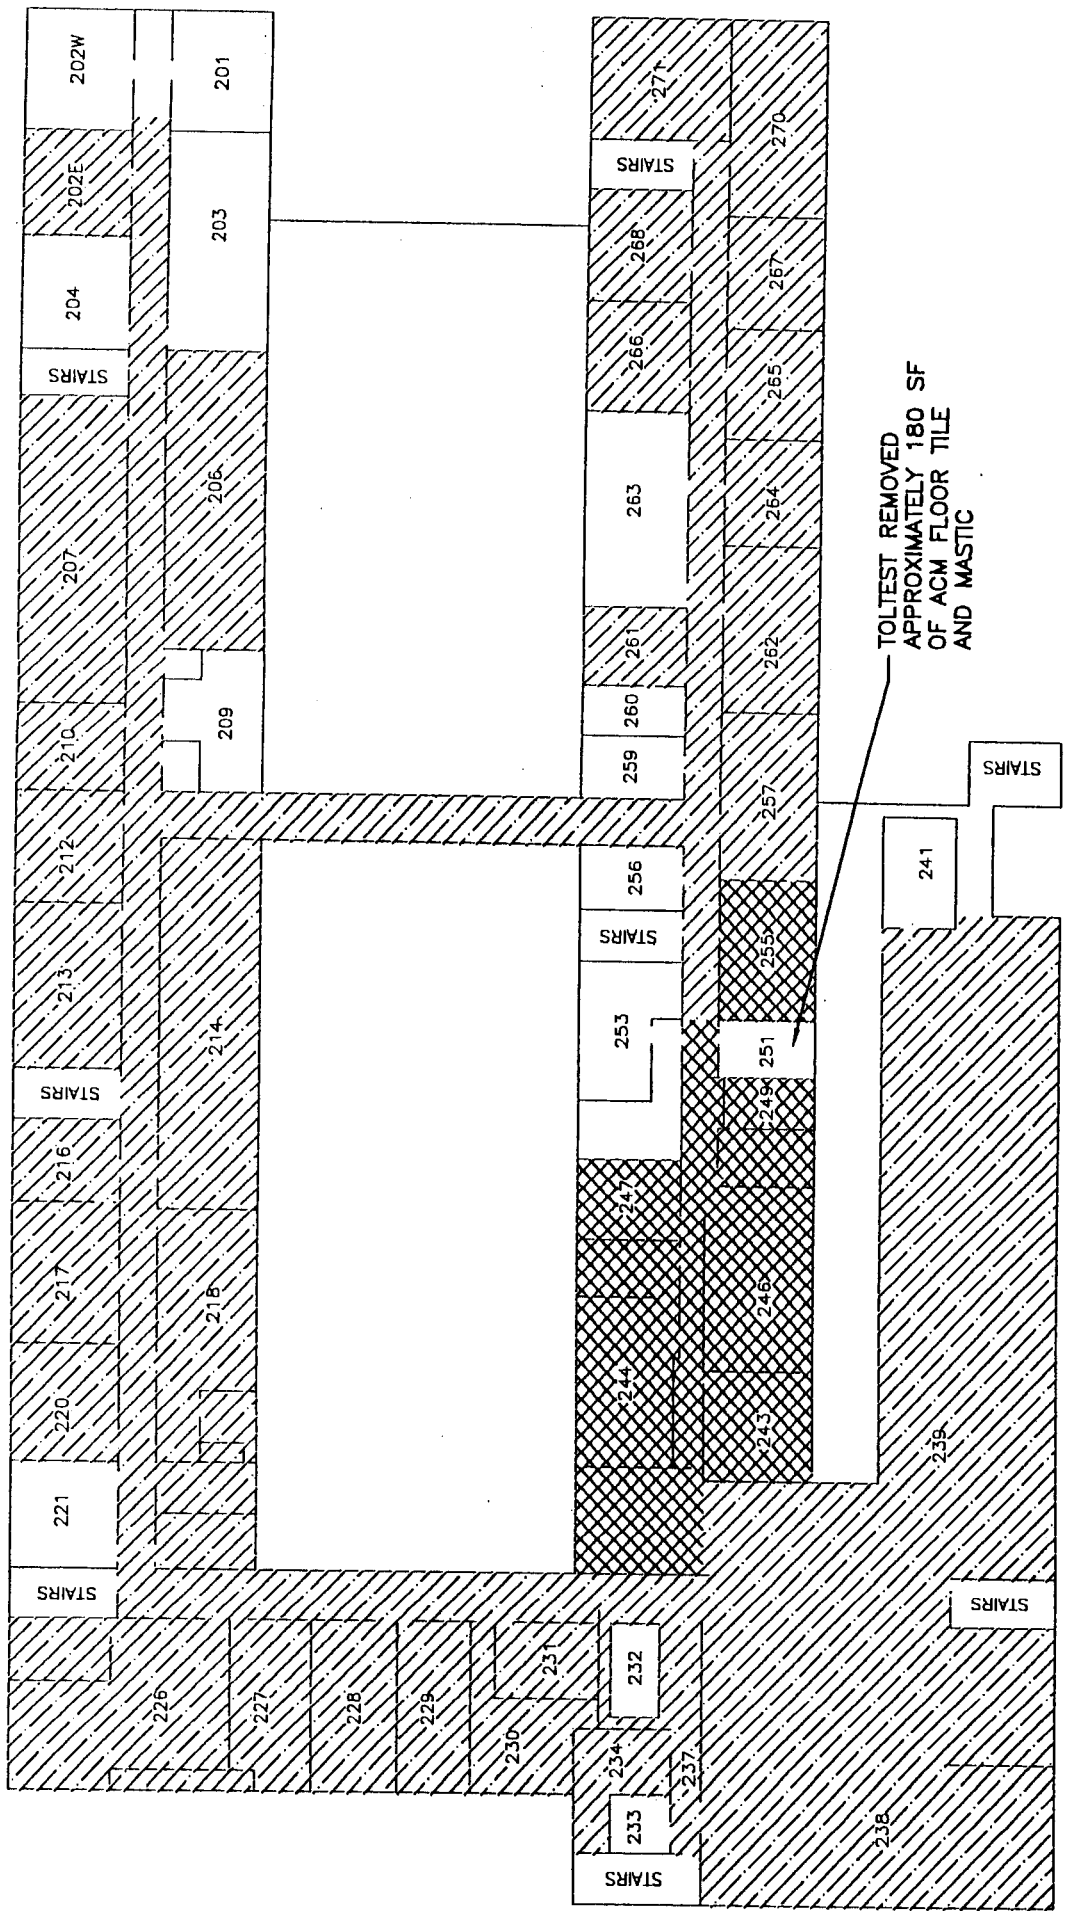
MAIN BUILDING - SECOND FLOOR PLAN
SCALE: 1/32" = 1'-0"

- LEGEND**
- ASBESTOS-CONTAINING MATERIALS (ACM)
IDENTIFIED ON FLOOR AND WALLS
INCLUDING TOTAL QUANTITIES:
- FLOOR COVERING WITH MASTIC (5,000 SQ.F.)
 - FLOOR COVERING MASTIC (20,000 SQ.F.)

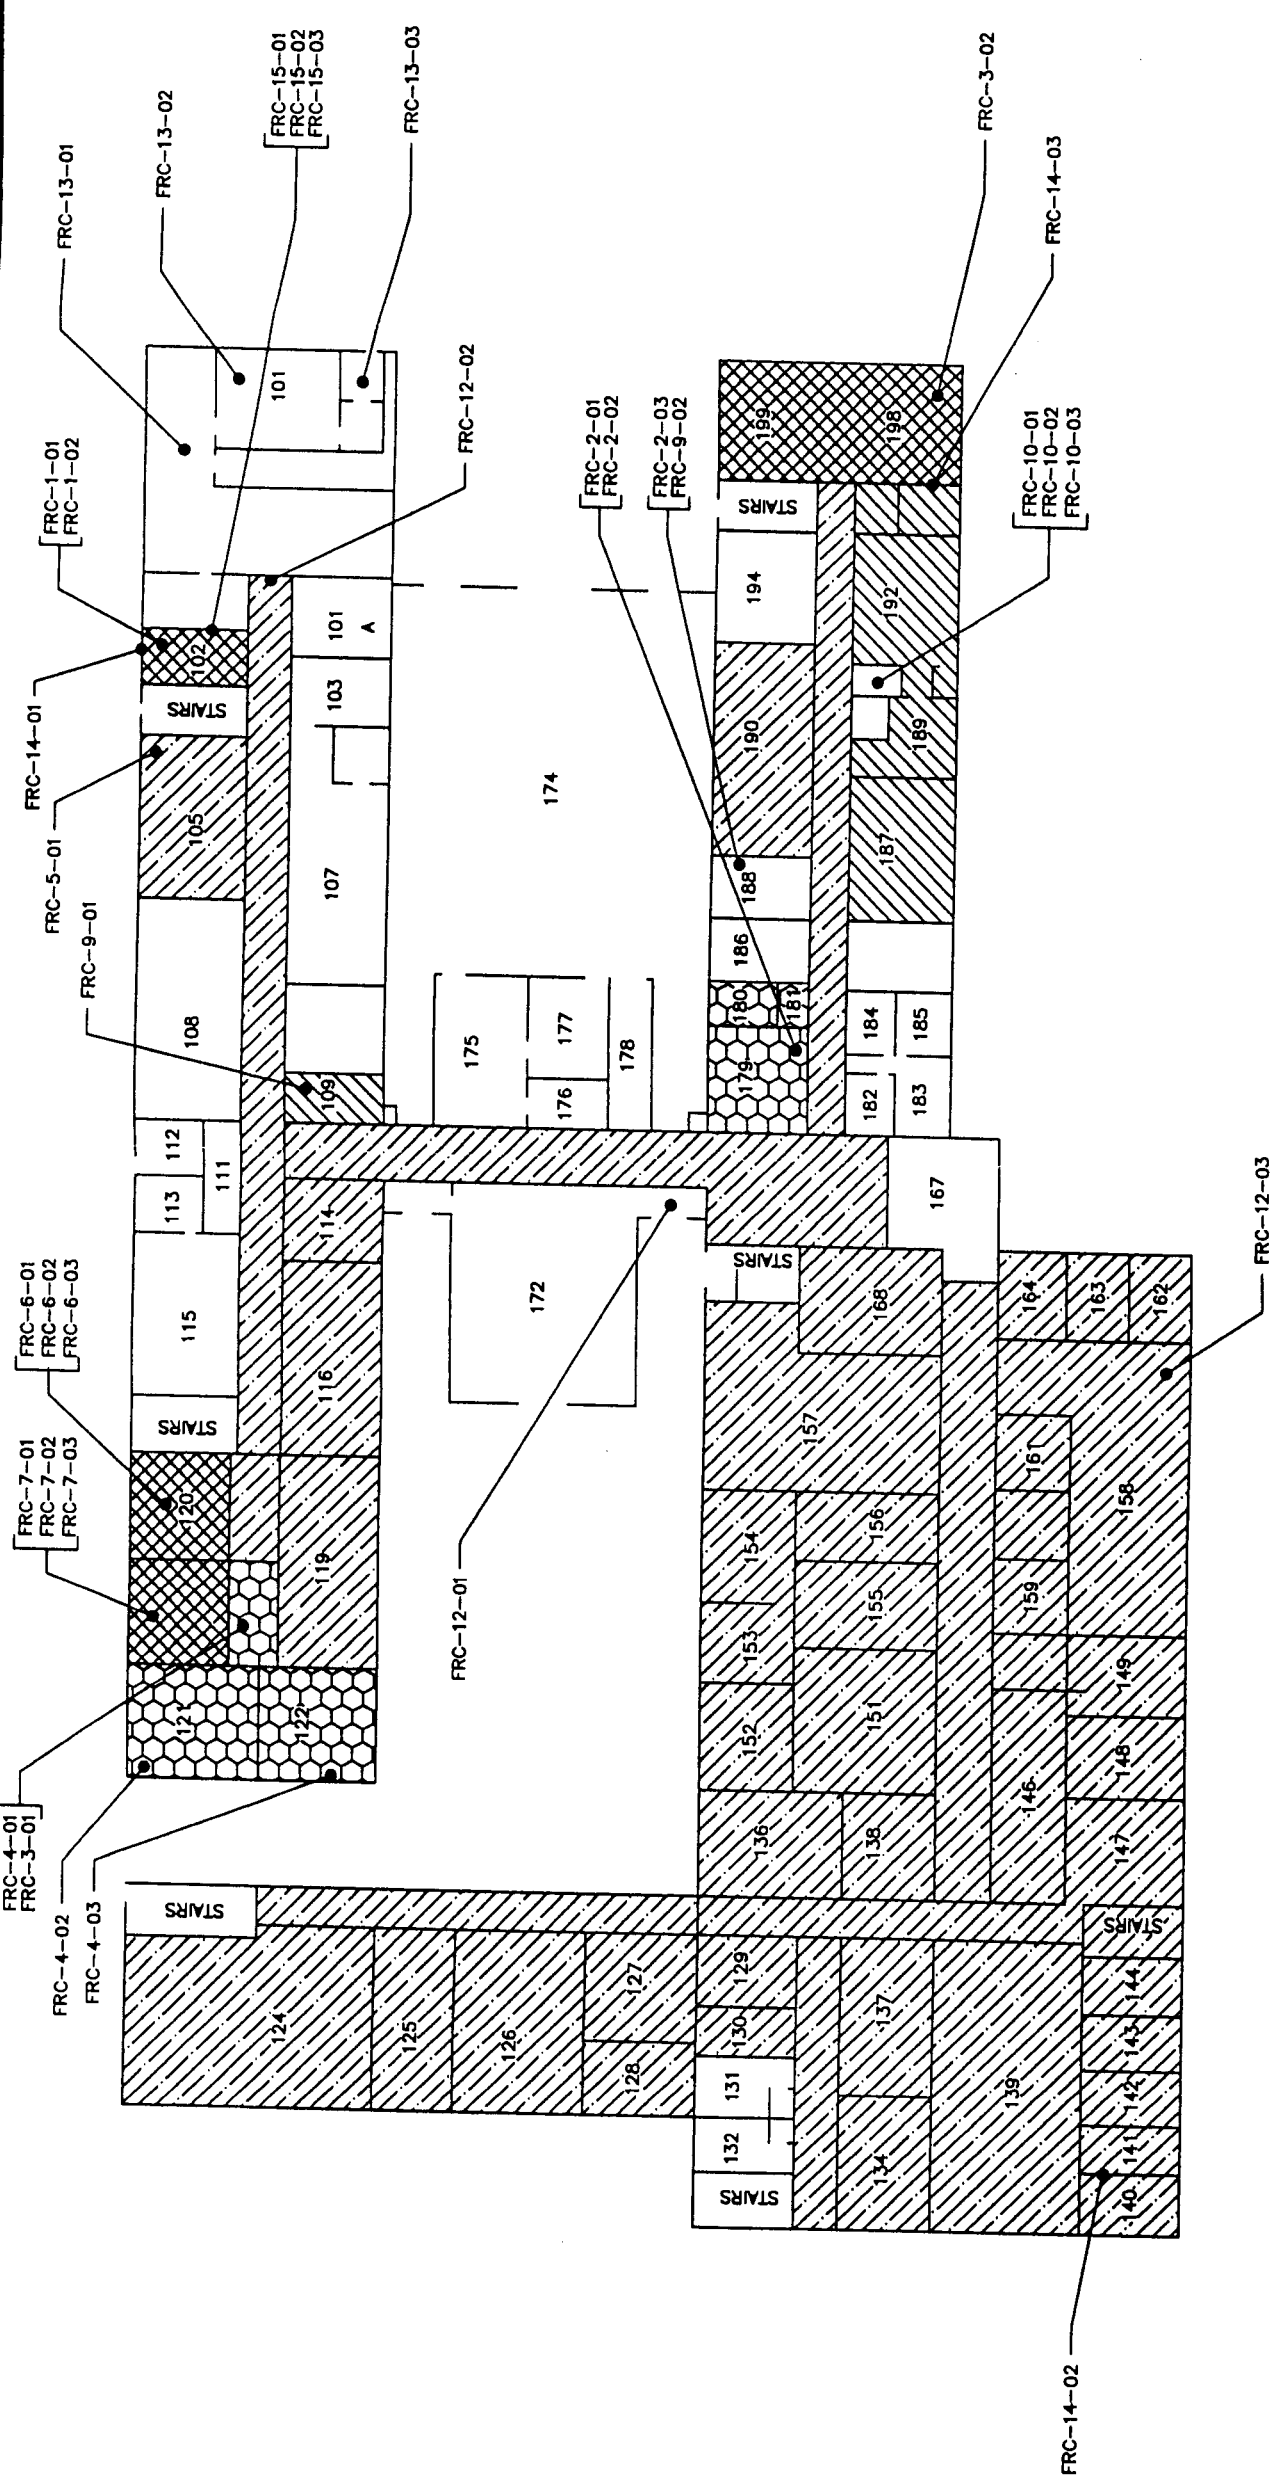
MAIN BUILDING - FIRST FLOOR PLAN
SCALE: 1/32" = 1'-0"

- LEGEND**
- ASBESTOS CONTAINING MATERIALS (ACM) IDENTIFIED ON FLOORS AND WALLS INCLUDING TOTAL QUANTITIES:
 - FLOOR COVERING WITH MASTIC (1000 SQ.F.)
 - FLOOR COVERING (1200 SQ.F.)
 - DOUBLE LAYERED FLOOR COVERING WITH MASTIC (1200 SQ.F.)
 - FLOOR COVERING MASTIC (25000 SQ.F.)
 - LOCATION OF SAMPLES COLLECTED

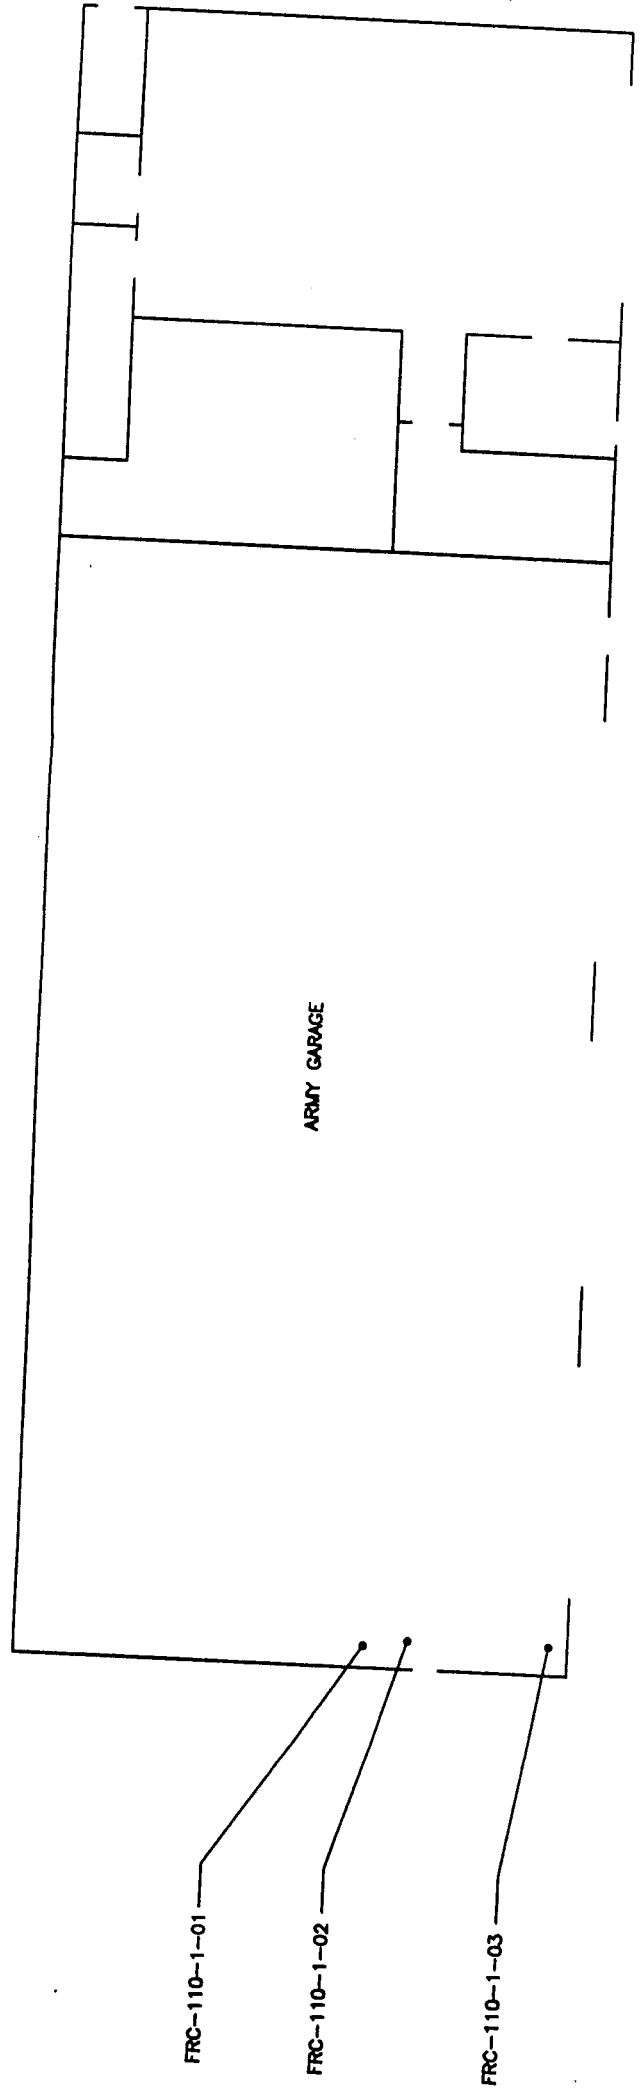
BUILDING 110 - FLOOR PLAN
SCALE: 1/16" = 1'-0"

NOTE:
ASBESTOS-CONTAINING WINDOW PUTTY MATERIAL
IDENTIFIED ON ALL EXTERIOR WINDOWS (800 LF)

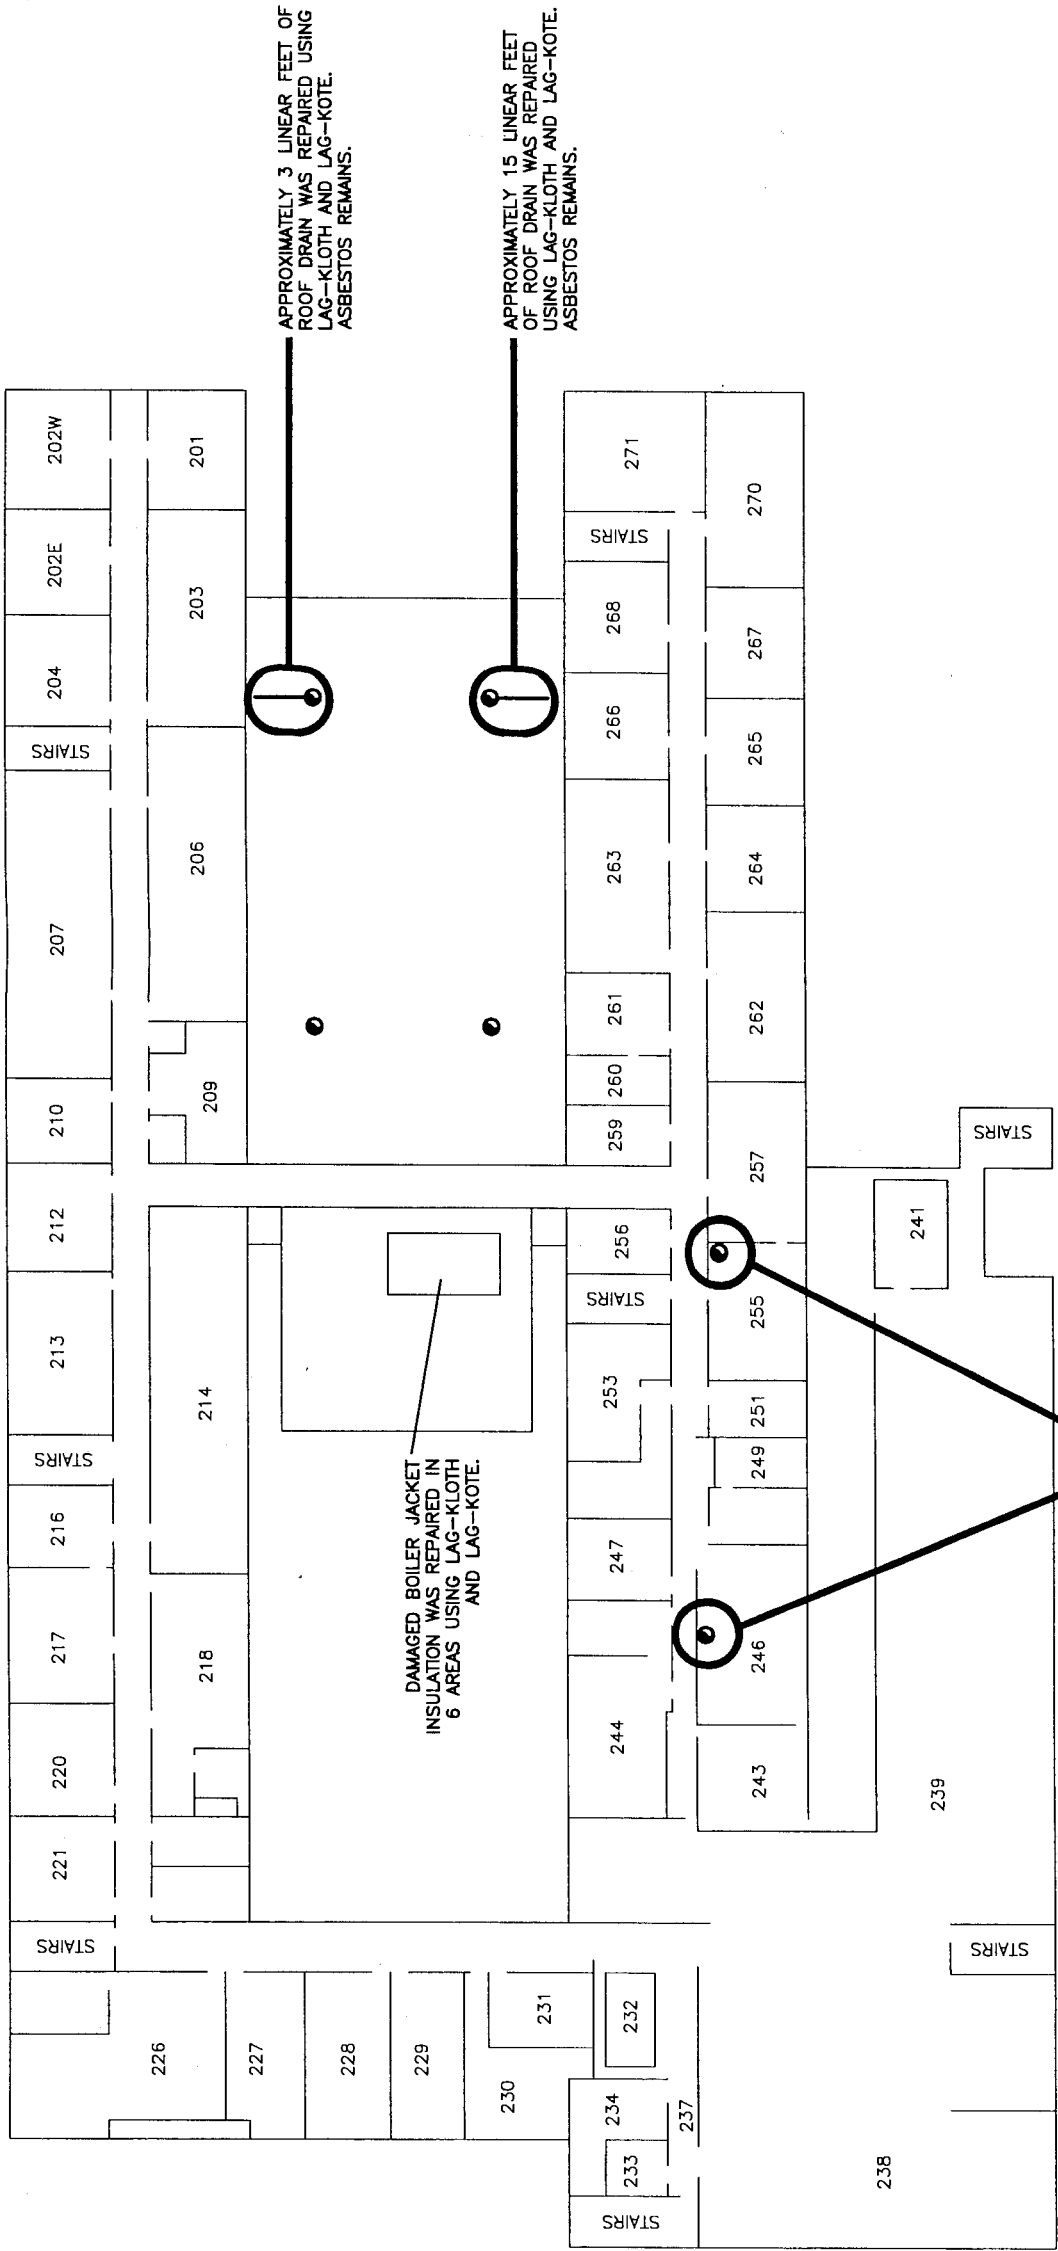
LEGEND
● PIPE INSULATION ON ROOF DRAINS (50 LF)

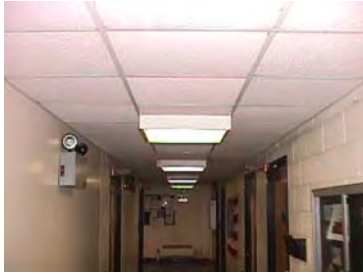
2' x 2' Ceiling Tile (Non ACM)

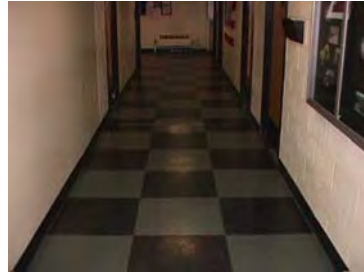
12' x 12' Floor Tiles (Non ACM)
MASTIC IS POSITIVE

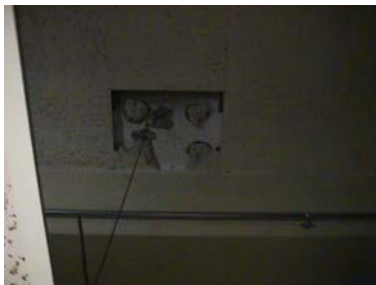
1' x 1' Ceiling Tiles (Non ACM)

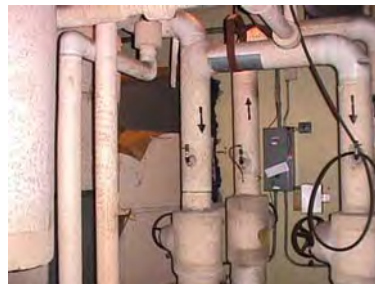
Thermal System Insulation (Non ACM)
