**Environmental Condition of Property Update Report
Armed Force Reserve Center (IL027)
7402 W. Roosevelt Road, Forest Park, Illinois 60130**

**Environmental Documentation in Support of
U.S. Army Reserve Facility Disposals**

January 2022

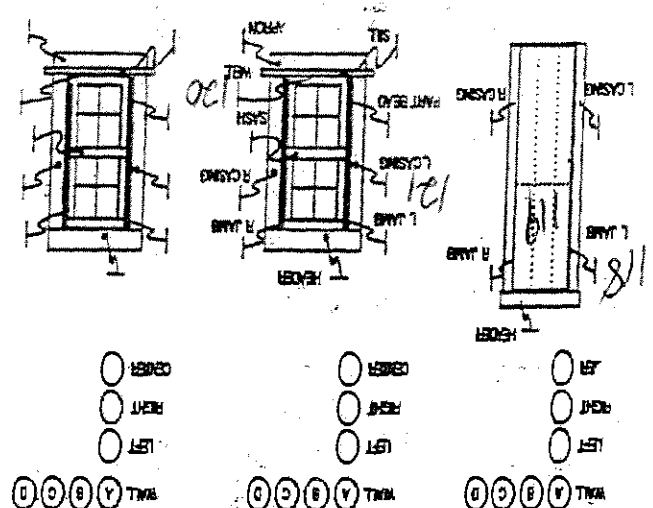
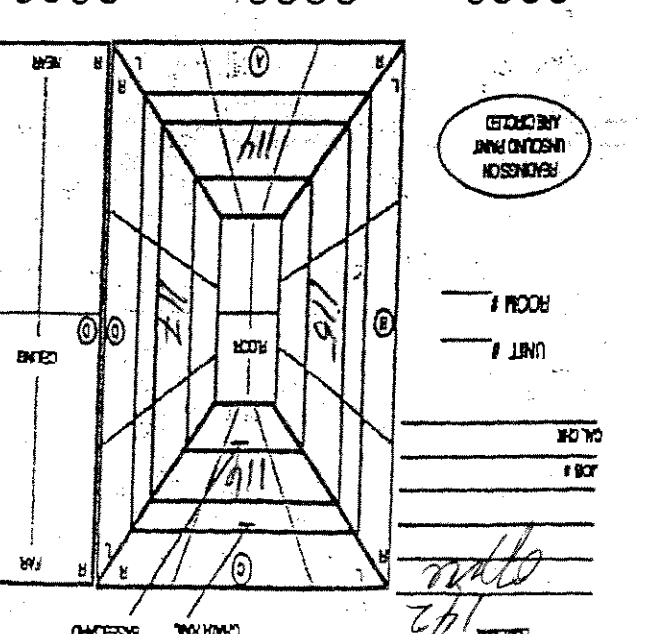
COMMENTS: The partition walls is of Timber
laminated steel port and all
other walls and structural members
are of timber laminated members
the doors is of wooden one is
are laminated substrate the
door frame is of Black laminated
metal substrate the windows
components is of Brown laminated
metal substrate

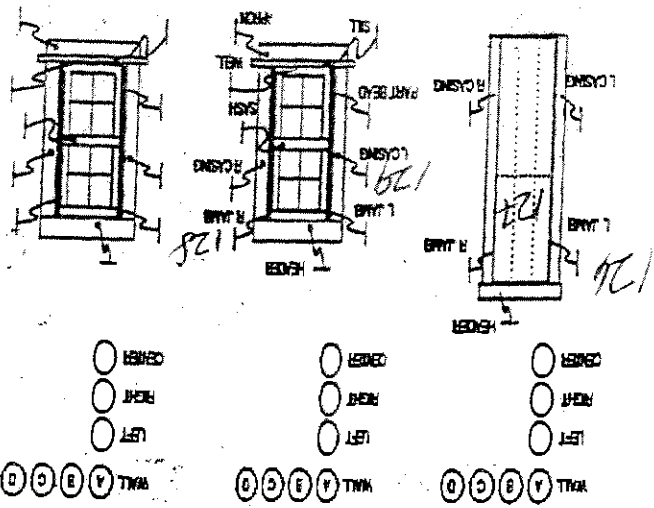
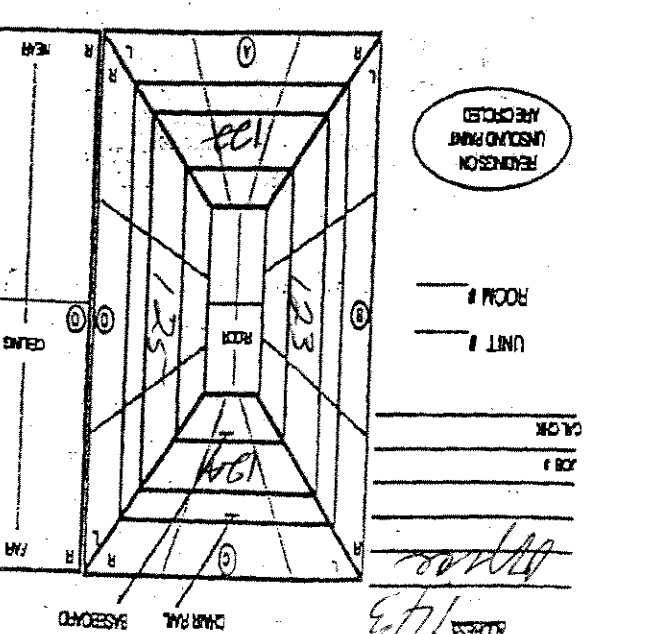
COMMENTS: The partitions walls is of Timber
laminated steel port and all
other walls and structural members
are of timber laminated members
the doors is of wooden one is
are laminated substrate the
door frame is of Black laminated
metal substrate the windows
components is of Brown laminated
metal substrate

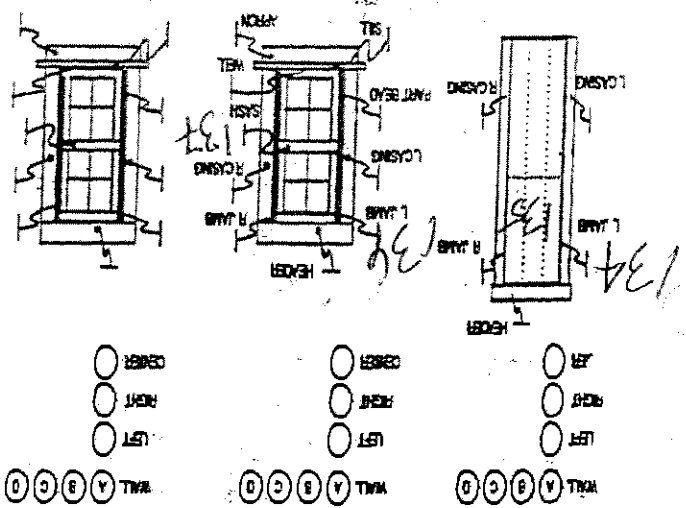
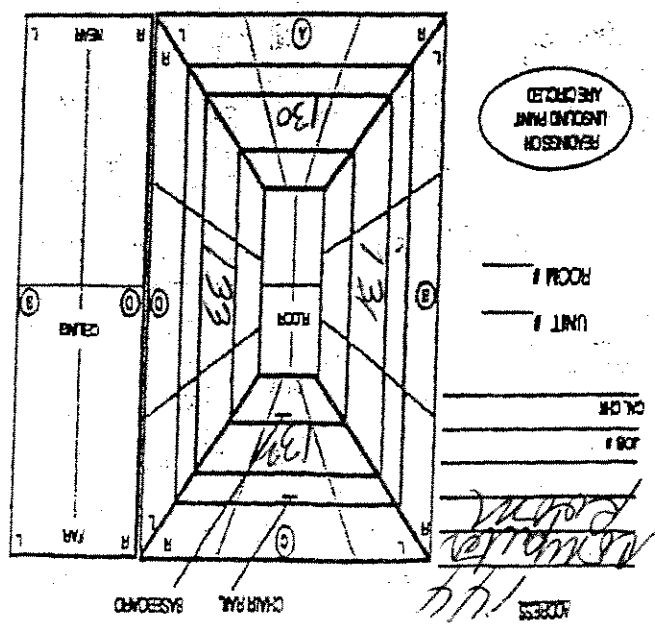
COMMENTS: The partition walls is of tin
plated sheet rock and all
other walls and structural members
are of tin plated metal.
The door is of wooden sash - A
the windowed substrate. The
door frame is of black finish
metal substrate. The window
component is of Brown
finishes metal substrate.

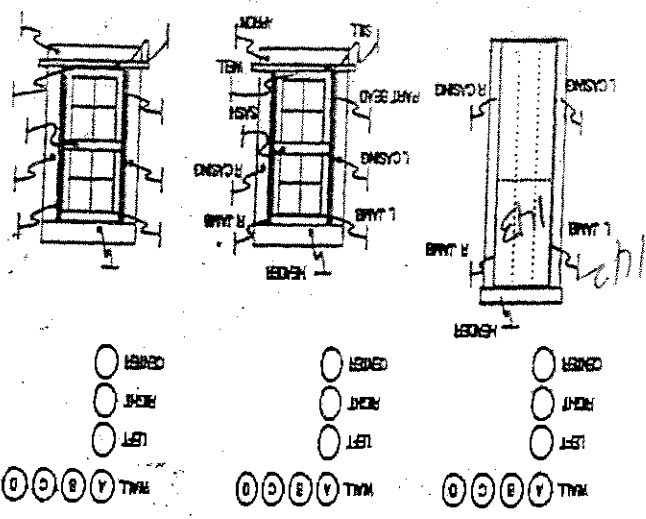
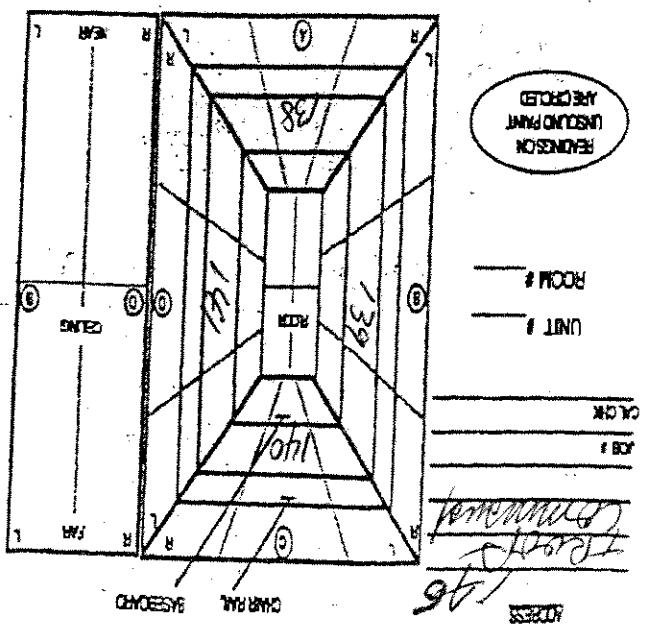
COMMENTS: The partitions walls is of tin
plated sheet rock and all
other walls and structural members
are of tin plated metal.
The door is of wooden sash - A
the windowed substrate. The
door frame is of black finish
metal substrate. The window
component is of Brown
finishes metal substrate.

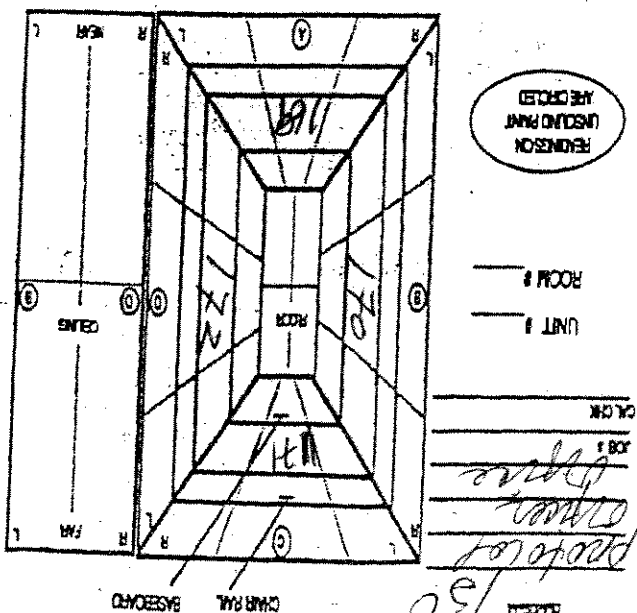
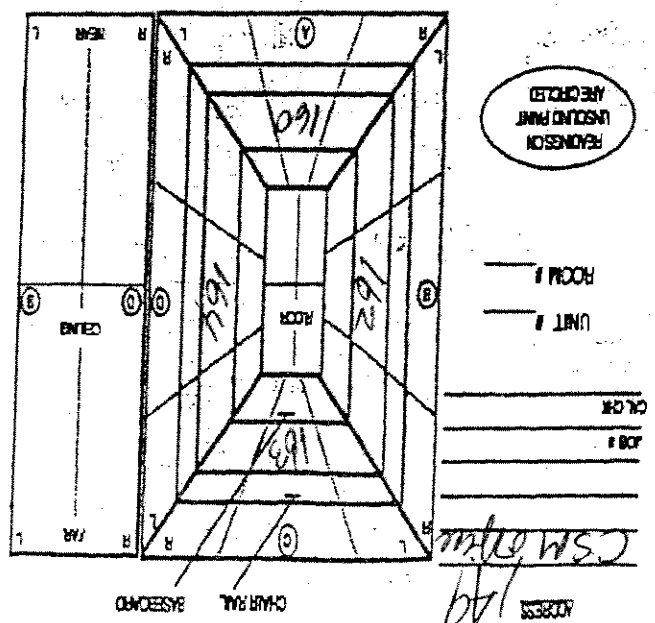
COMMENTS: The partitions walls is a fire finished steel post, all other areas and structural columns of concrete blocks and poured concrete masonry. The door is a steel - A - C - finish of wooden substrate, and the doors joints is of Black finish metal substrate.

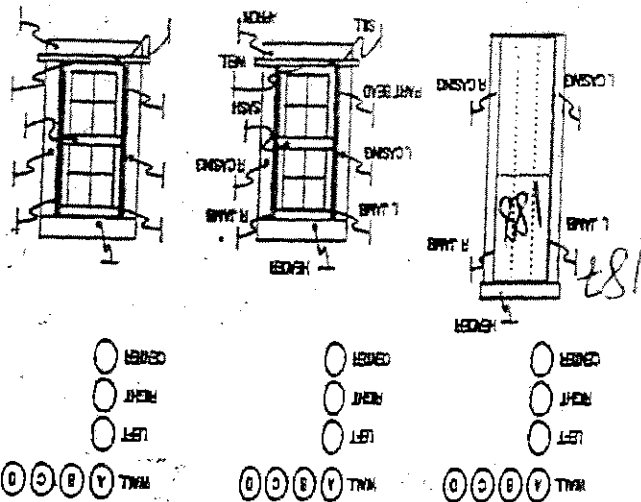
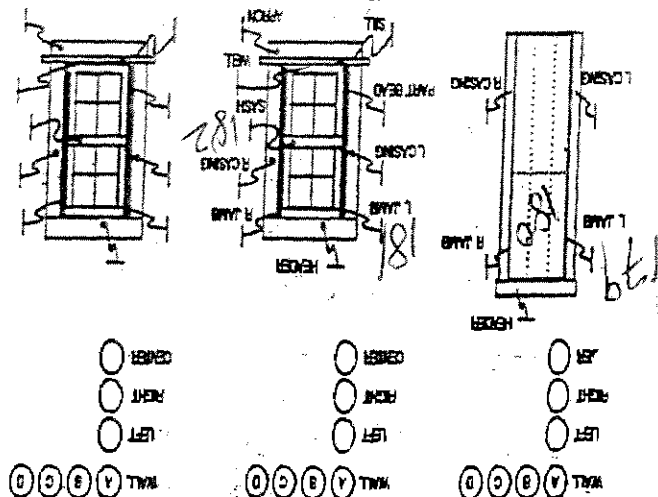
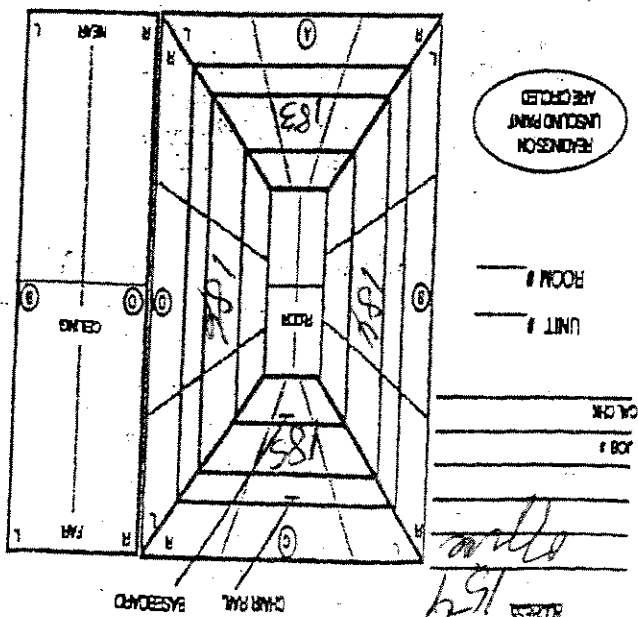
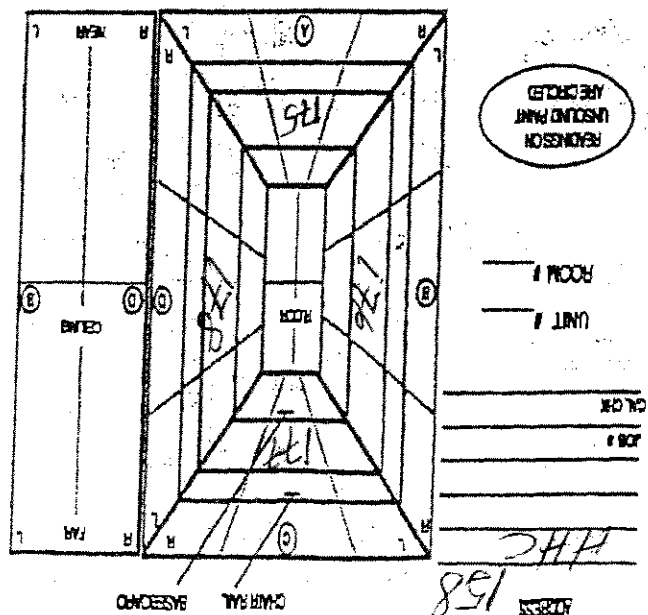
COMMENTS: The porch on walls is of Tan
Painted short port and all
outer walls and structural members
are of Tan Painted concrete
Bridges of concrete columns,
The door is of wooden she-A-
lar finished substrate. The
door frame is of Black painted
metal outside.

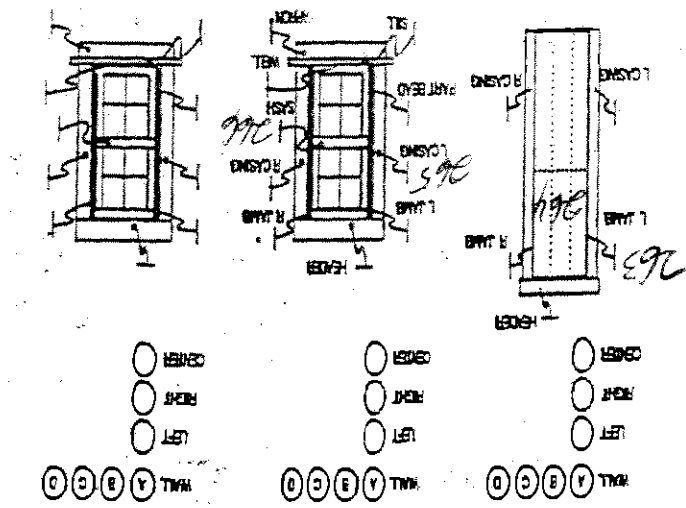
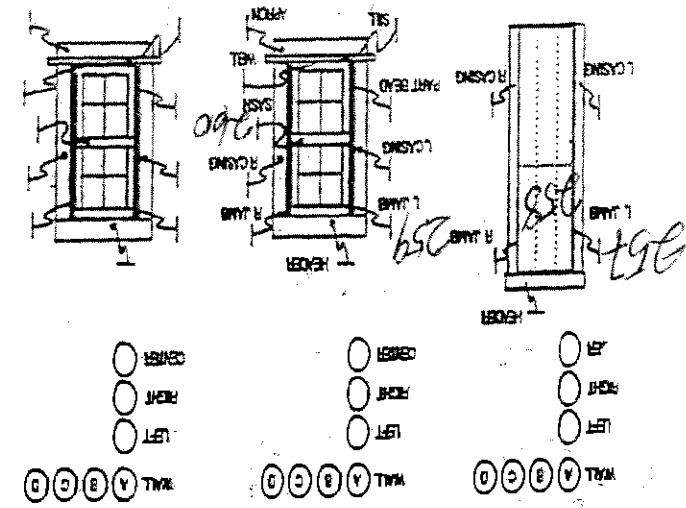
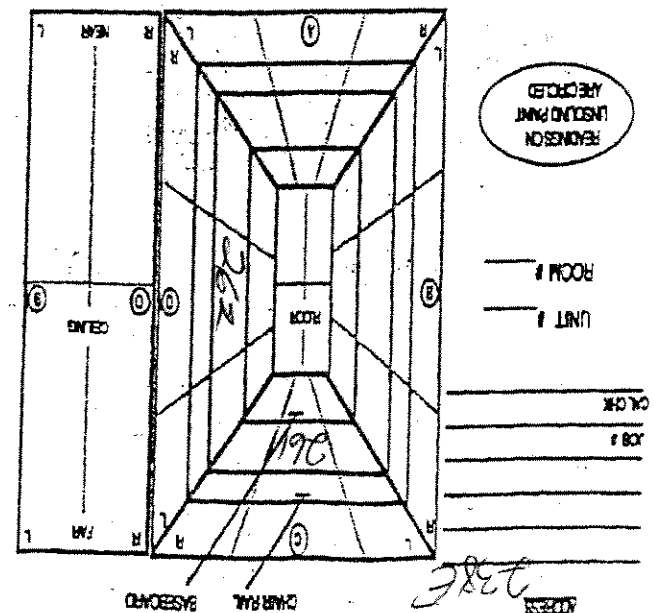
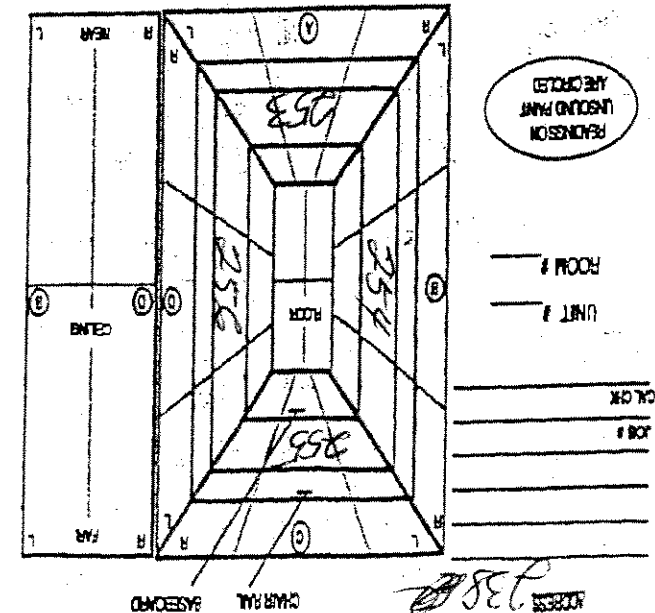
COMMENTS: The Partition walls are of Tan finished sheet rock. All outer walls are of concrete blocks, concrete columns or concrete blocks. Block layered. The door is of SHE-A-LAC Woodwork substrate. The doors are of Black finished metal jambs is of Black finished metal substrate. Wall B is of Black framed glass. Wall C is of PE-Cost framed glass units. The windows components is of framed Brown metal substrate

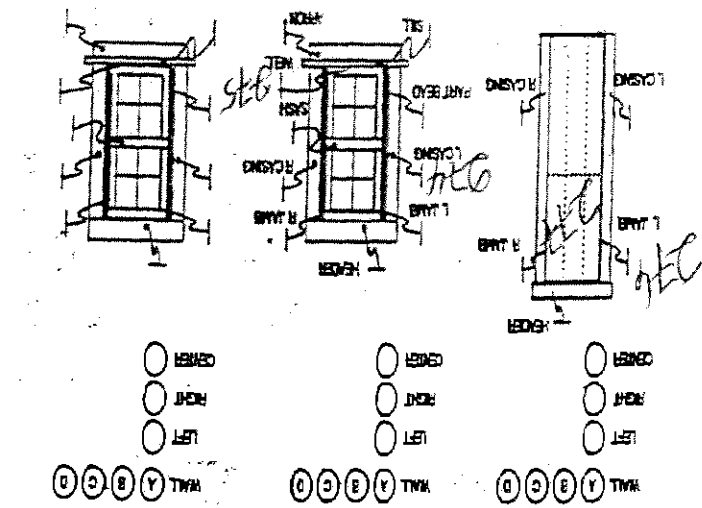
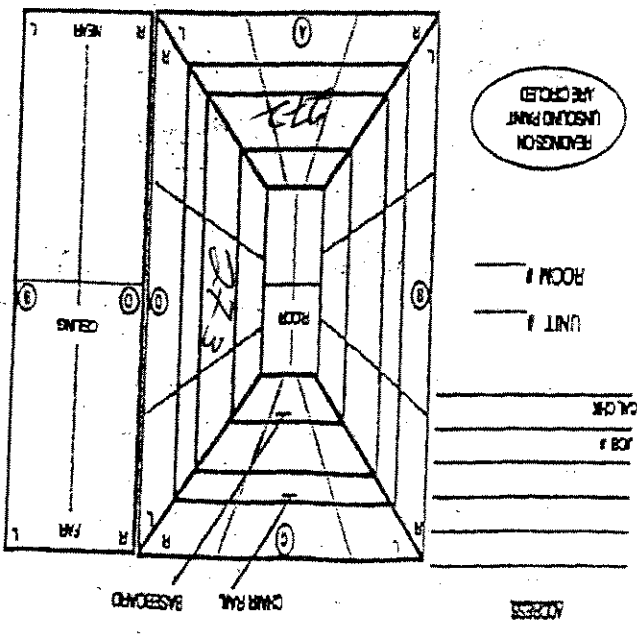
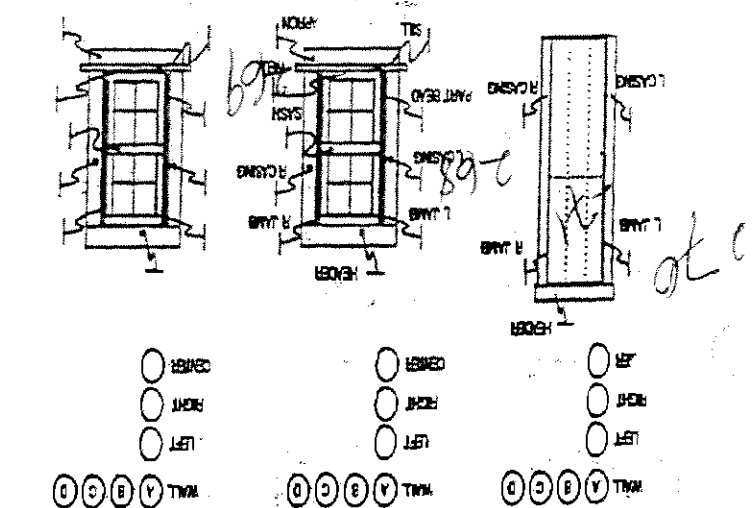
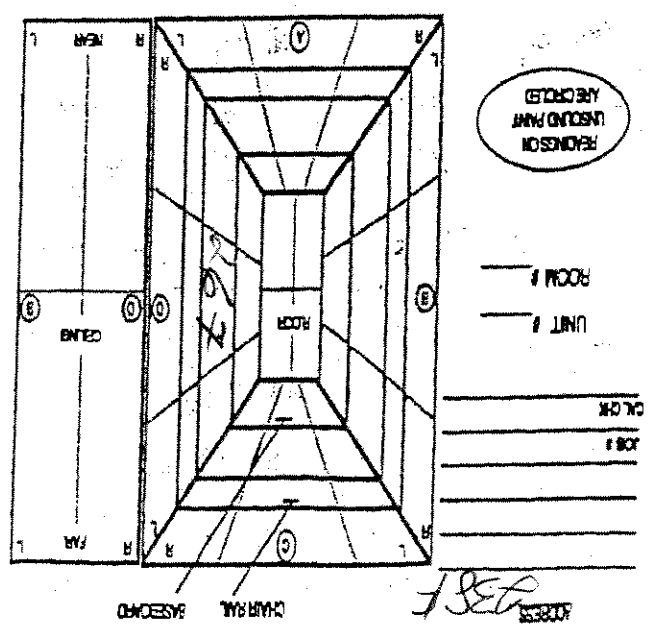
COMMENTS: The partition walls are of Tan finished sheet rock. All outer walls are of concrete blocks, concrete columns or concrete blocks. Black painted. The doors are of wood finished wood. The door blocks Black painted. The door is of She-A-Lac finished wood substrate. The doors jambs is of Black finish metal substrate.

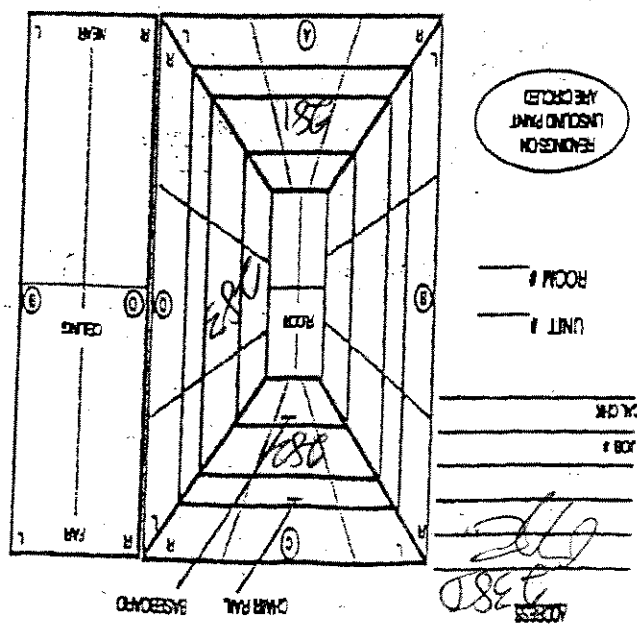
COMMENTS: The partition walls are of Tan finished wood. All outer walls and structural walls are of concrete. Brick blocks concrete medium or concrete blocks black painted, the door is of She-A-Lac finished wood. IS of She-A-Lac finished wood. Substrate, the door jambs is of Black Finish Metal Substrate.

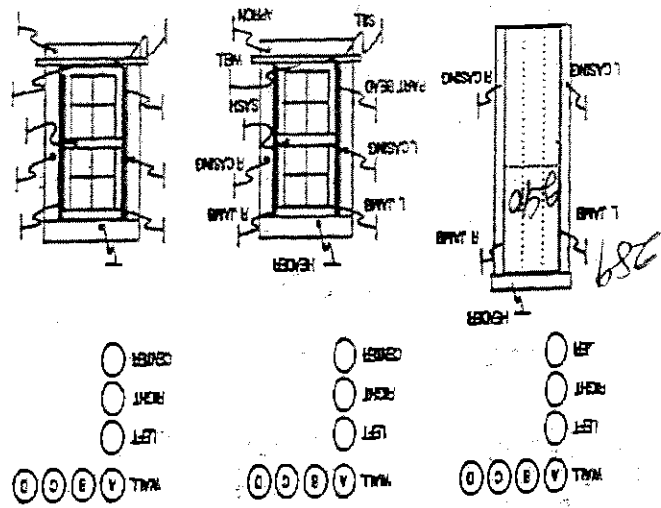
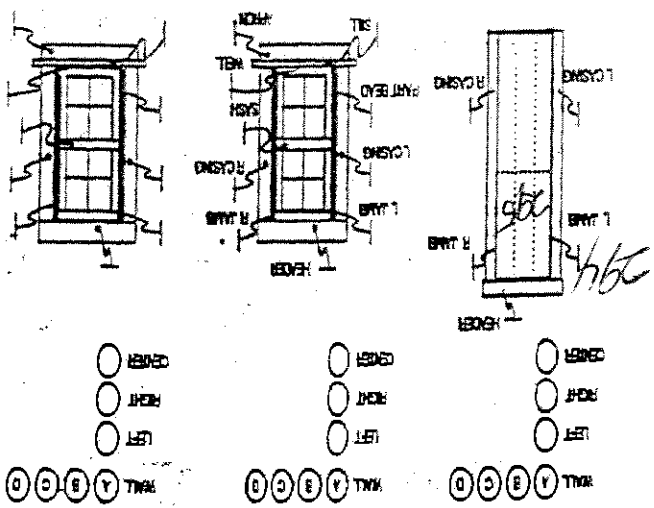
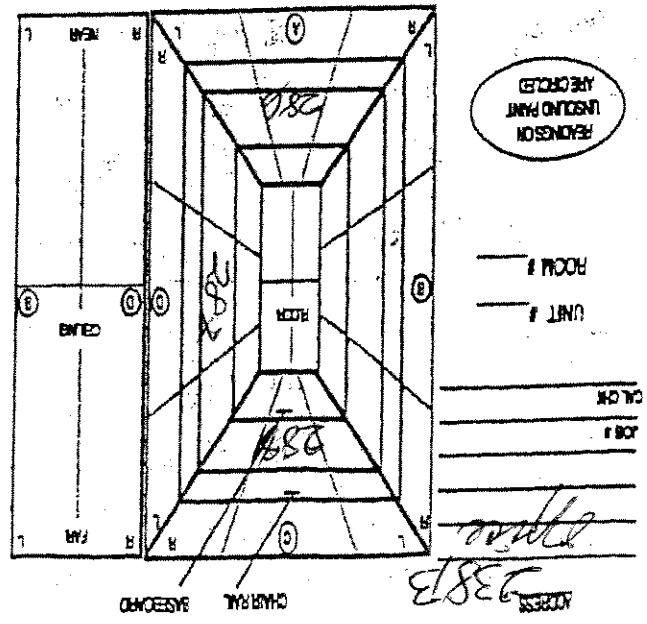
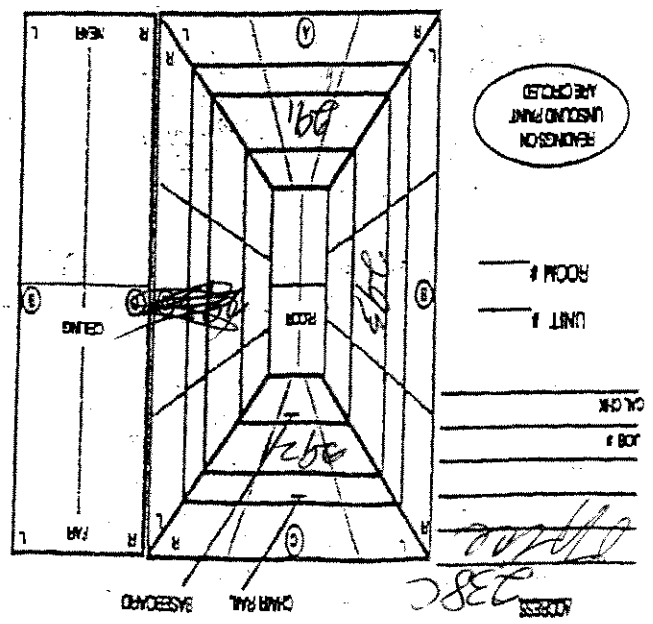
COMMENTS
The partition walls are in
fair condition except for
substrate all exterior walls and
structural walls are of concrete
blocks, concrete, masonry or concrete
blocks. Black layered, the door
is of she-A-lac finished wooden
substrate, the doors jacks is of
Black finish the metal substrate.

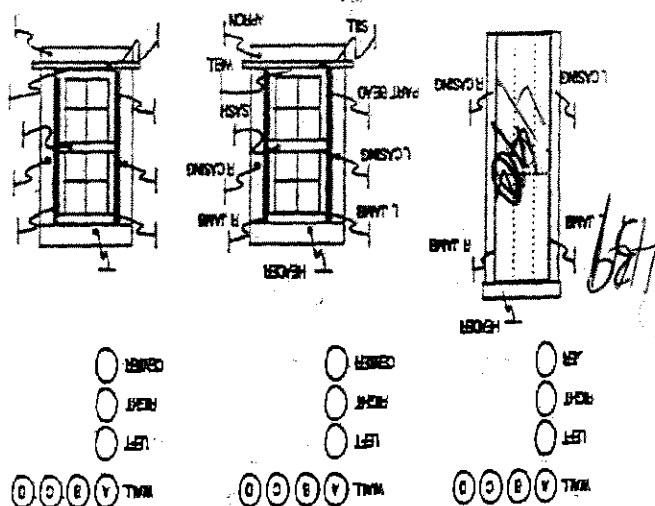
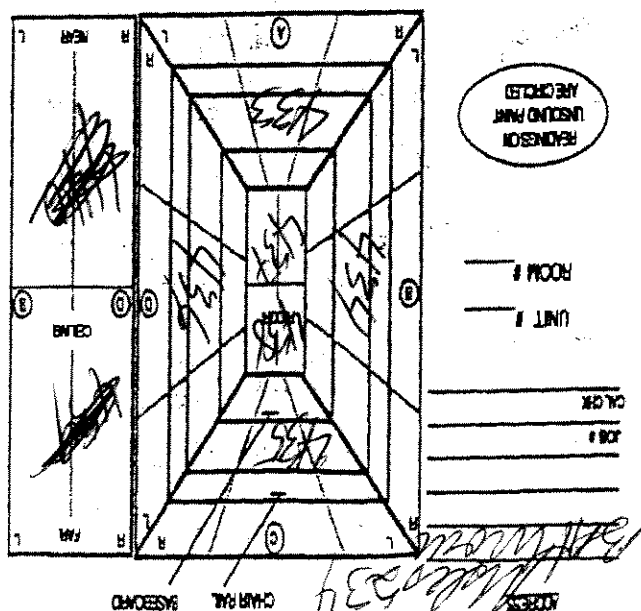
2 of the wall is of brown
concrete the other is white
painted but still peeling
the rest is of sheetrock
lined on ceiling & one
on metal delimitate the
floor is of green & black
~~tile~~ / no laminate floor & carpet

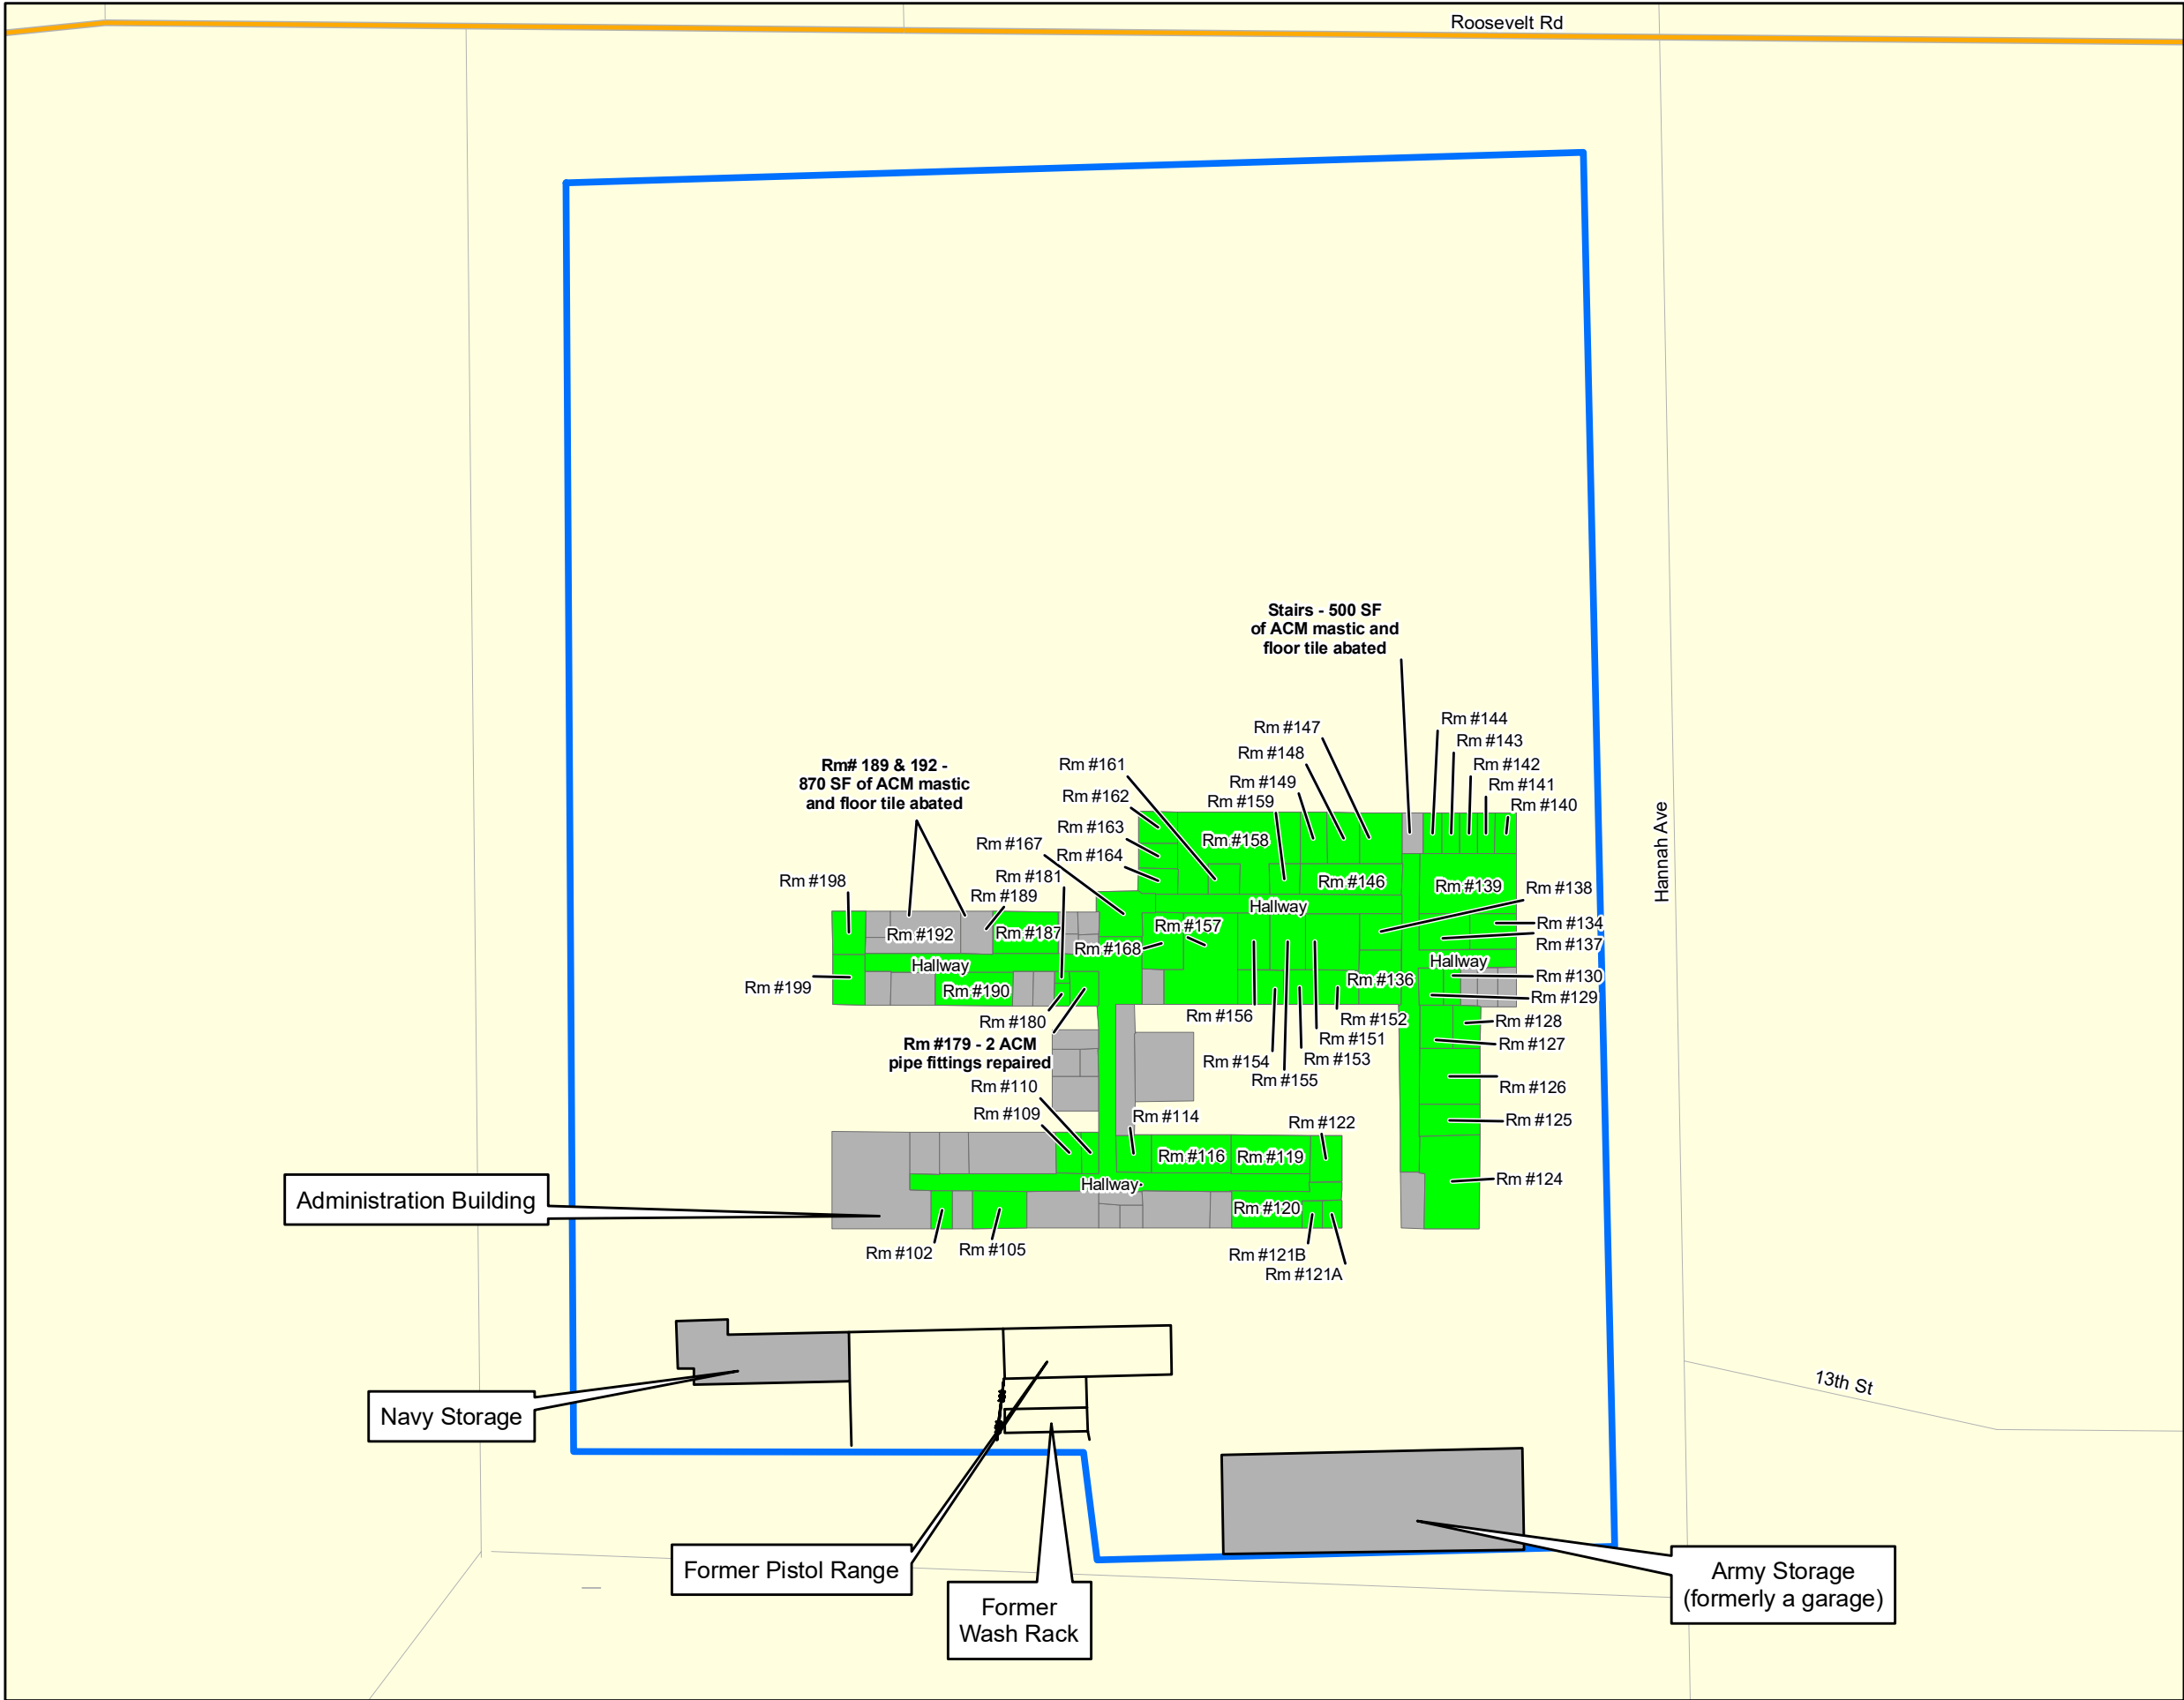
FIGURE
4-1

1997a). Cape Environmental, Inc. removed the suspect ACM from the Building 101 roofing, and conducted an asbestos survey of the administration building, Pistol Range, and the two storage buildings at NRC Forest Park (Cape 1997b). The survey results identified the presence of ACM throughout the facility in the floor tile mastic, pipe insulation, heating system insulation, and roof drains. The survey report recommended initiation of an operation and maintenance program for most ACM, and implementation of repair/replacement for other ACM. A summary of the findings and recommendations of the asbestos survey is presented in **Table 4-1** and the locations of ACM are shown in **Figure 4-1** and **Figure 4-2**.

survey. ACM still remains on the heating system pipe insulation in the Boiler Room and in Room 109; domestic water pipe and fitting insulation in Room 109; mastic on sink of Room 109; and on the heating system pipe fitting insulation located throughout the first floor of the Army side of the building. The locations where ACM and PACM were identified are summarized in **Table 4-2**. The location of the remaining ACM and PACM are shown on **Figure 4-1** and **Figure 4-2**.

LOCATIONS OF ASBESTOS CONTAINING MATERIAL FIRST FLOOR

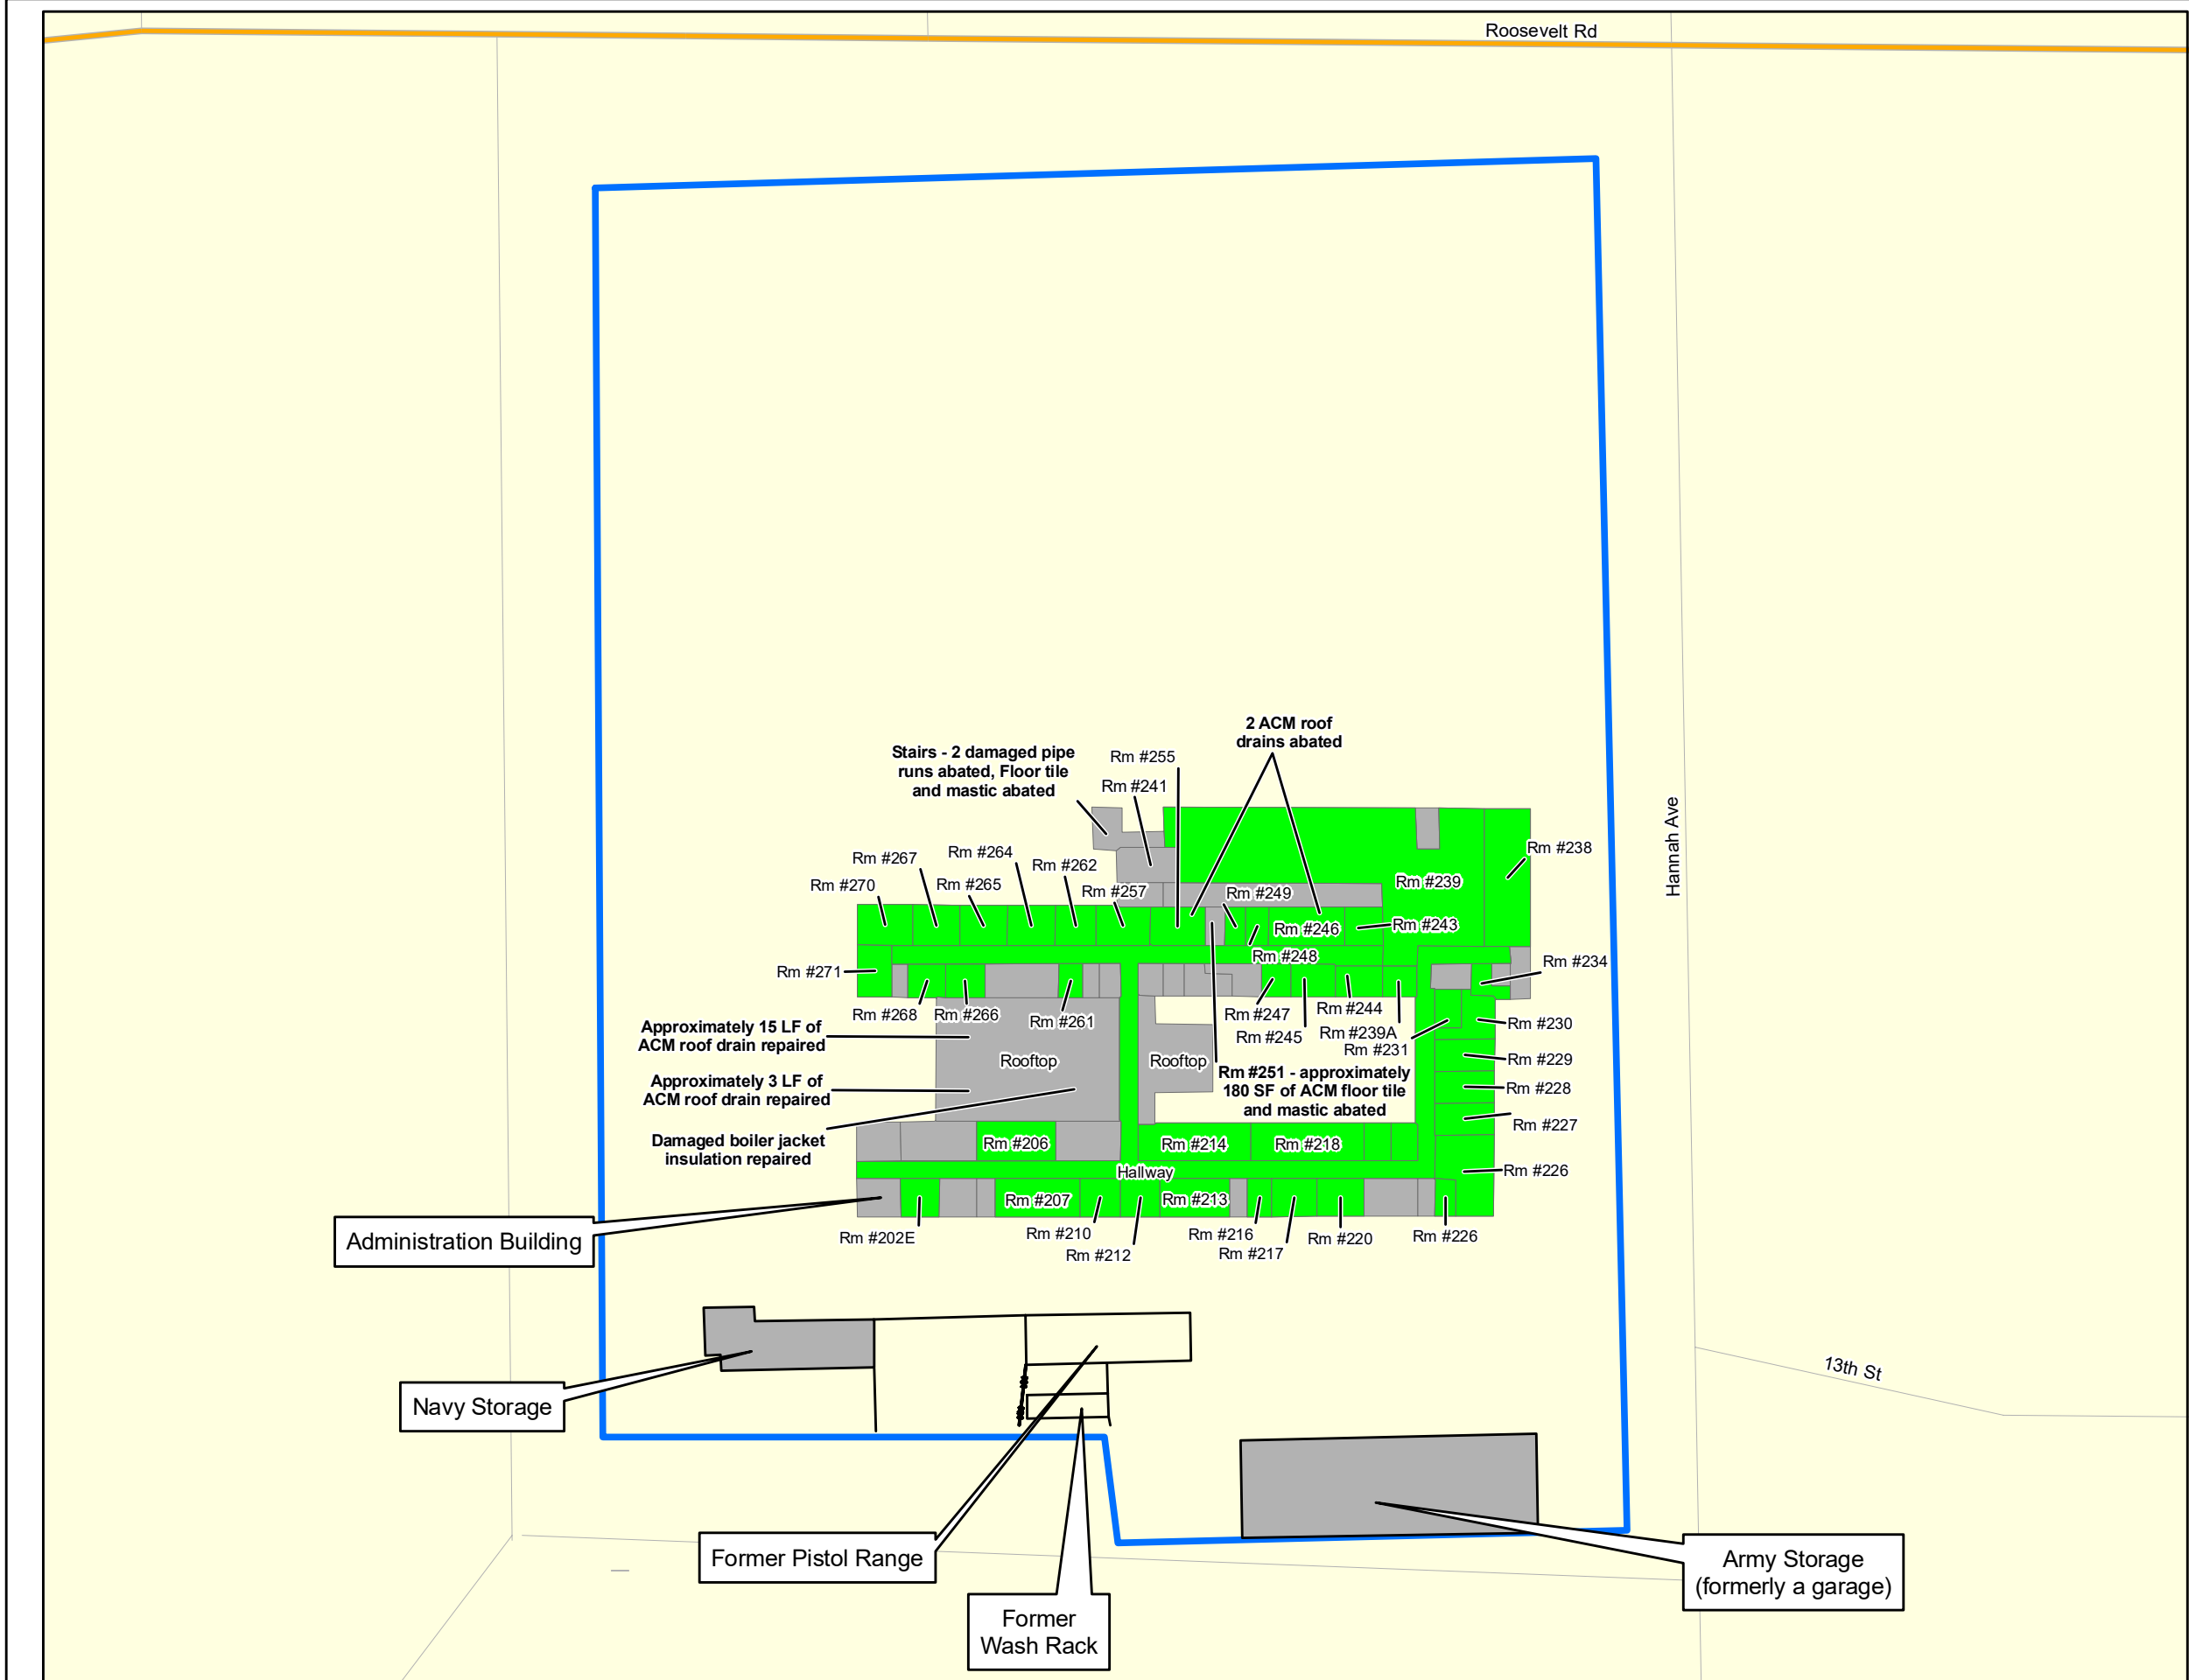
FIGURE 4-2

TITLE	
LOCATIONS OF ASBESTOS CONTAINING MATERIAL SECOND FLOOR	
Navy Reserve Center Forest Park, IL	
LEGEND

NOTES & SOURCES	
Coordinate System: NAD 83, UTM Zone 16 Data Sources: TolTest 2000, 2001; Cape 1997b Note: Rooms 242, 240 and 247 listed in Cape 1997b as containing ACM. Could not identify rooms on floor plan.	
0 37.5 75 Feet 0 10 20 Meters
