**Environmental Condition of Property Update Report
Armed Force Reserve Center (IL027)
7402 W. Roosevelt Road, Forest Park, Illinois 60130**

**Environmental Documentation in Support of
U.S. Army Reserve Facility Disposals**

January 2022

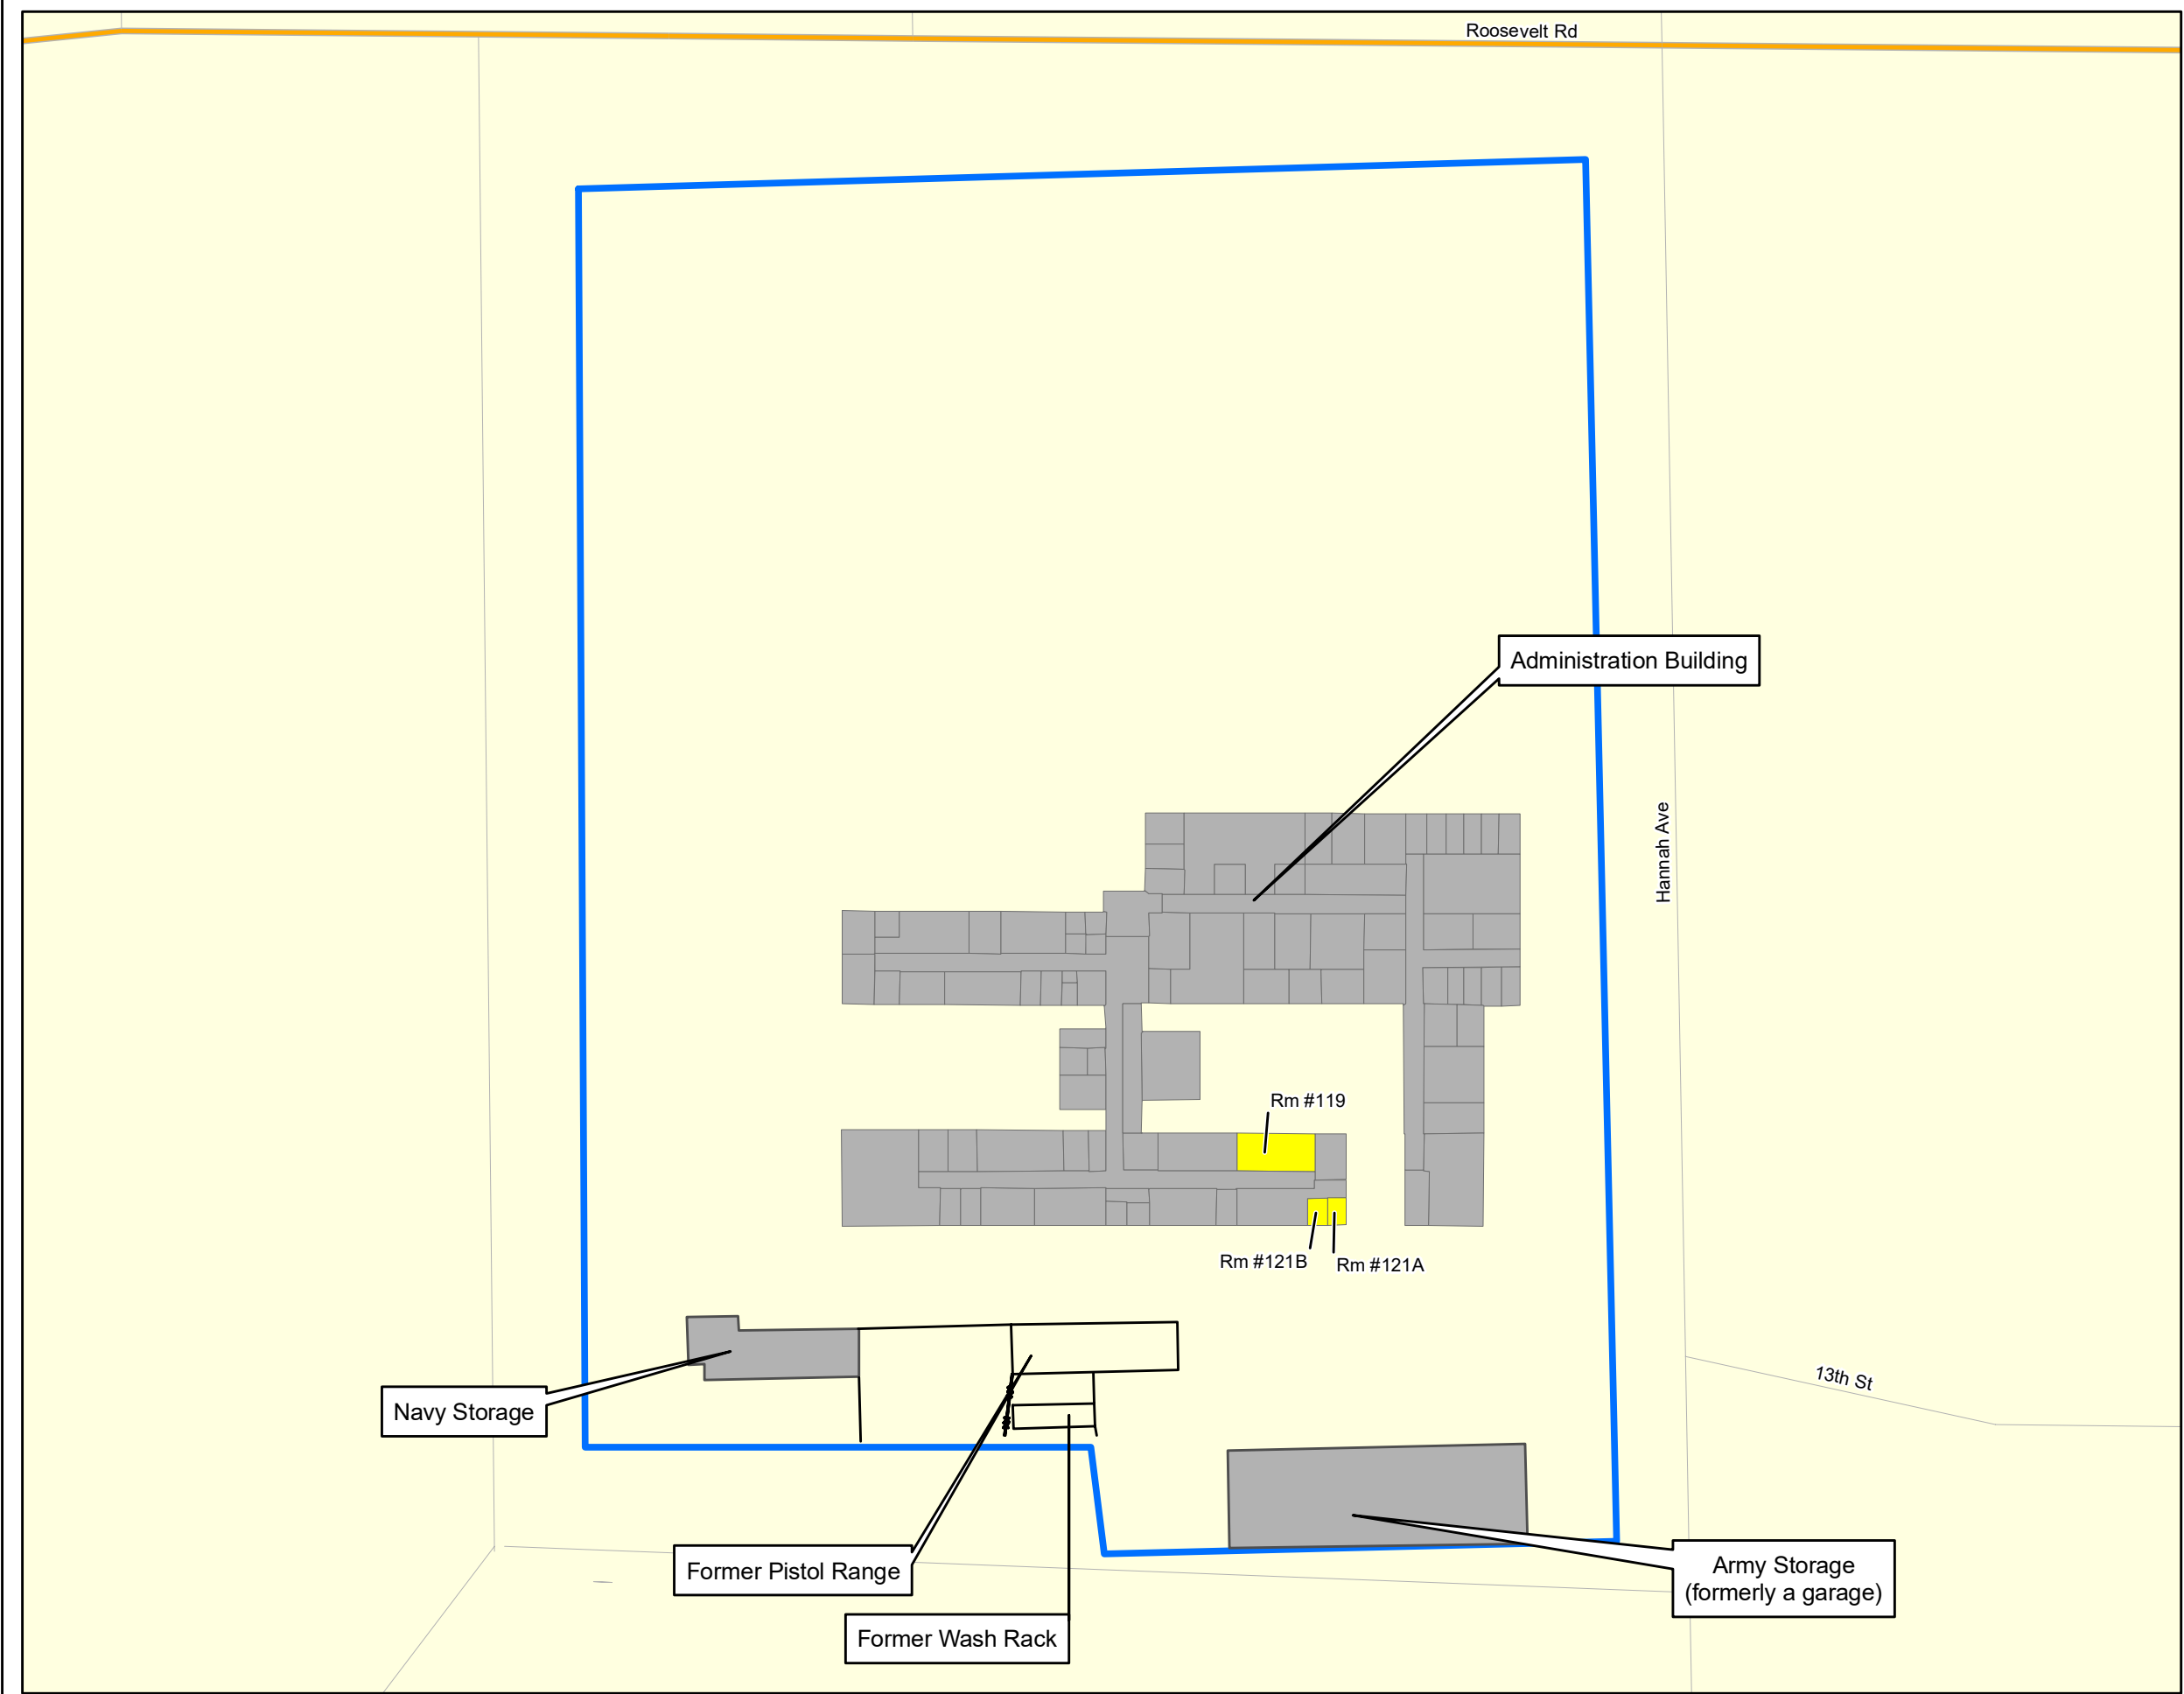
FIGURE
4-4

The NRC Forest Park operates both medical and dental service (Rooms 119, 121A, and 121B). All medical waste generated by these facilities is transported and disposed of off-site by a licensed contractor (Marin 2006c). Locations where medical waste is located or stored are presented in **Figure 4-4**.

MEDICAL WASTE LOCATIONS

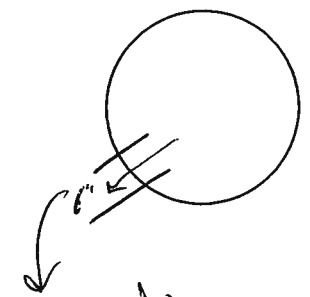
<p>According to drawing, 6" Connection to line between MH1 and B100</p>		<p>- Greater than 12" of Sediment in manhole</p> <p>- 7209-7210</p> <p>- Could not locate exit pipe in CB, too much debris.</p>

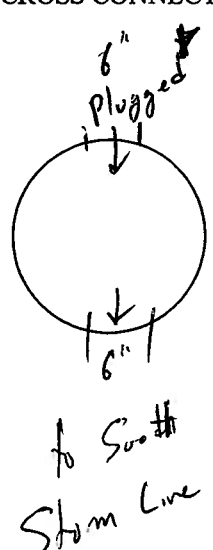
<div style="margin-left: 20px;"> <p>6" Plugged</p> <p>6"</p> <p>to South Storm Line</p> </div> </div>						
	COMMENTS: <p>7214-7215</p> <p>- Debris on bench</p> <p>* Formerly connected to B100, according to drawings.</p>

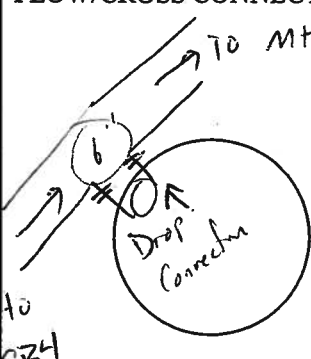
<u>7216-7217</u> <u>Up/down drop connection.</u> <u>Up opening cemented shut</u>

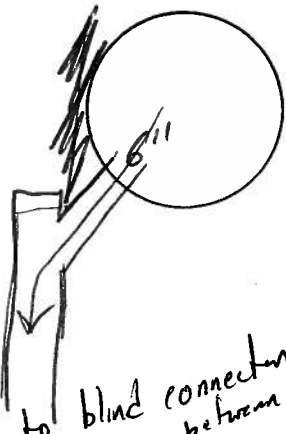
<p style="font-size: 2em; margin: 0;">N ↑</p> <p style="font-size: 1.5em; margin: 0;">7249-7250</p> <p style="font-size: 1.2em; margin: 0;">Power struck to frame, could not open</p>					
		<p style="font-size: 1.2em; margin: 0;">to blind connection between manhole #4 + Upstream East</p>

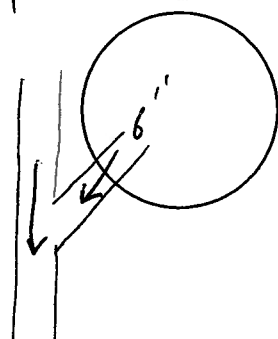
<p>to MHS</p>		<p>7236-7237</p> <p>Porer sealed to frame, could not open.</p>

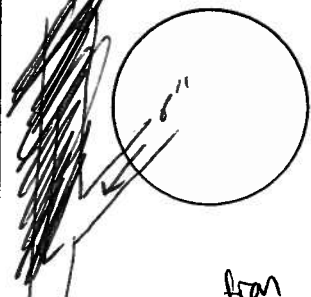
<p style="font-size: 1.2em;">to blind connection between MH5 and MH6</p> </div> <div style="width: 50%;"> <p style="font-size: 1.5em;"><i>7264-7265</i></p> <p style="font-size: 1.2em;"><i>Could not open cover, stuck to frame.</i></p> </div> </div>

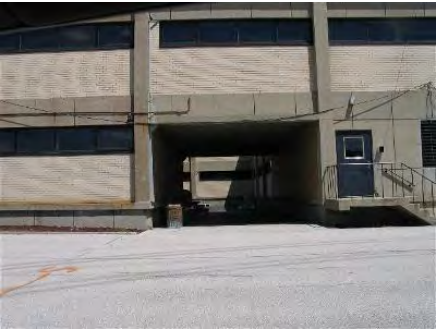
Photograph ID: 6 Date: May 21, 2008 Location: Building 100 Direction: North Comments: A view of the access point to the center courtyard in Building 100. Note that catch basin CB3 is located in the courtyard (not visible in this photograph).

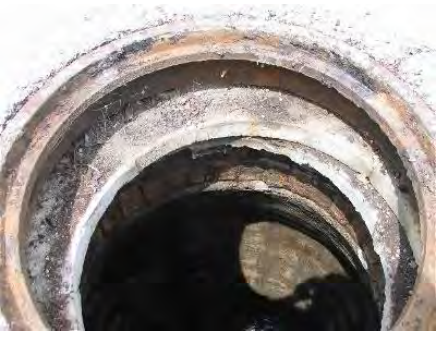
Photograph ID: 23 Date: May 20, 2008 Location: Manhole MH5 (Sanitary) Direction: North (Top) Comments: An interior view of manhole MH5. Note the offset riser.

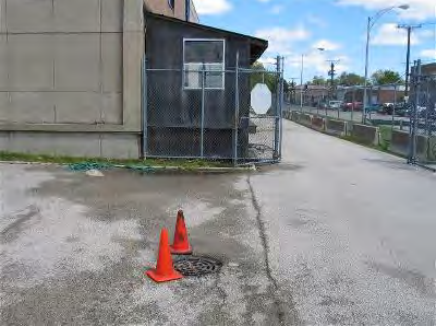
Photograph ID: 35 Date: May 21, 2008 Location: Catch Basin CB4 Direction: North (Top) Comments: View of catch basin CB4. The cover was stuck to the frame (possibly paved) and could not be opened after several attempts.

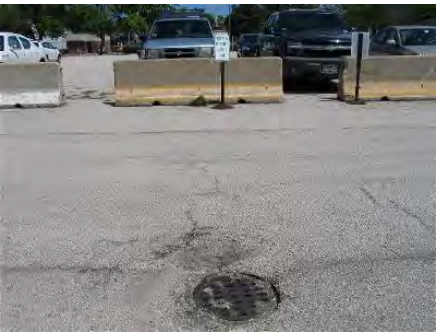
Photograph ID: 39 Date: May 21, 2008 Location: Catch Basin CB6 Direction: North (Top) Comments: View of catch basin CB6. The cover was stuck to the frame (possibly paved) and could not be opened after several attempts.

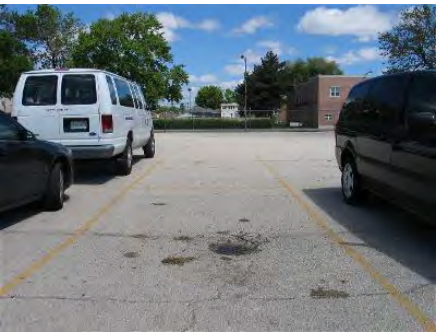
Photograph ID: 41 Date: May 21, 2008 Location: Catch Basin CB7 Direction: North (Top) Comments: View of catch basin CB7. The cover was stuck to the frame (possibly paved) and could not be opened after several attempts.

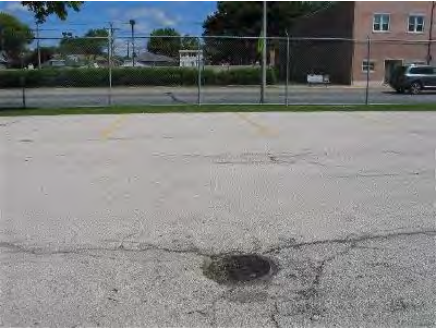
Photograph ID: 43 Date: May 21, 2008 Location: Catch Basin CB8 Direction: North (Top) Comments: View of catch basin CB8. The cover was stuck to the frame (possibly paved) and could not be opened after several attempts.

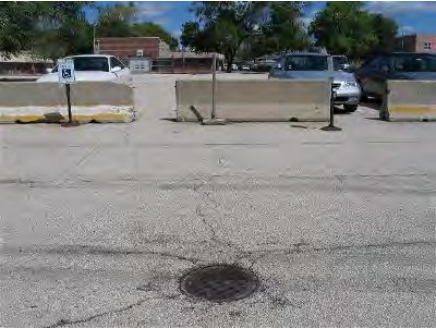
Photograph ID: 45 Date: May 21, 2008 Location: Catch Basin CB9 Direction: North (Top) Comments: View of catch basin CB9. The cover was stuck to the frame (possibly paved) and could not be opened after several attempts.

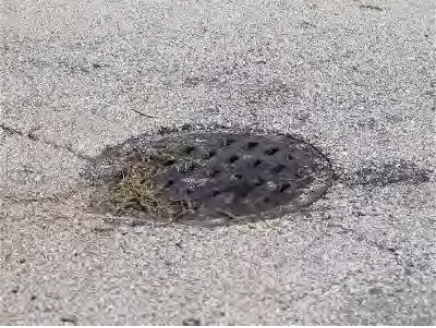
Photograph ID: 47 Date: May 21, 2008 Location: Catch Basin CB10 Direction: North (Top) Comments: View of catch basin CB10. The cover was stuck to the frame (possibly paved) and could not be opened after several attempts.

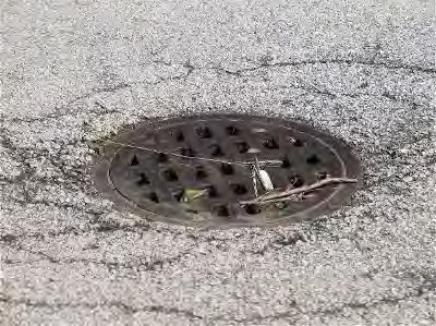
Photograph ID: 49 Date: May 21, 2008 Location: Catch Basin CB11 Direction: North (Top) Comments: View of catch basin CB11. The cover was stuck to the frame (possibly paved) and could not be opened after several attempts.

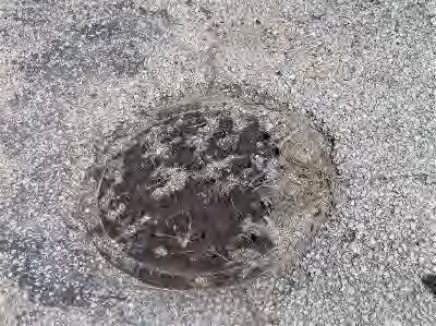
Photograph ID: 51 Date: May 21, 2008 Location: Catch Basin CB12 Direction: North (Top) Comments: View of catch basin CB12. The cover was stuck to the frame (possibly paved) and could not be opened after several attempts.

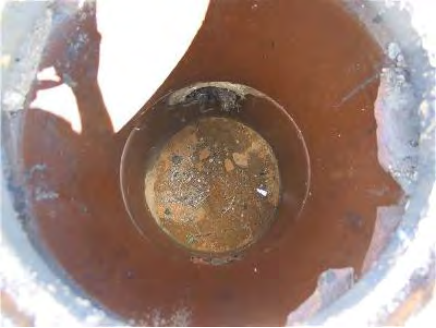
Photograph ID: 53 Date: May 21, 2008 Location: Catch Basin CB13 Direction: North (Top) Comments: An interior view of catch basin CB13. Note that the abandoned connections (at 12 and 6 o'clock from top, midway down) have tree roots growing within. The active connection is on the bottom of the catch basin (at 8 o'clock from top).

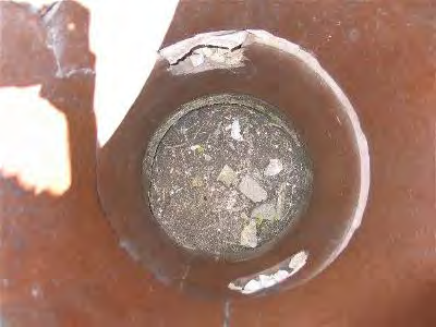
Photograph ID: 55 Date: May 21, 2008 Location: Catch Basin CB14 Direction: North (Top) Comments: An interior view of catch basin CB14. Note that the abandoned connections (at 11 and 5 o'clock from top, midway down). The active connection is on the bottom of the catch basin (at 7 o'clock from top).

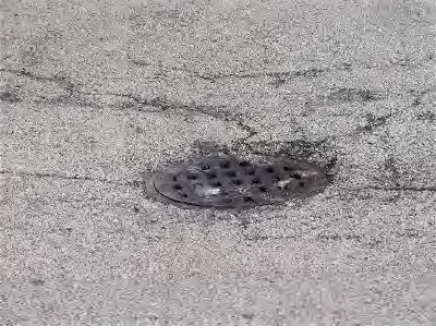
Photograph ID: 57 Date: May 21, 2008 Location: Catch Basin CB15 Direction: North (Top) Comments: View of catch basin CB15. The cover was stuck to the frame (possibly paved) and could not be opened after several attempts.

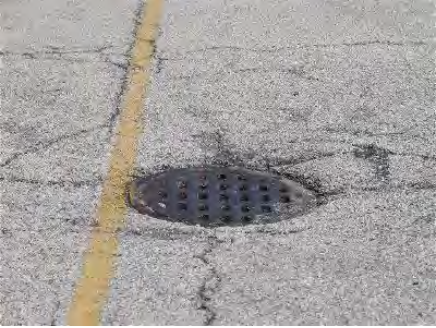
Photograph ID: 59 Date: May 21, 2008 Location: Catch Basin CB16 Direction: North (Top) Comments: View of catch basin CB16. The cover was stuck to the frame (possibly paved) and could not be opened after several attempts.

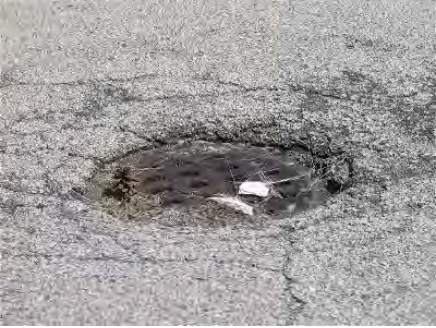
Photograph ID: 61 Date: May 21, 2008 Location: Catch Basin CB17 Direction: North (Top) Comments: View of catch basin CB17. The cover was stuck to the frame (possibly paved) and could not be opened after several attempts.

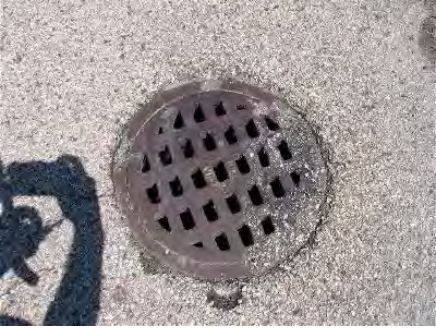
Photograph ID: 63 Date: May 21, 2008 Location: Catch Basin CB18 Direction: North (Top) Comments: View of catch basin CB18. The cover was stuck to the frame (possibly paved) and could not be opened after several attempts.

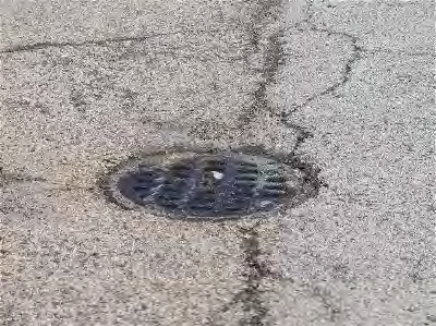
Photograph ID: 65 Date: May 21, 2008 Location: Catch Basin CB19 Direction: North (Top) Comments: View of catch basin CB19. The cover was stuck to the frame (possibly paved) and could not be opened after several attempts.

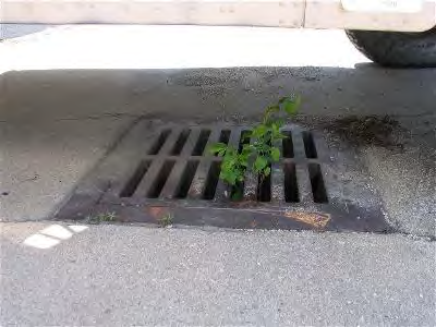
Photograph ID: 69 Date: May 21, 2008 Location: Catch Basin CB21 Direction: South Comments: An external view of catch basin CB21. The cover was stuck to the frame (possibly paved) and could not be opened after several attempts.

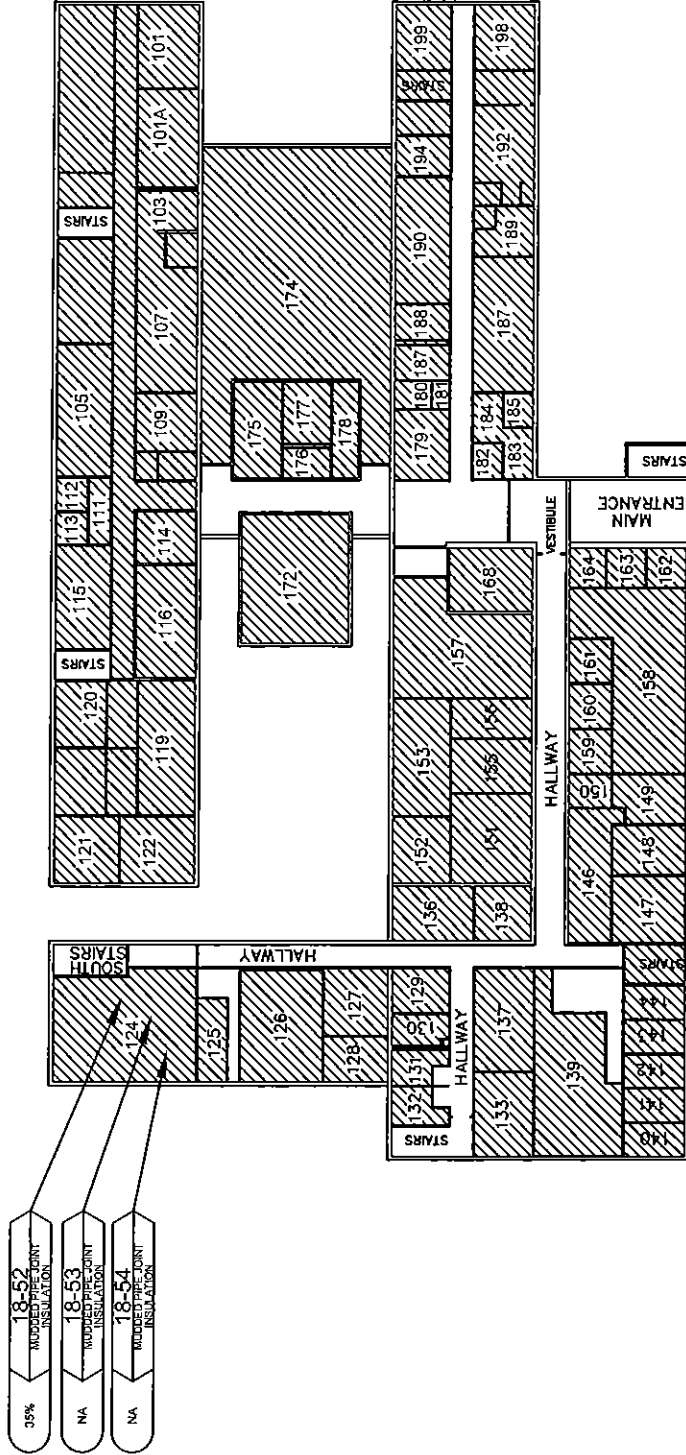
AFRC FIRST FLOOR PLAN

- 2" pipe elbow insulation (approximately 160 pipe elbows) confirmed throughout the building (above ceilings, in the hallway and mechanical rooms), as depicted by the cross-hatched areas on Figure 3. This material is shown in Photograph 18. Samples were collected from room 124.

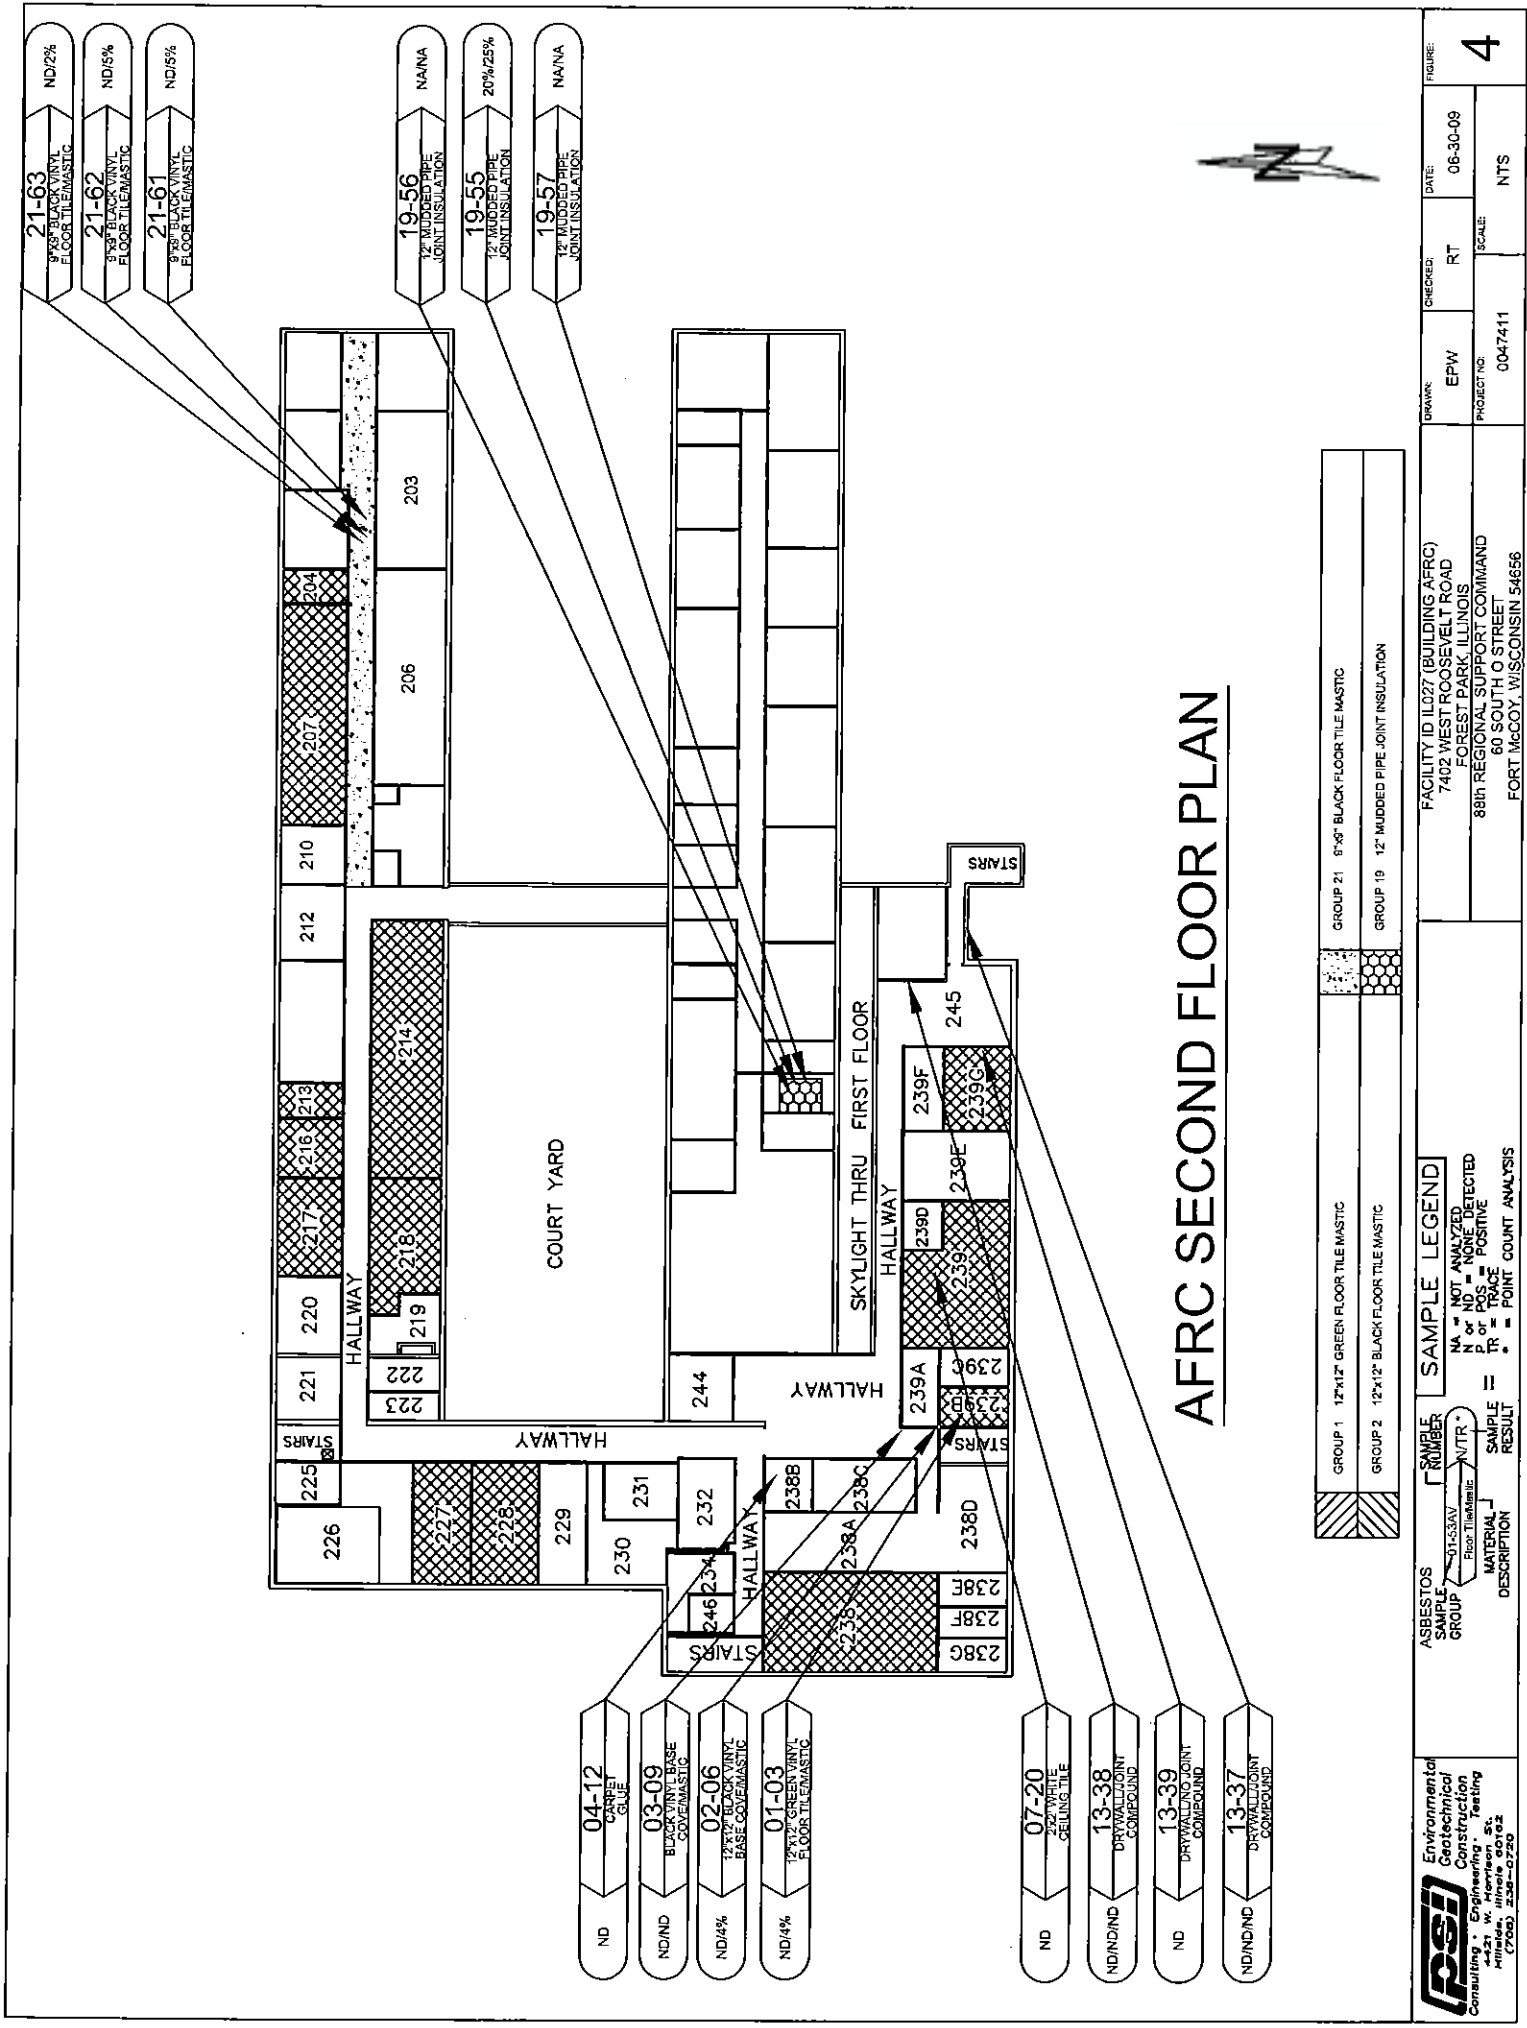
AFRC SECOND FLOOR PLAN

- 12" drain pipe elbow insulation (approximately 25 pipe elbows) confirmed in a 2nd floor room, as depicted by the shaded area on Figure 4. This material is shown in Photograph 19. Samples were collected from the un-numbered room on the 2nd floor of the building.

- Black mastic for 9" x 9" black vinyl floor tile (approximately 1,000 sf) confirmed in the 2nd floor northeast hallway, as depicted by the shaded area on Figure 4. This material is shown in Photograph 21. The floor tile is non-ACM. Samples were collected from the 2nd floor northeast hallway.

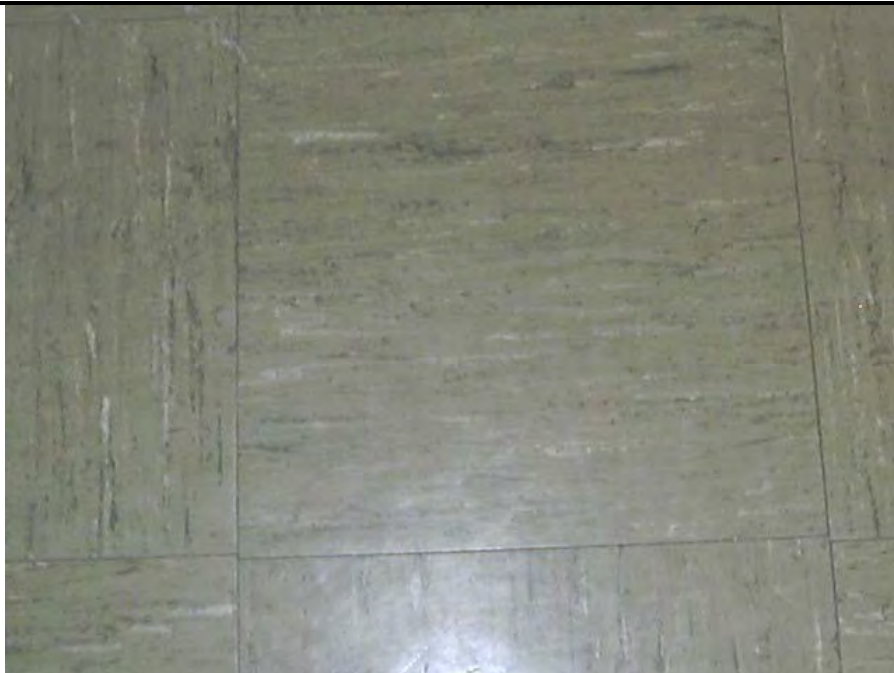
**Photo 1: 12" x 12" green vinyl floor tile/ mastic – AFRC Building
(Tile is Non-ACM, Mastic is positive for Asbestos)**

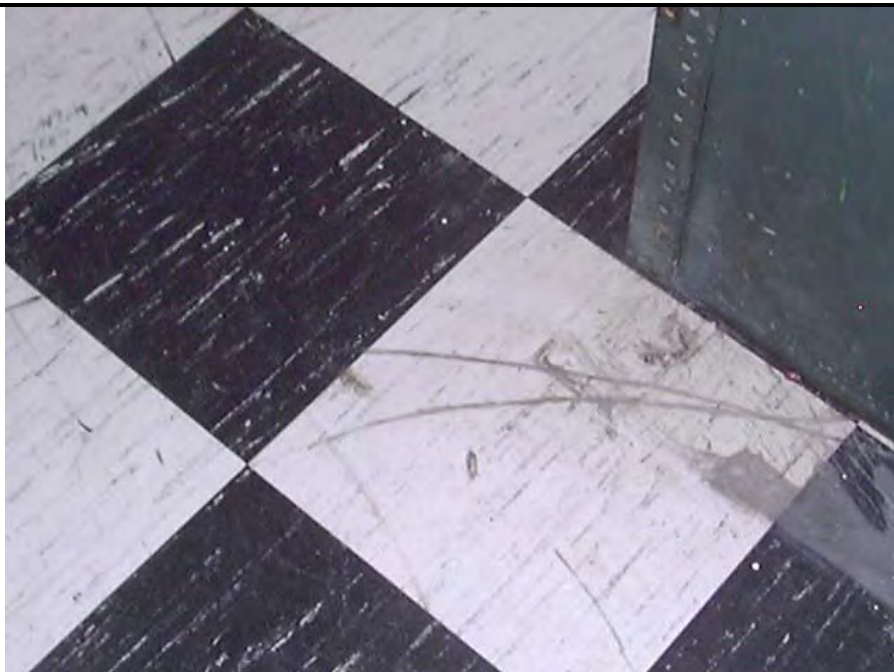
**Photo 2: 12" x 12" black vinyl floor tile/ mastic– AFRC Building
(Tile is Non-ACM, Mastic is positive for Asbestos)**

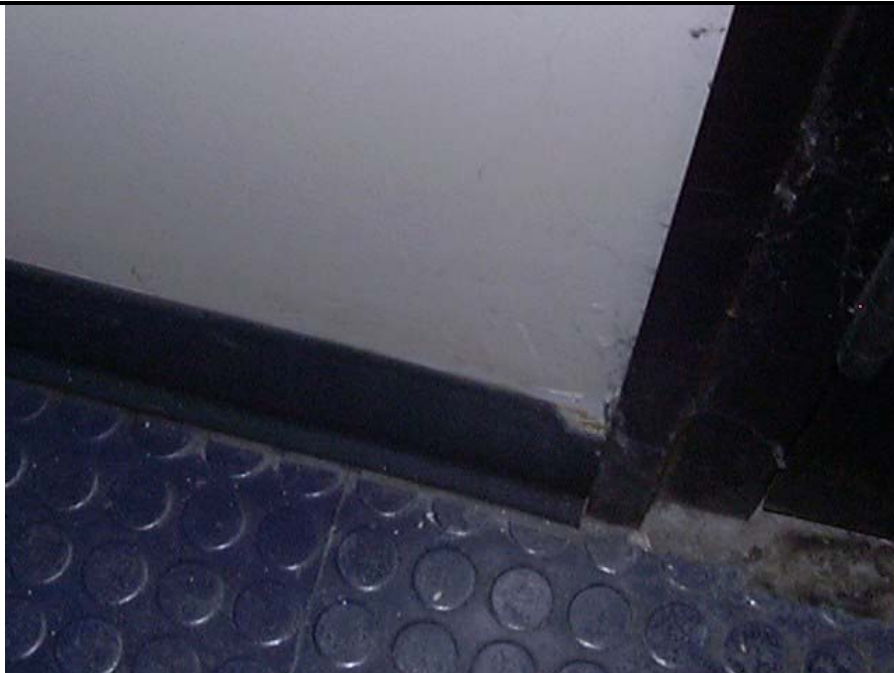
- Black vinyl non-asbestos baseboard and brown mastic observed throughout the AFRC building. This material is shown in Photograph 3.
- Yellow carpet non-asbestos mastic observed on the first and second floors. This material is shown in Photograph 4.

Photo 3: black vinyl baseboard/ mastic– AFRC Building (Non-ACM)

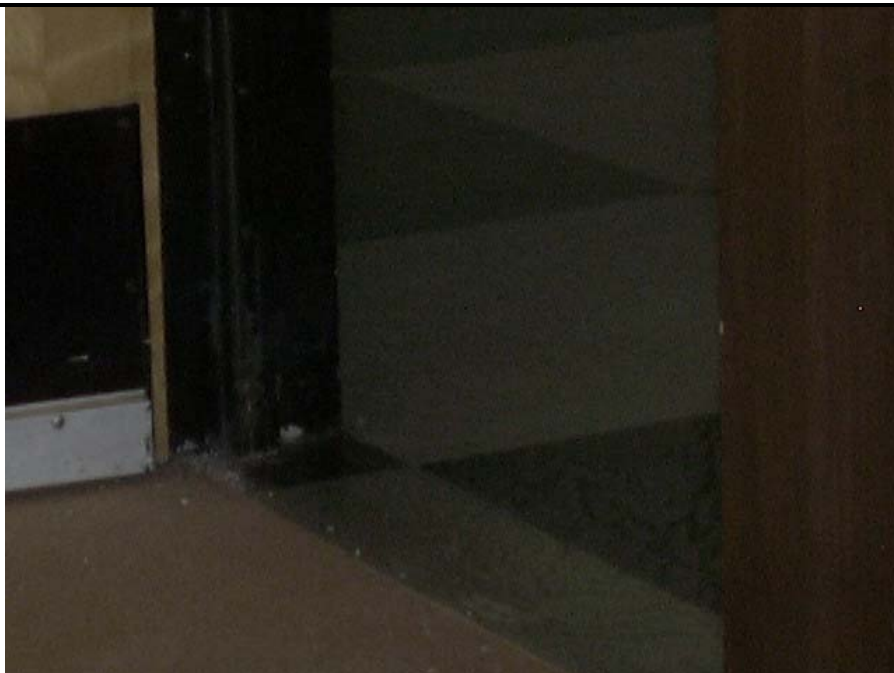
Photo 4: Carpet mastic – AFRC Building (Non-ACM)

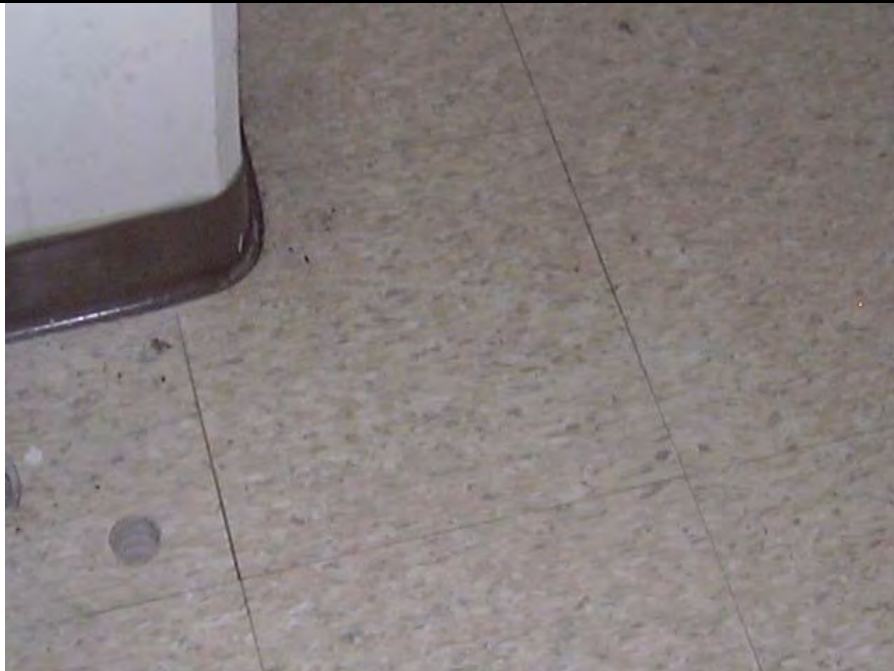
Photo 5: 12" x 12" gray vinyl floor tile/ mastic - AFRC Building Rooms 121 and 122 (Top Layer Tile and Mastic, Bottom Layer Tile is Non-ACM, Bottom Layer Mastic is positive for Asbestos)

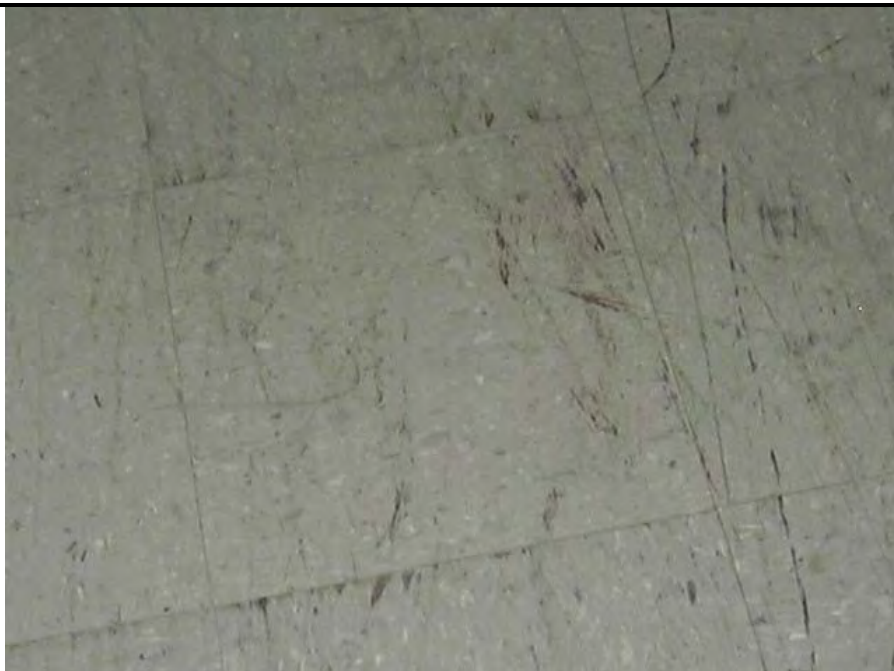
- 12" x 12" gray vinyl non-asbestos floor tile and yellow mastic observed in rooms 179, 180, and 187. All three layers of this floor tile and mastic are non-ACM. This material is shown in Photograph 6.

Photo 6: 12" x 12" gray vinyl floor tile/ mastic– AFRC Building Rooms 179, 180, 187 (Non-ACM)

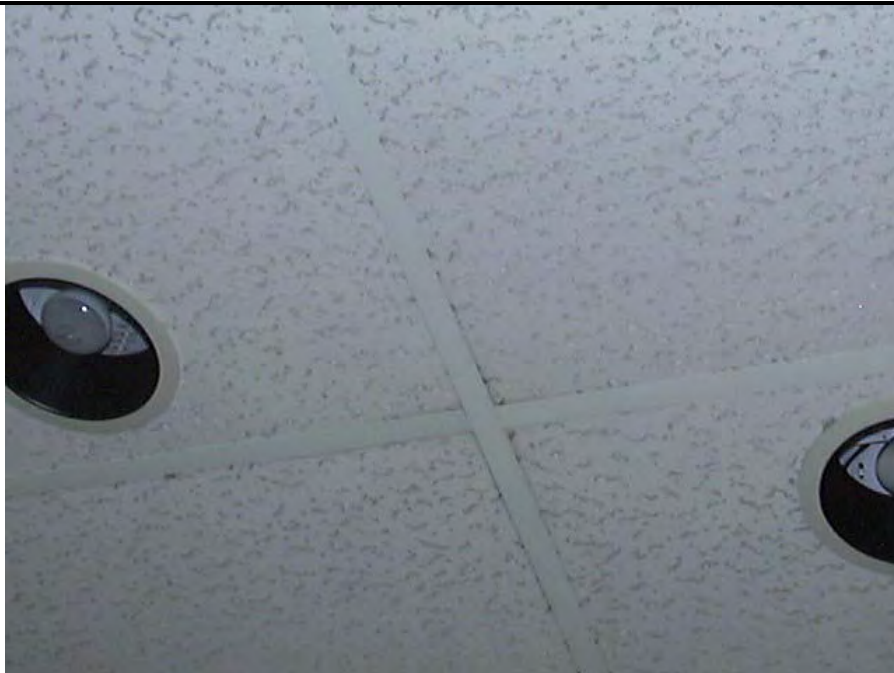
- 2' x 2' white non-asbestos lay-in ceiling tile observed throughout the building. This material is shown in Photograph 7.
- Gray vinyl non-asbestos baseboard and yellow mastic observed on the east side of the first floor. This material is shown in Photograph 8.

Photo 7: 2' x 2' white lay-in ceiling tile– AFRC Building (Non-ACM)

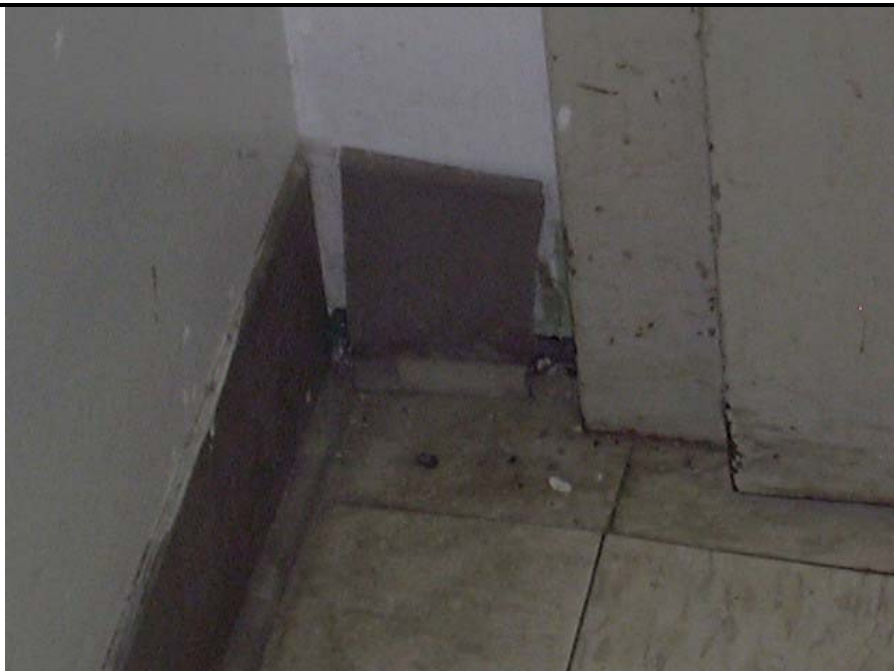
Photo 8: Gray vinyl baseboard/ mastic– AFRC Building (Non-ACM)

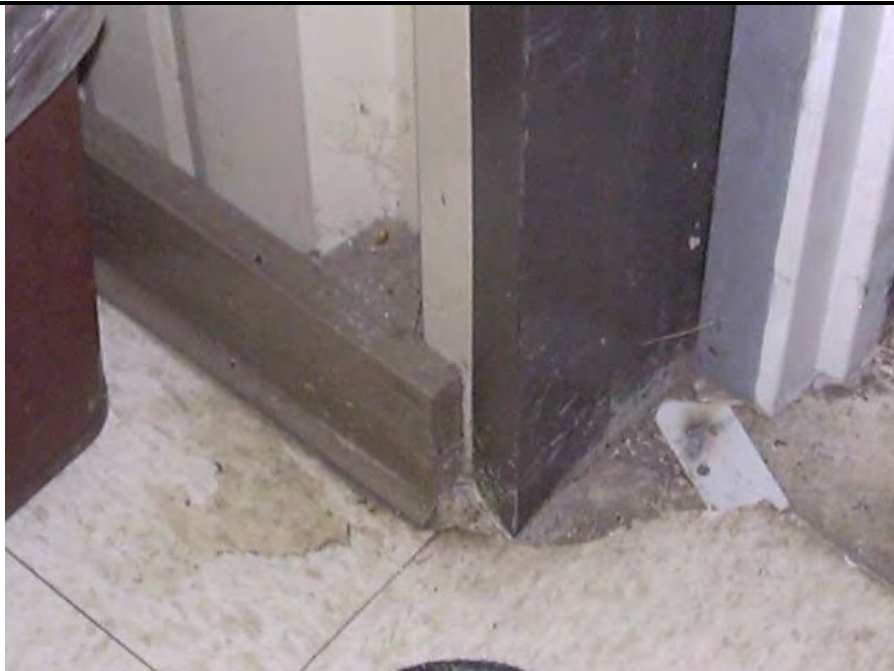
- Blue vinyl non-asbestos baseboard and tan mastic observed in the vestibule. This material is shown in Photograph 9.
- Brown vinyl non-asbestos baseboard and tan mastic observed in rooms 182, 183, 184, and 185. This material is shown in Photograph 10.

Photo 9: Blue vinyl baseboard/ mastic – AFRC Building (Non-ACM)

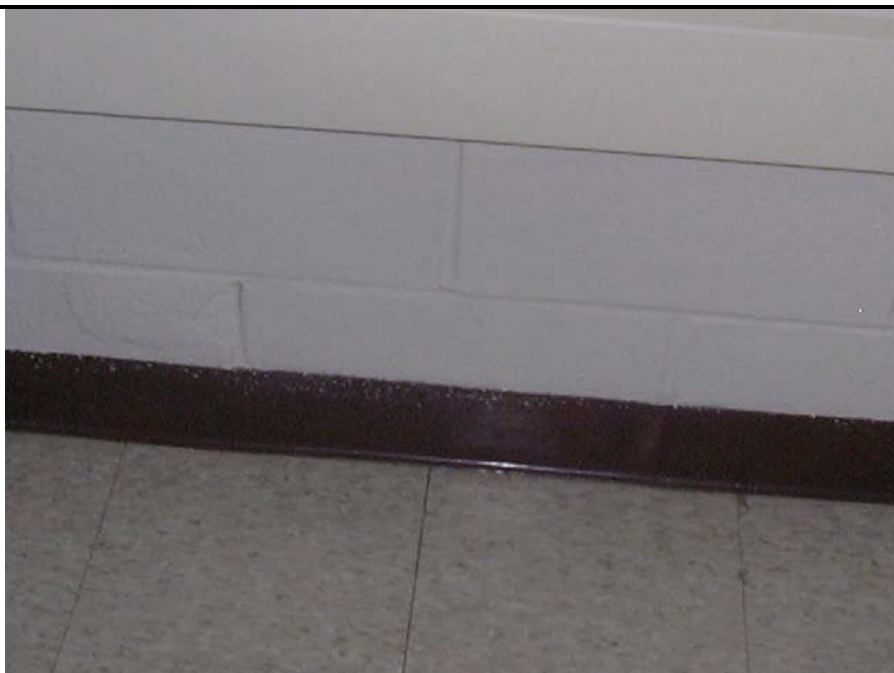
Photo 10: Brown vinyl baseboard/ mastic– AFRC Building (Non-ACM)

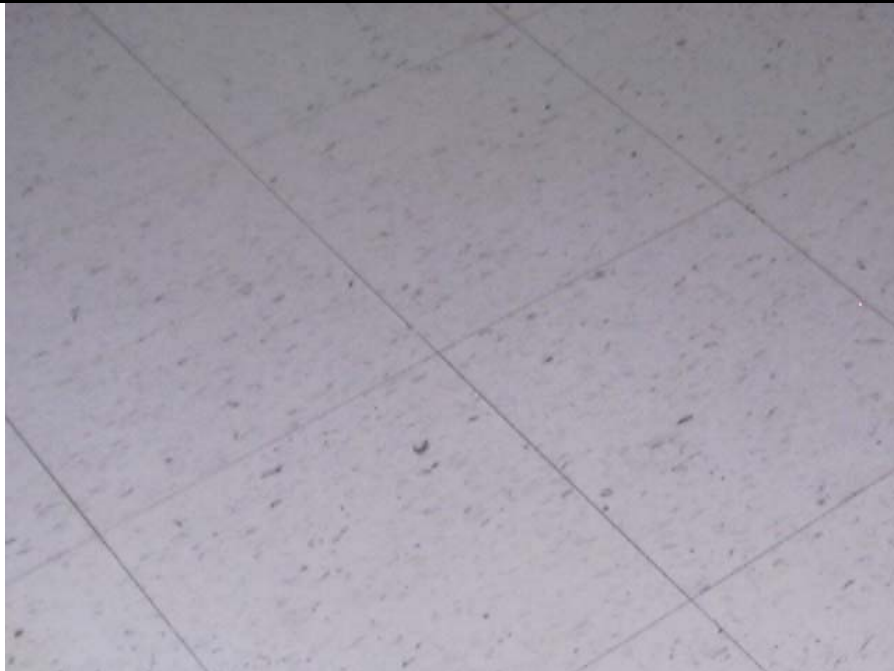
Photo 11: 12" x 12" off-white vinyl floor tile/ mastic– AFRC Building
(Tile is Non-ACM, Mastic is positive for Asbestos)

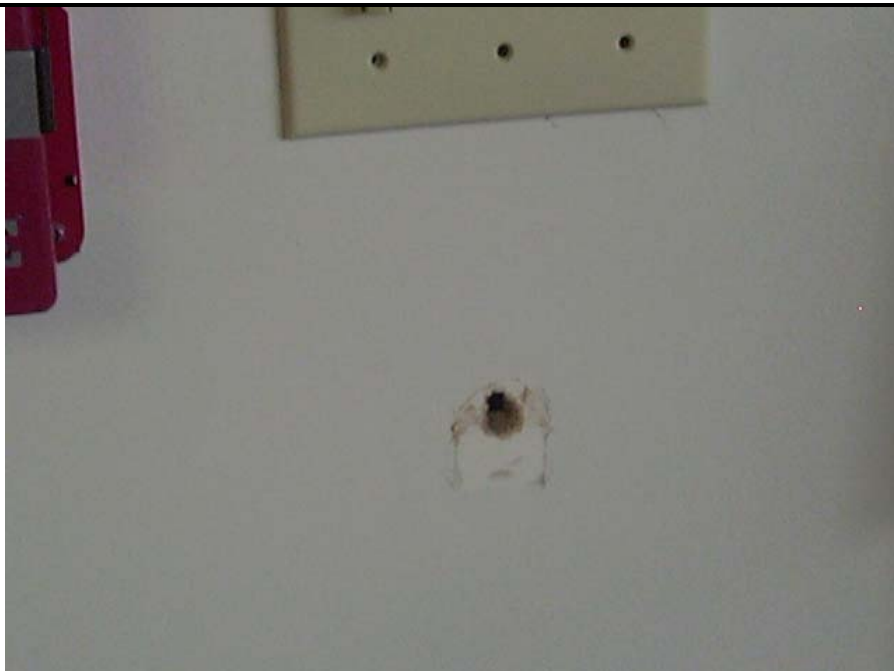
- Non-asbestos plaster observed in the west hallway of the building and in the vestibules. This material is shown in Photograph 12.
- Non-asbestos drywall and joint compound throughout the building. This material is shown in Photograph 13.
- Non-asbestos roofing material and roof caulk on the building's exterior. This material is shown in Photographs 16 and 17.

Photo 12: Plaster – AFRC Building (Non-ACM)

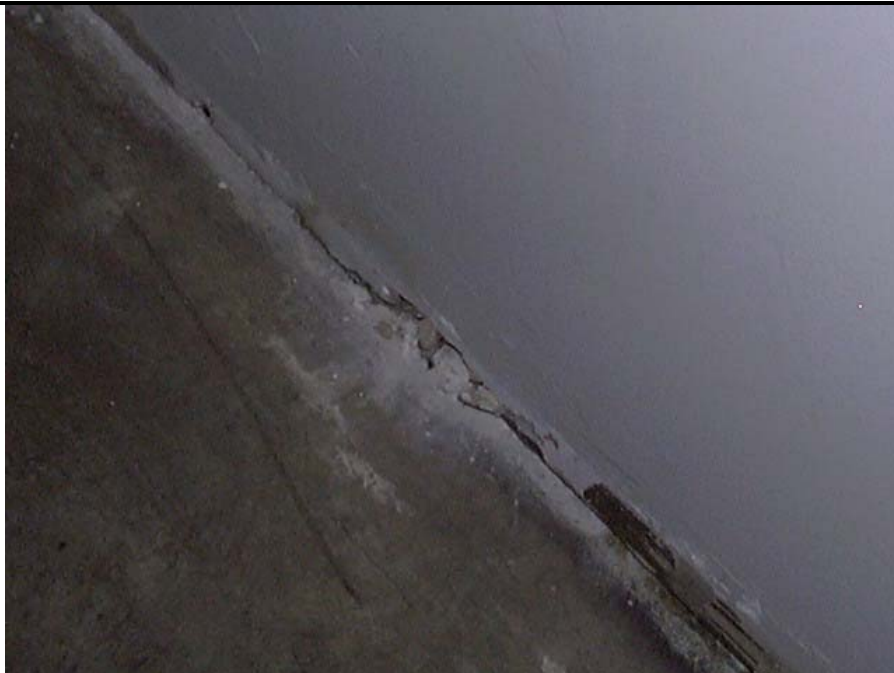
Photo 13: Drywall/ joint compound – AFRC Building (Non-ACM)

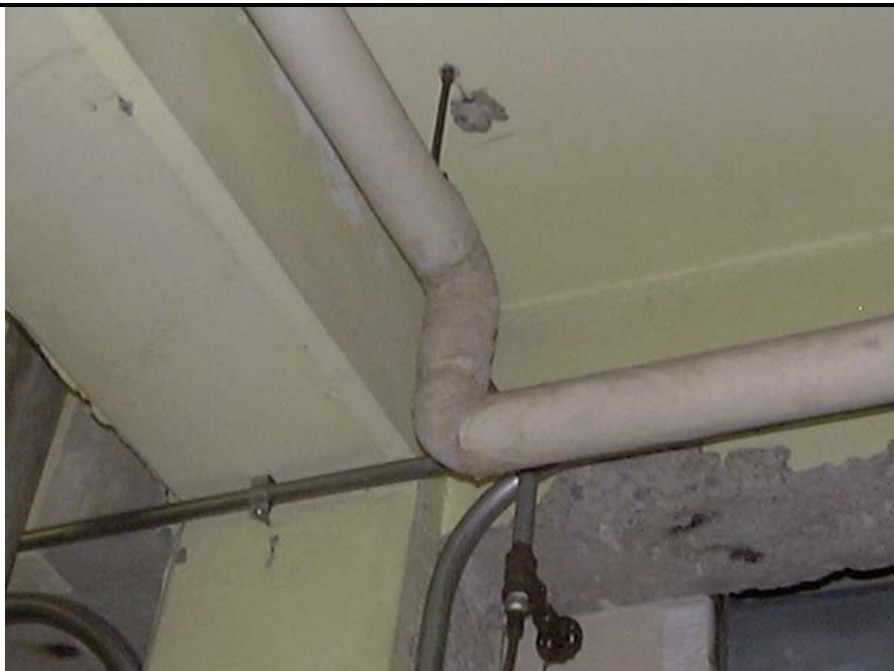
- Non-asbestos paper on fiberglass insulation observed on the garage ceiling. This material is shown in Photograph 14.
- Non-asbestos roofing material on the roof. This material is shown in Photograph 22.

Photo 14: Paper on fiberglass insulation - OMS Building (Non-ACM)

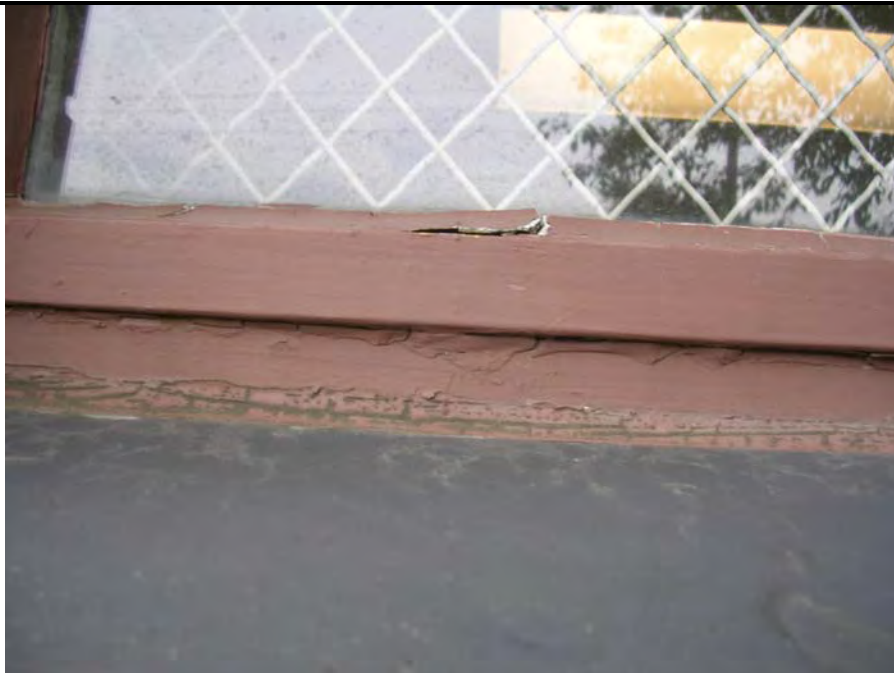
- Window caulking observed on the interior windows. There are three layers of window caulking, all of which are ACM. This material is shown in Photograph 15.

Photo 15: Window caulk-OMB Building (**Caulk is positive for Asbestos**)
