**Environmental Condition of Property Update Report
Armed Force Reserve Center (IL027)
7402 W. Roosevelt Road, Forest Park, Illinois 60130**

**Environmental Documentation in Support of
U.S. Army Reserve Facility Disposals**

January 2022

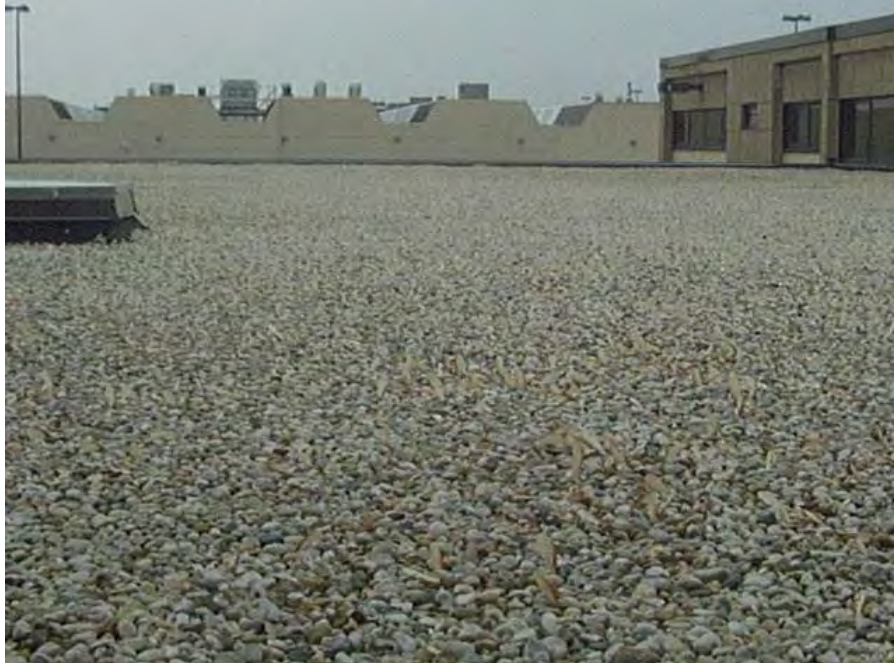
Photo 16: Roofing material- AFRC Building (Non-ACM)

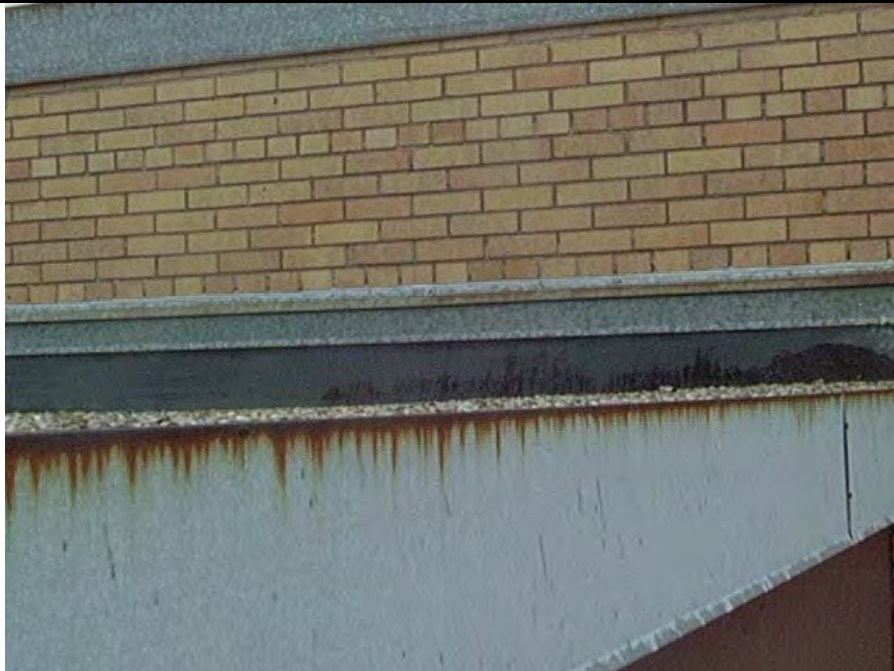
Photo 17: Roof caulk- AFRC Building (Non-ACM)

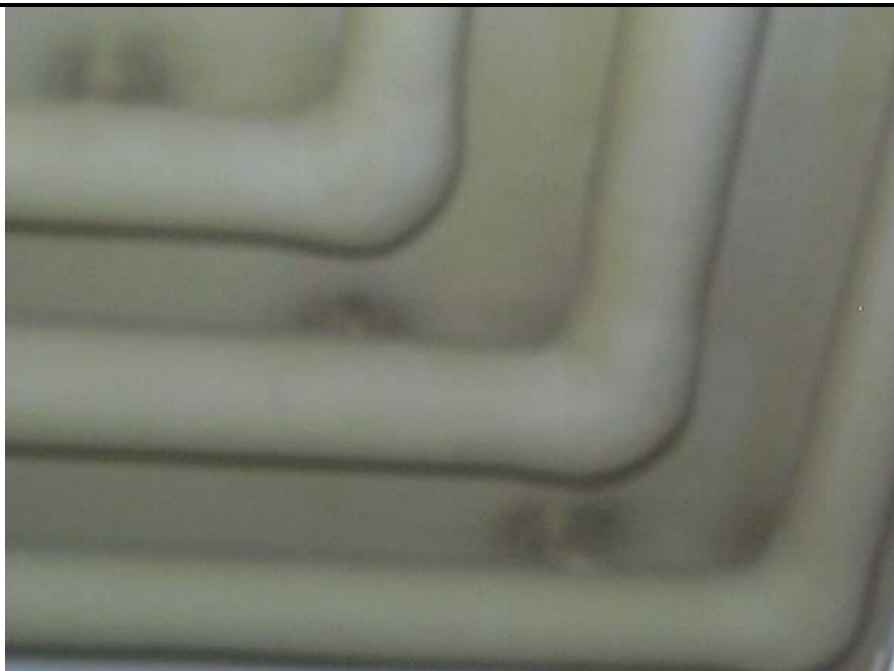
Photo 18: 2" pipe elbow insulation- AFRC Building (Insulation Positive for ACM)

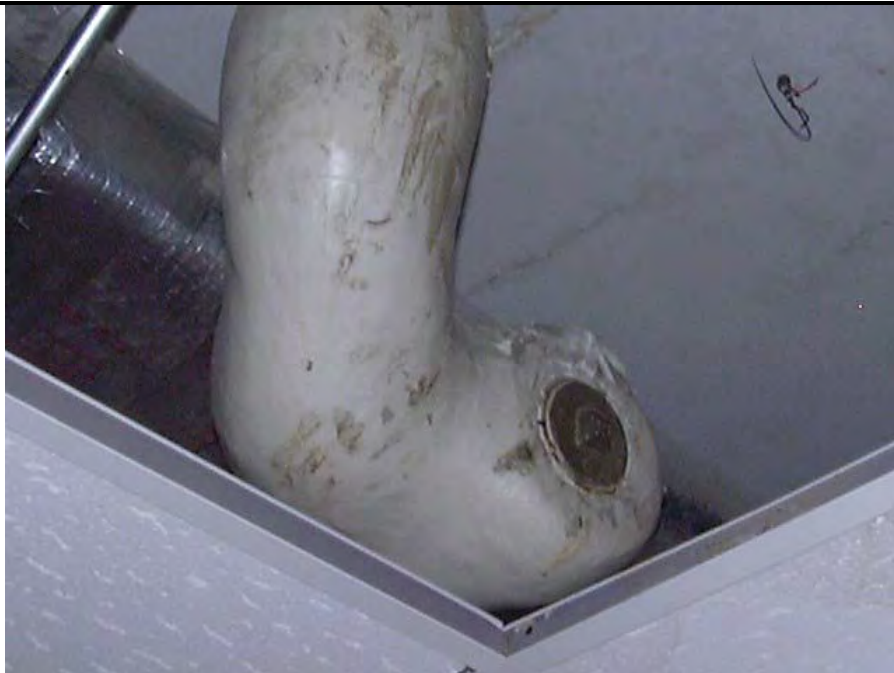
Photo 19: 12" drain pipe insulation- AFRC Building (Insulation Positive for ACM)

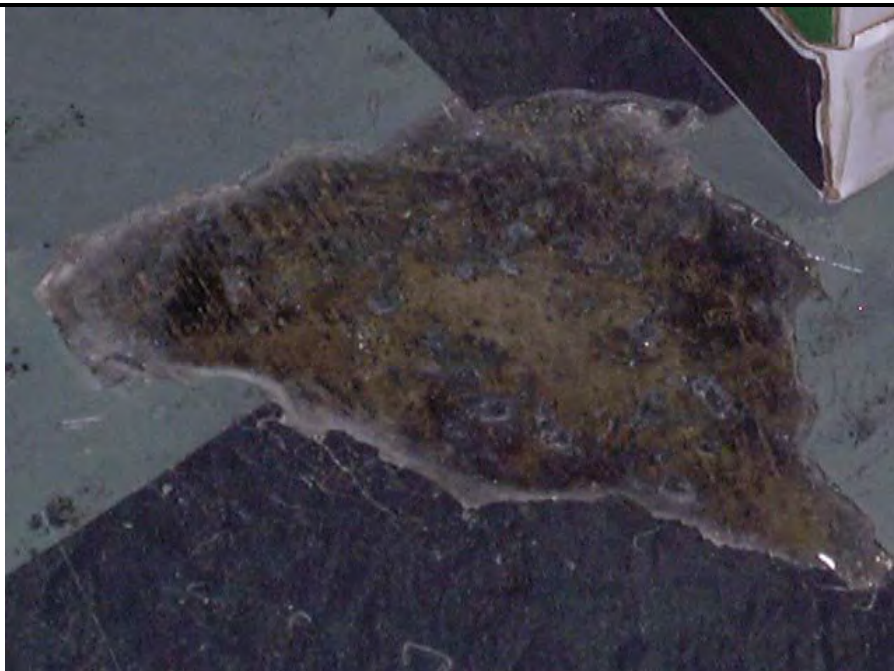
**Photo 20: 12" x 12" black vinyl floor tile/ mastic– AFRC Building Room 120
(2 Layers of Tile is positive for Asbestos, 2 Layers of Mastic is positive for Asbestos)**

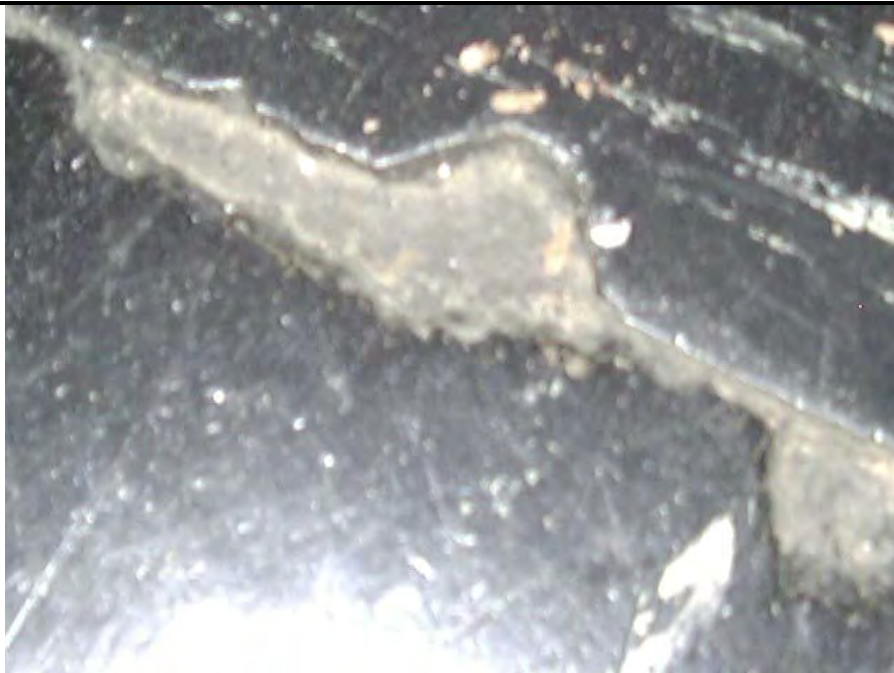
Photo 21: 9" x 9" black vinyl floor tile/ mastic– AFRC Building
(Tile is Non-ACM, Mastic is positive for Asbestos)

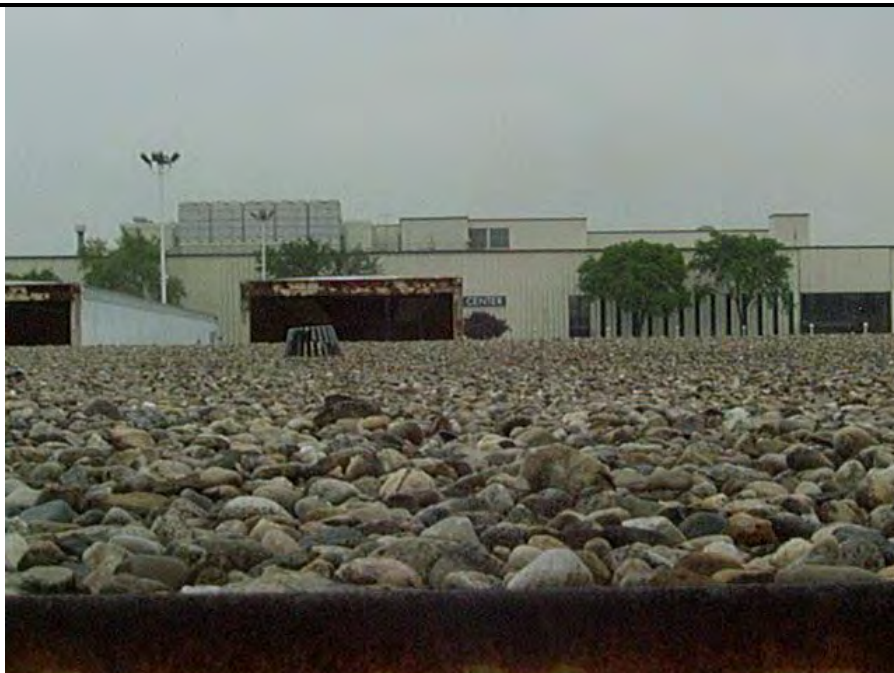
Photo 22: Roofing material - OMS Building (Non-ACM)

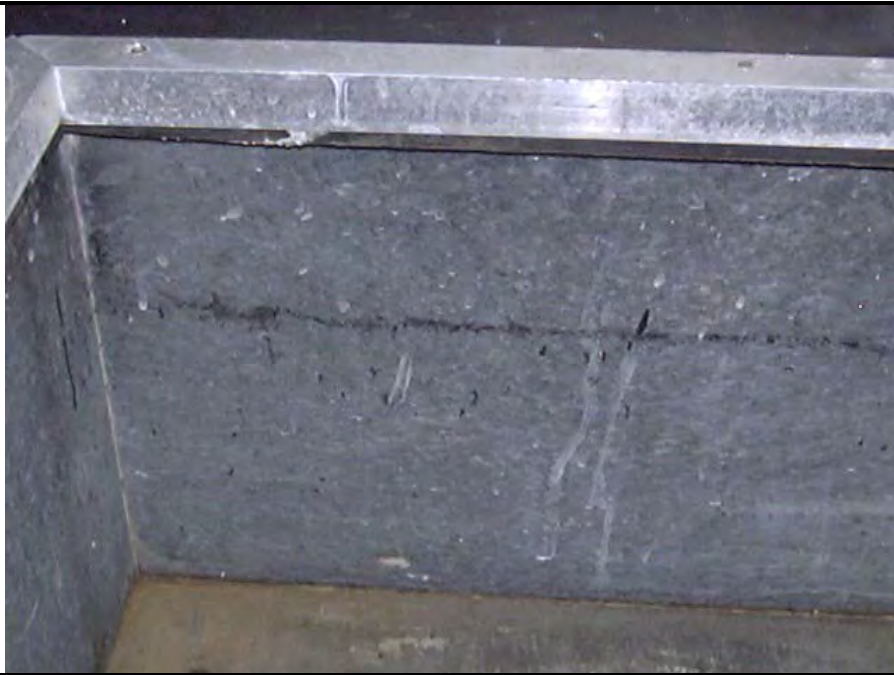
Photo 23: Transite sink- AFRC Building Room 261 (Presumed ACM)
