Appendix A

Engineering

Savannah Harbor Expansion Project (SHEP),
Georgia and South Carolina, Fish Passage at
New Savannah Bluff Lock and Dam (NSBLD)
Post-Authorization Analysis Report and
Environmental Assessment

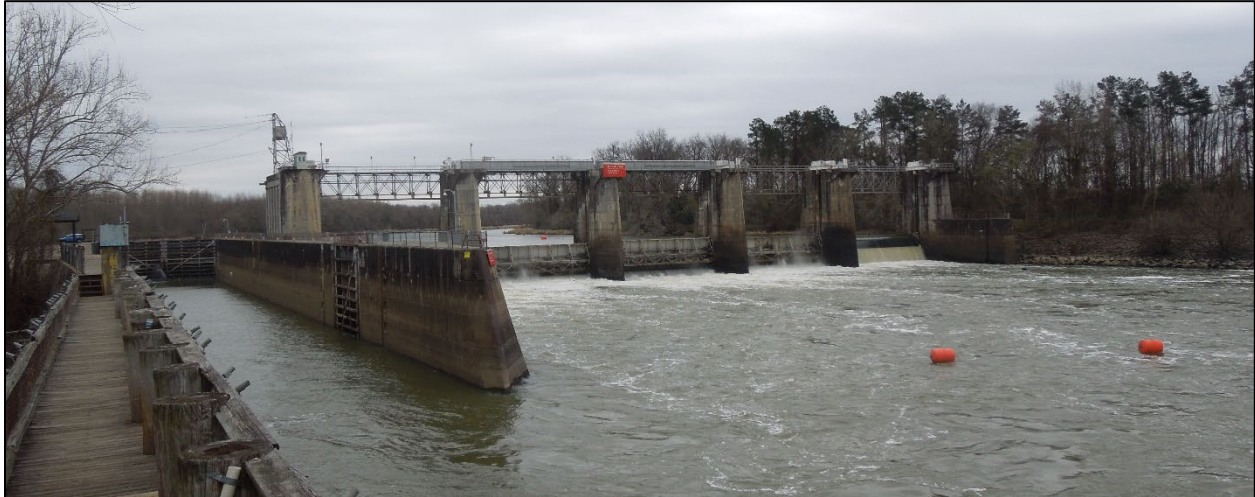
Figure 1 - New Savannah Bluff Lock and Dam - viewpoint looking upstream from the Georgia side.

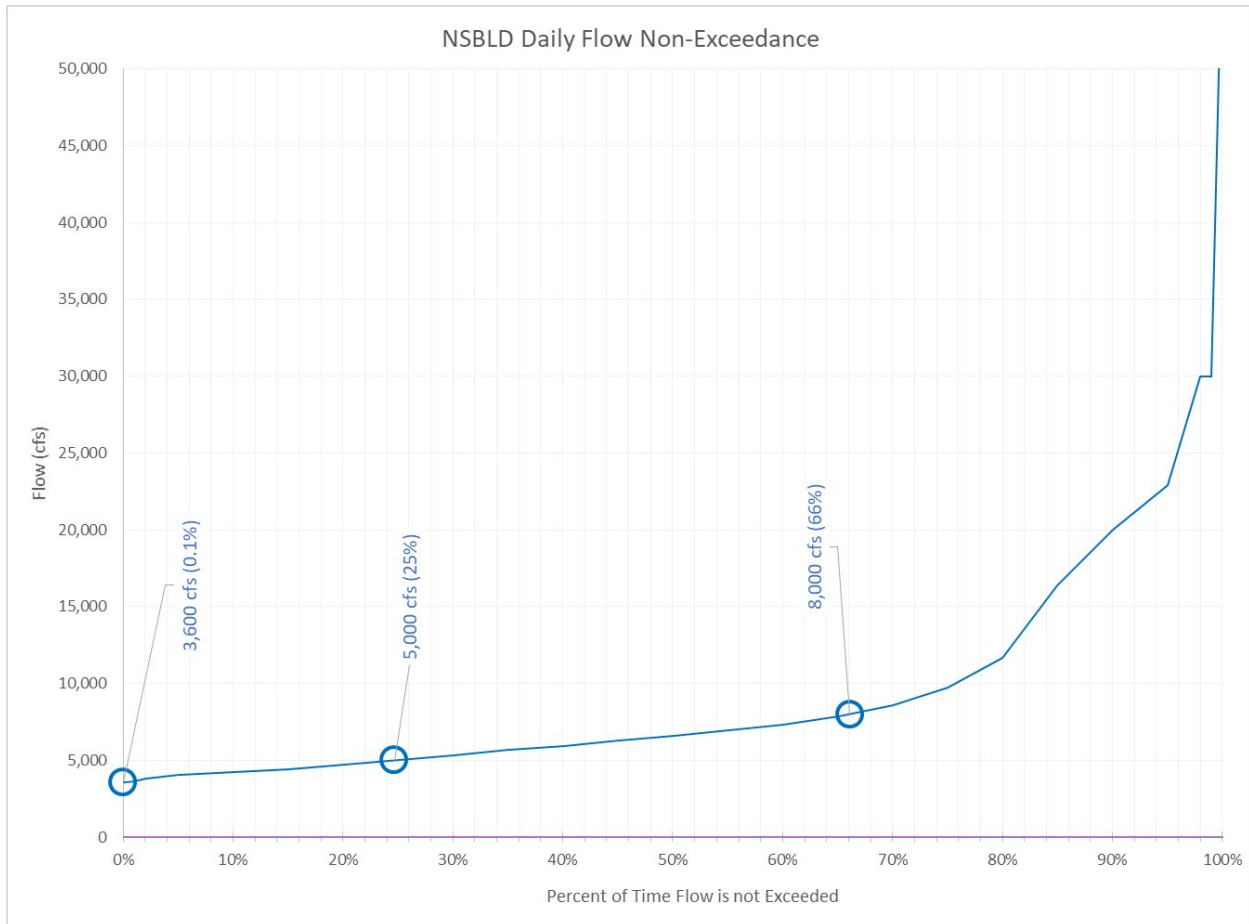
Figure 7 - Flow Non-Exceedance at New Savannah Bluff Lock and Dam

8,000 cfs was also used in the basis of design for the 2014 SHEP Fish Passage Mitigation Feature discussed elsewhere in this report. The results of the statistical analysis showing the non-exceedance probability for various flow levels at NSBLD are shown in Figure 7 below. The non-exceedance probability, for average daily flows, means that for a certain percentage of time over the observed period of record, mean daily flow values do not exceed that threshold value. For example, over the period of record flow in the river did not exceed 5,000 cfs 25 percent of the time.

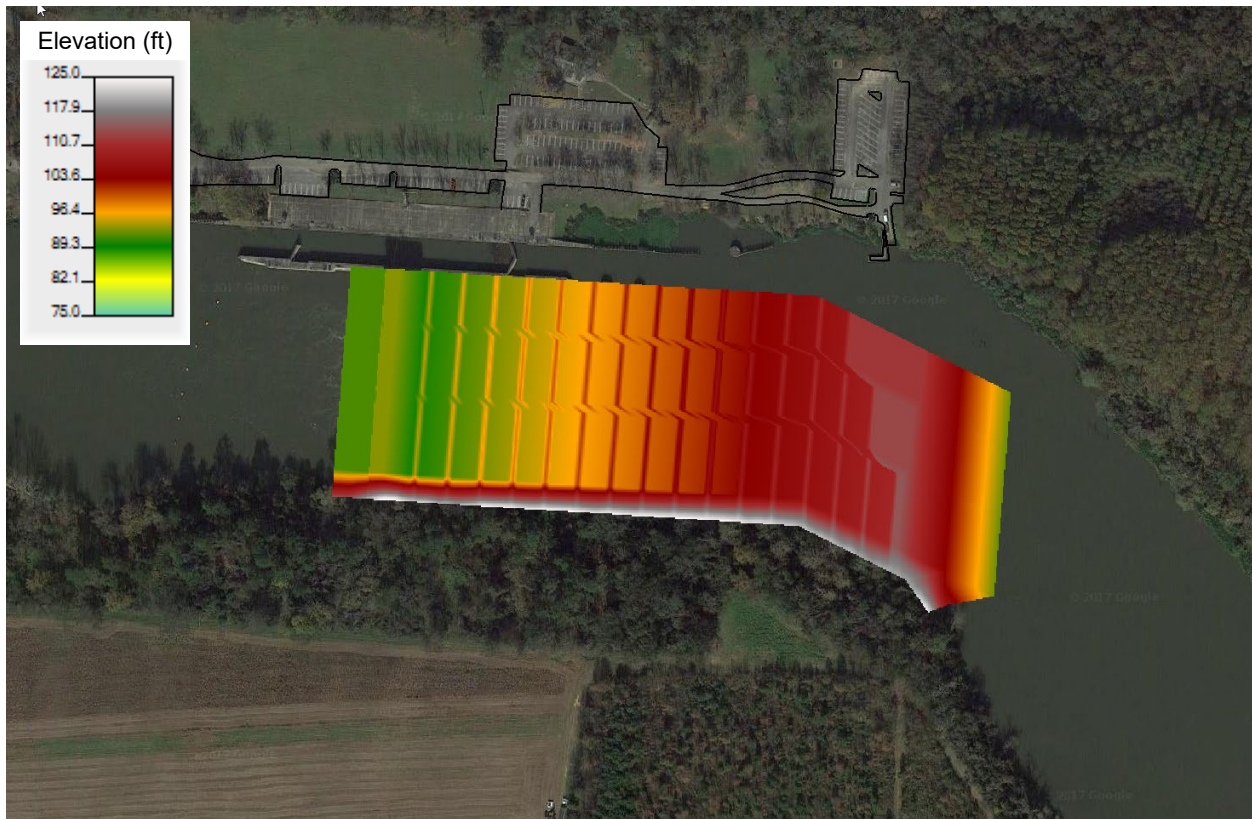
Figure 10 - Alternative 1-2 Layout

A schematic of the general site configuration and terrain model used for this alternative can be found in Figure 10 below. This alternative would lower the normal pool elevation near the lock and dam by 1.2 feet, with the impacts attenuating as you move upstream. The pool at 5th St. Bridge would be around elevation 113.5 NAVD 88 (0.8 feet lower than existing) during normal flow conditions (5,000 cfs).

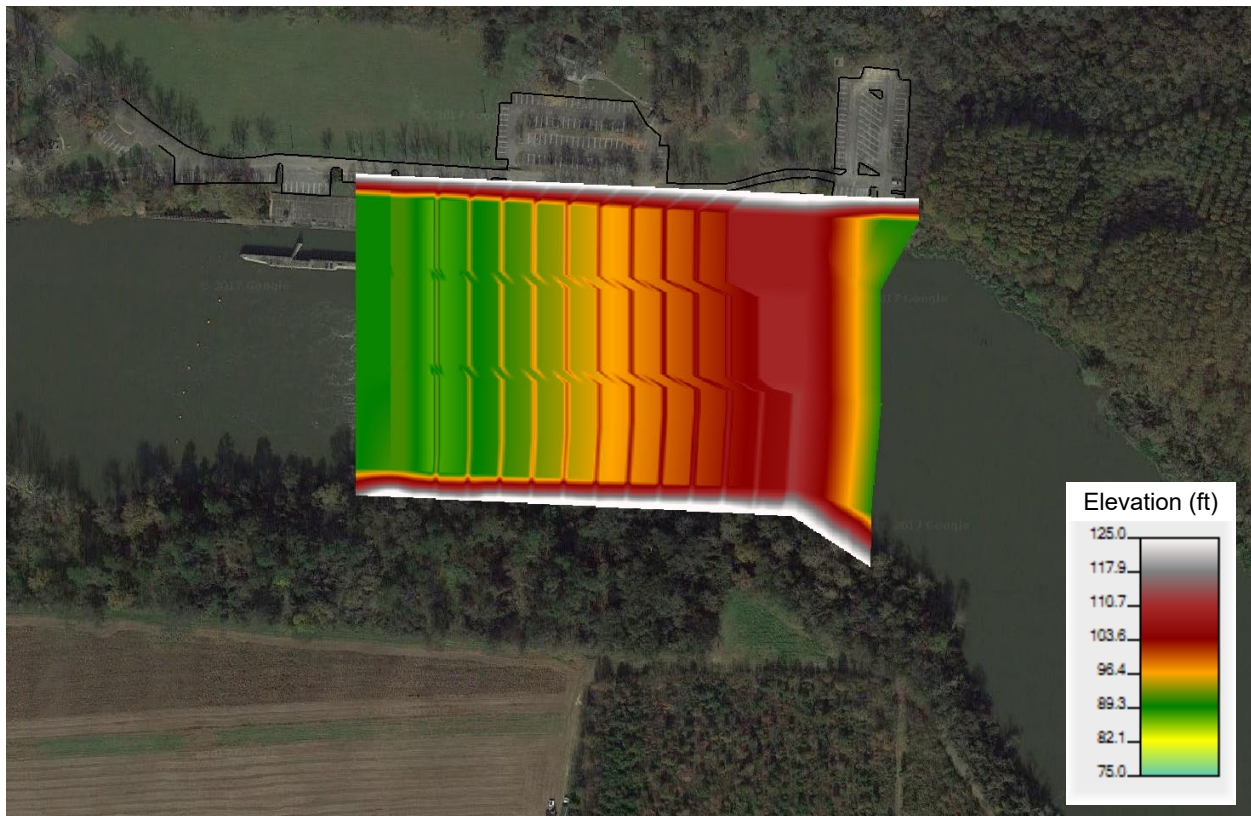
Figure 11 - Alternative 2-1 Layout

with a crest 500' in length will then be placed upstream of the existing dam location, sloping 2% upstream to the ultimate weir crest elevation of 104.2 NAVD 88 (105 feet NGVD 29). Several alternatives follow this configuration and vary only in the weir crest elevation. The weir crest is in a terraced configuration with the thalweg located on the north side of the weir. The terrain model and 2D mesh were modified to incorporate the rock ramp structure into the HEC-RAS model geometry. A manning's n region was created for the area of the rock ramp and an n value of 0.08 specified, in accordance with the procedure used in the 1D model.

A schematic of the general site configuration and terrain model used for this alternative can be found in Figure 11 below.

This alternative would lower the normal pool elevation near the lock and dam by 6 feet, with the impacts attenuating as you move upstream. The pool at 5th St. Bridge would be around elevation 111.3 NAVD 88 (3.0 feet lower than existing) during normal flow conditions (5,000 cfs).

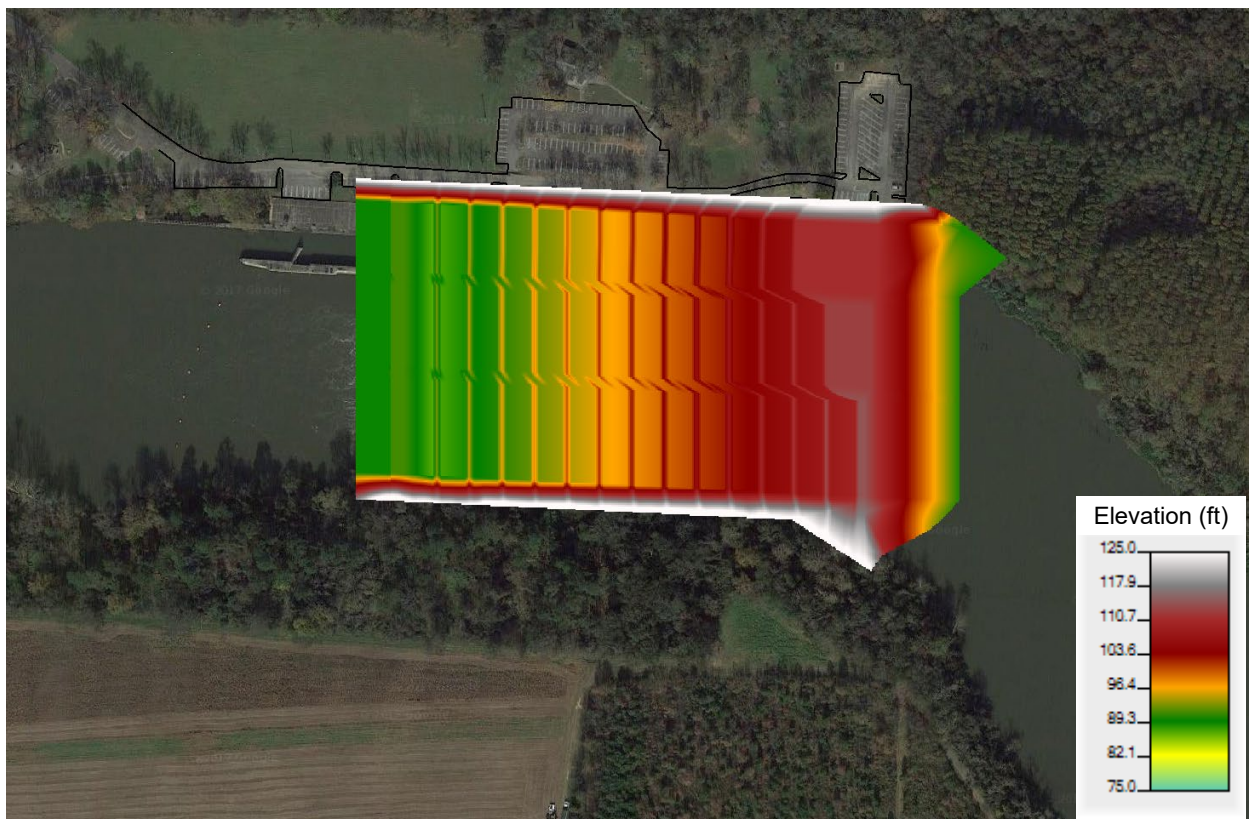
Figure 13 - Alternative 2-3 Layout

This alternative includes the removal of both lock walls, removal of dam gates and piers, and partial demolition of the dam foundation to elevation 91.2 NAVD 88. A rock ramp 500' in width will then be placed on the upstream side of the dam, sloping 2% upstream to the ultimate weir crest elevation of 106.2 NAVD 88 (107 NGVD 29). The weir crest for this alternative is in a terraced configuration, with the thalweg located on the north side of the weir. The terrain model and 2D mesh were modified to incorporate the rock ramp structure into the geometry. A manning's n region was created for the area of the rock ramp and an n value of 0.08 specified, in accordance with the procedure used in the 1D model. A schematic of the general site configuration and terrain model used for this alternative can be found in Figure 13 below.

This alternative would lower the normal pool elevation near the lock and dam by 4.8 feet, with the impacts attenuating as you move upstream. The pool at 5th St. Bridge would be around elevation 111.6 (NAVD 88) (2.7 feet lower than existing) during normal

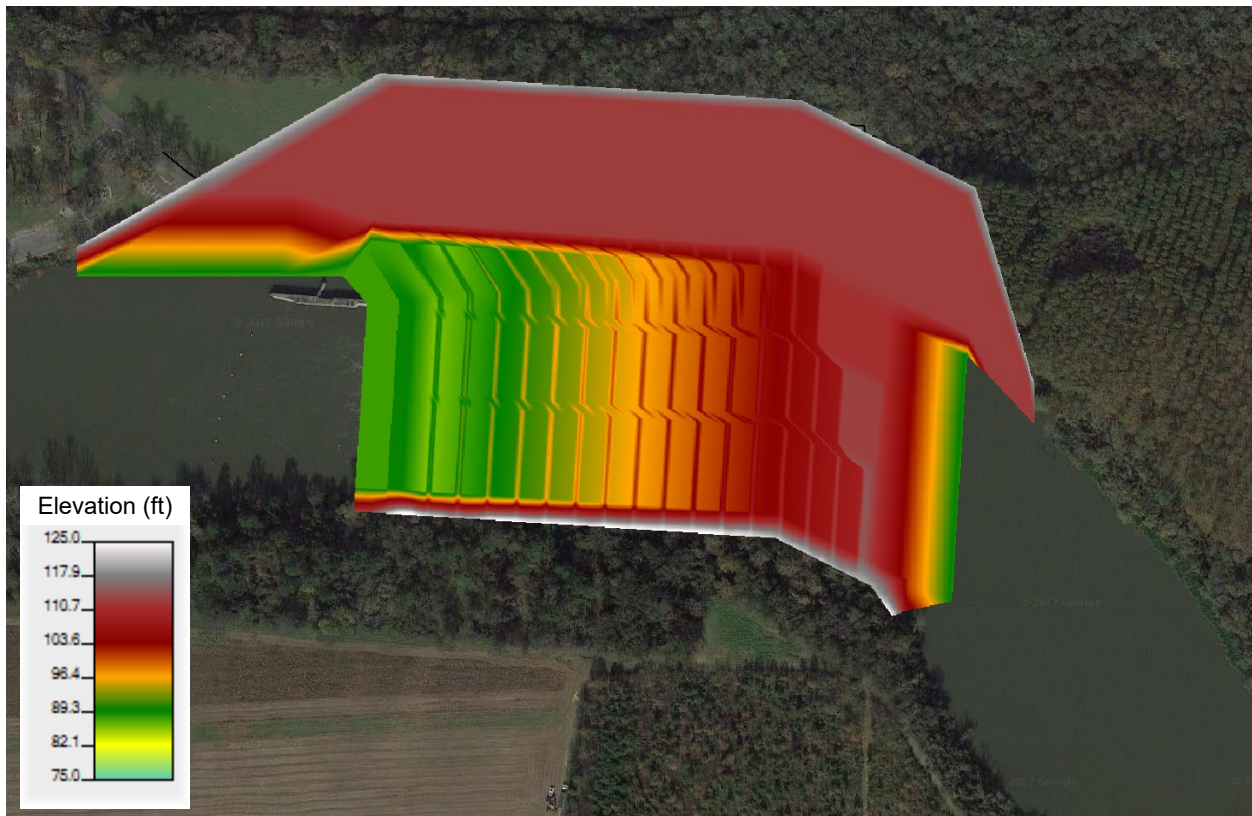
Figure 16 - Alternative 2-6A Layout

2.3.12. Fixed Crest Weir at elevation 110 with Floodplain Bench (Alternative 2-6A)
Alternative 2-6A consists of a fixed crest weir with a rock ramp sloping upstream from the existing dam location and a low-lying floodplain bench in the right overbank to

provide additional flow conveyance. The lock and dam would be removed, including the foundation down to elevation 91.2 NAVD 88. The weir would be 500 feet in width with an average crest elevation of 109.2 feet NAVD 88 (110.0 NGVD 29). A floodplain bench approximately 275 feet in width would be excavated down to elevation 110 NAVD 88 (approximately 1.8ft higher than the adjacent rock-ramp terrace) on the Georgia side of the existing dam location. The bench would ease the passage of flood waters past that point in the river. The bench was modeled as grass-lined in the HEC-RAS model to provide a hydraulically efficient flow area; though paving may be required to prevent erosion. A schematic of the general site configuration and terrain model used for this alternative can be found in Figure 16 below.

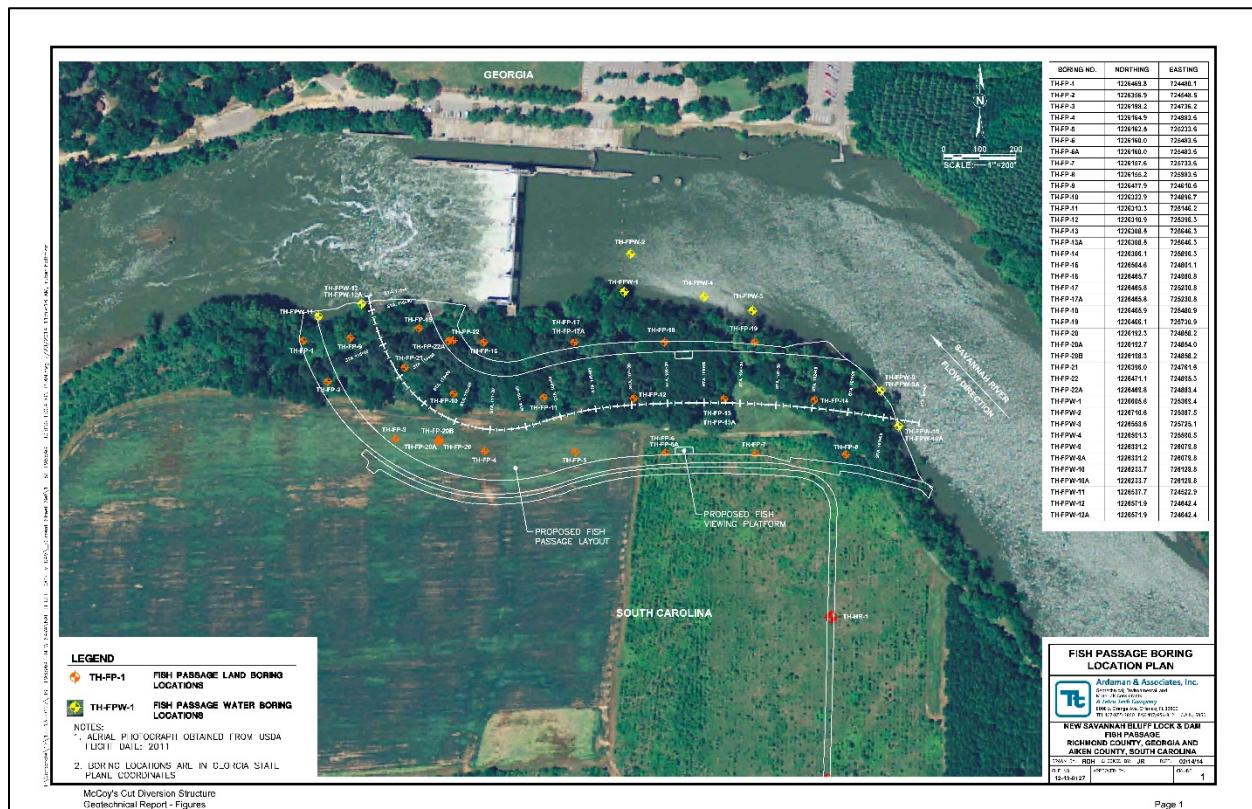
Figure 32 - Fish Passage Boring Locations (2014)

The drilling program was conducted in November 2012 and February 2013 by Ardaman & Associates, Inc., a Tetra Tech Company. Laboratory testing of samples collected was conducted at their office laboratory in Orlando, FL. The area investigated focused largely on the South Carolina bank where the proposed fish passage structure and associated haul roads would be constructed (Figure 32). There were 6 water boring locations and 5 land boring locations that are applicable to the in-stream rock weir design. However, they are all located along or adjacent to the southern bank (South Carolina). There are no other borings available that would lend more information on what might be encountered on the northern bank (Georgia). As part of this effort 53 Standard Penetration Test (SPT) borings were advanced to depths of 15 to 75 feet (Elevation 102.3 to 43.0 feet NAVD 88).
