STRATEGIC OPTIMIZATION TECHNICAL MEMORANDUM

Buxton Naval Facility Buxton, North Carolina FUDS Numbers I04NC000101 and I04NC000103

U.S. Army Corps of Engineers Huntsville Center Environmental and Munitions Center of Expertise 1616 Capitol Avenue Omaha, Nebraska 68102

May 2024

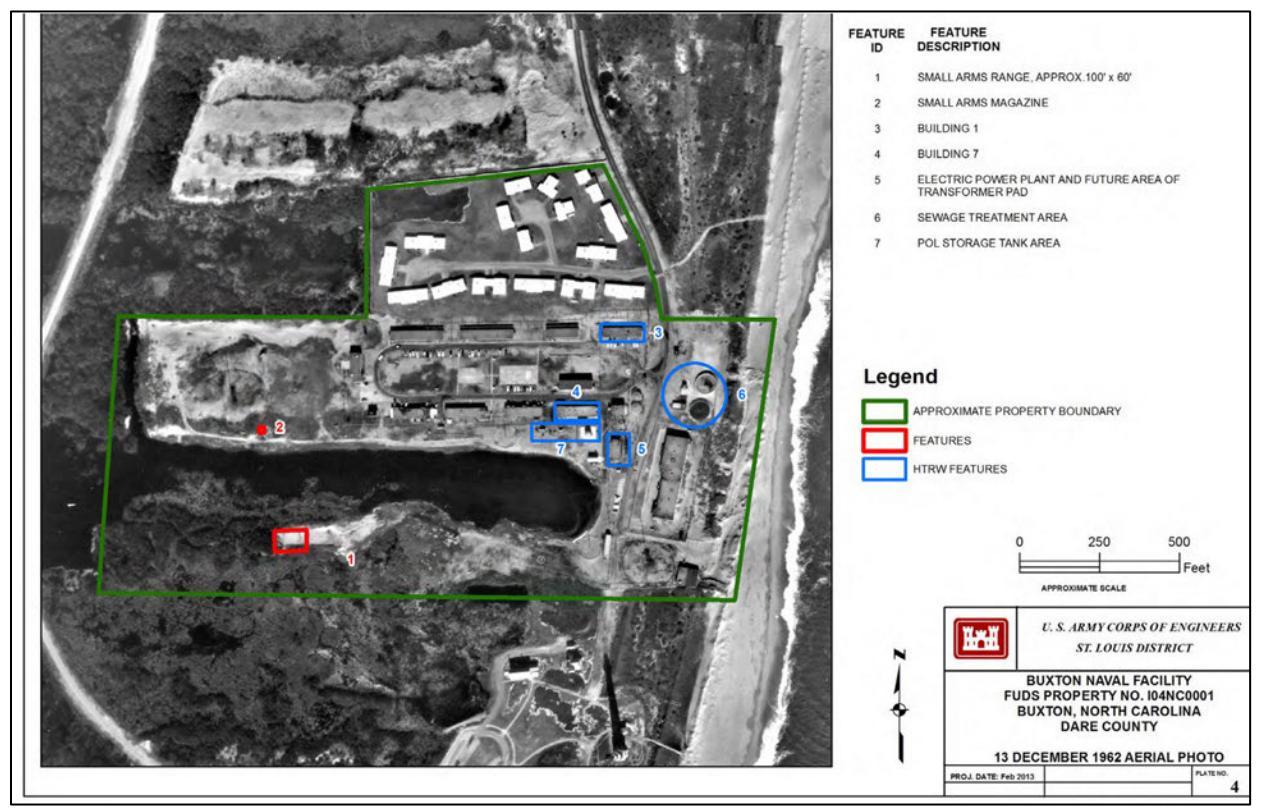
Figure 4 from the 2013 Preliminary Assessment – 1962 Aerial photo indicating Areas 4, 5, and 7.

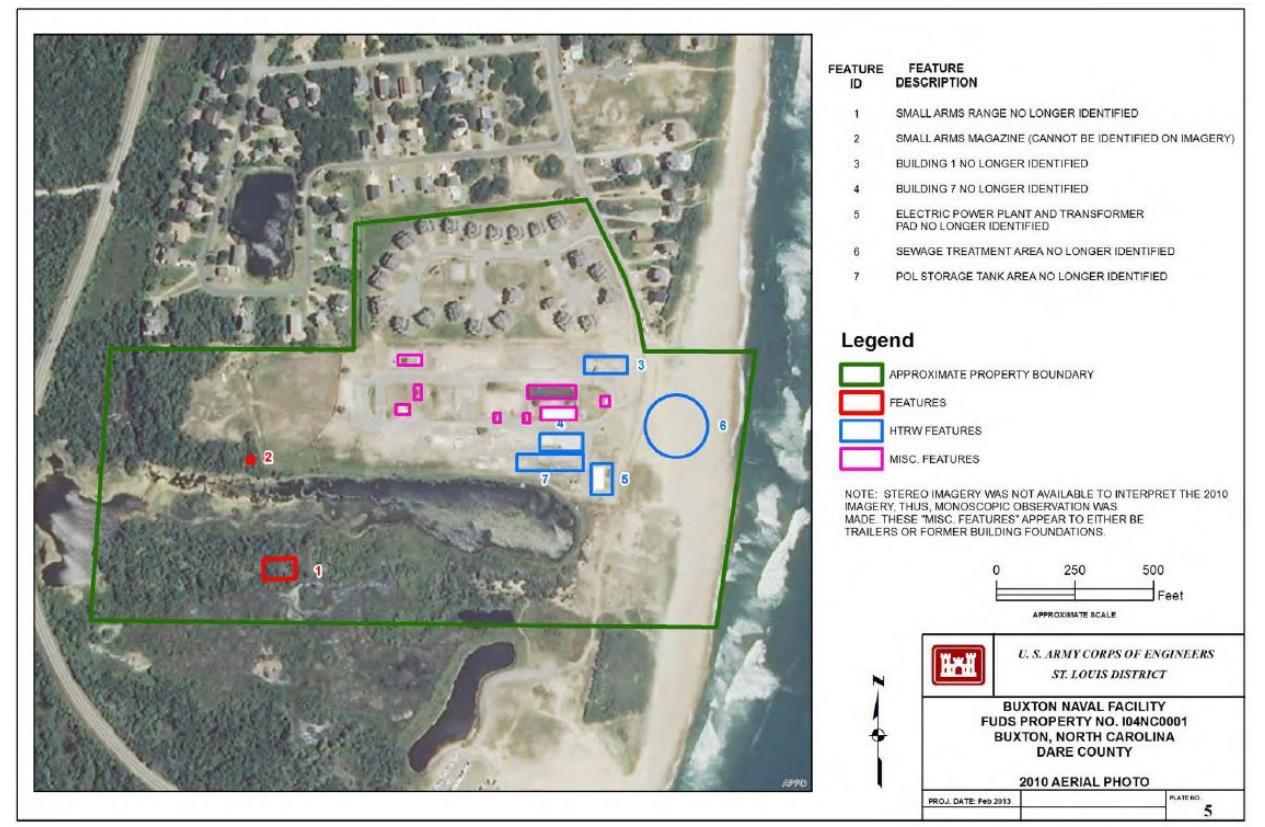
Figure 5 from the 2013 Preliminary Assessment - 2010 Aerial photo indicating Areas 4, 5, and 7.

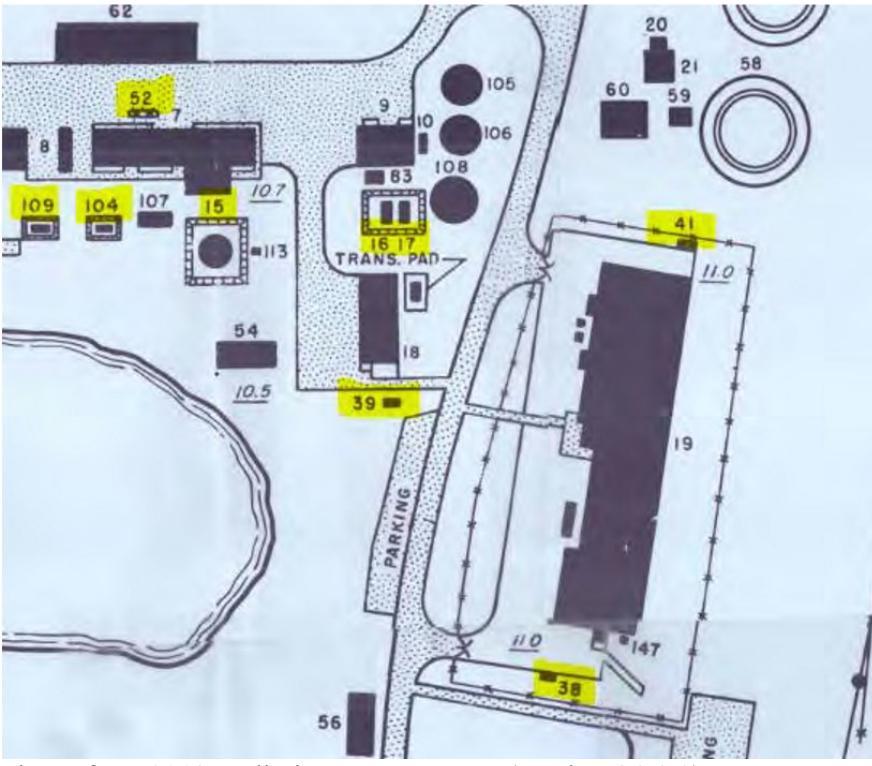
Figure from 2013 Preliminary Assessment (Section 4.2.2.2):

The petroleum, oil, and lubricants (POL) storage tanks and distribution operations at Buxton Naval Facility included a 540 BBL Diesel Oil Tank (#15), two 5,000 gallon fuel oil tanks (#16 and #17), a 1,000 gallon diesel oil tank (#38), two 2,000 gallon diesel oil tanks (#39 and #41), two motor gasoline (MOGAS) pumps (#52) at the service station, a 3,000 gallon MOGAS tank (#104), and a 1,500 gallon MOGAS tank (#109)

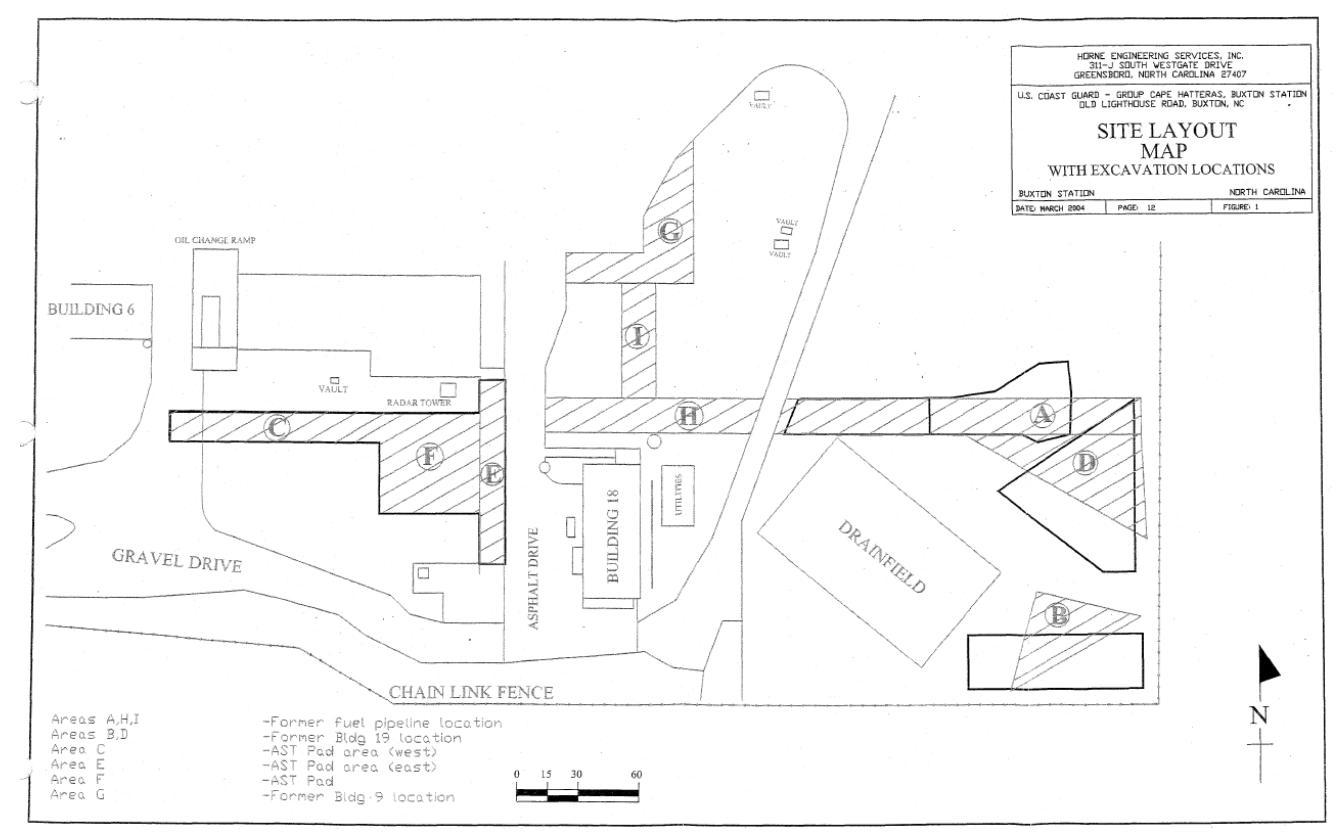
Figure 1 from 2005 Soil Cleanup Report

Some portion of the fuel distribution pipeline likely remains at the site; removal activities were limited in Areas G, H, and I (see Figure 1 excerpted from 2005 Soil Cleanup Report) due to subsurface concrete pads, utility corridors, and direct-buried utilities; and removal activities were limited vertically in Area E due to concerns related to destabilizing the adjacent road, utility damage, and impacting the Building 7 foundation. Residual petroleum contamination could remain in any of these areas. Because these areas are located near a shoreline with high rates of erosion, the areas are susceptible to surface exposure if erosion continues to progress.

- Based on the likely progression of shoreline erosion, recommend attempting to re-acquire (potentially using geophysical methods) any fuel distribution pipeline that may have been abandoned in place during the 2000 AST/pipeline removal (see attached map, pg. 13).

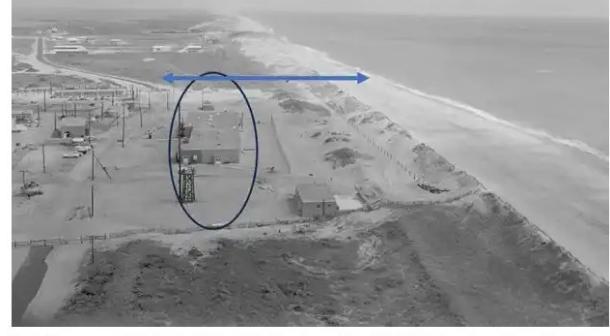
Photos from presentation by the National Park Service on March 27, 2024 show dramatic erosion. The location of buildings in the Navy Base and the current position of the tide line. Courtesy NPS

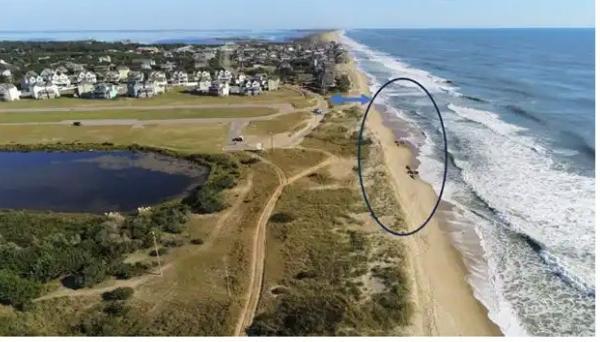
Photos from presentation by the National Park Service on March 27, 2024 show dramatic erosion. The location of buildings in the Navy Base and the current position of the tide line. Courtesy NPS

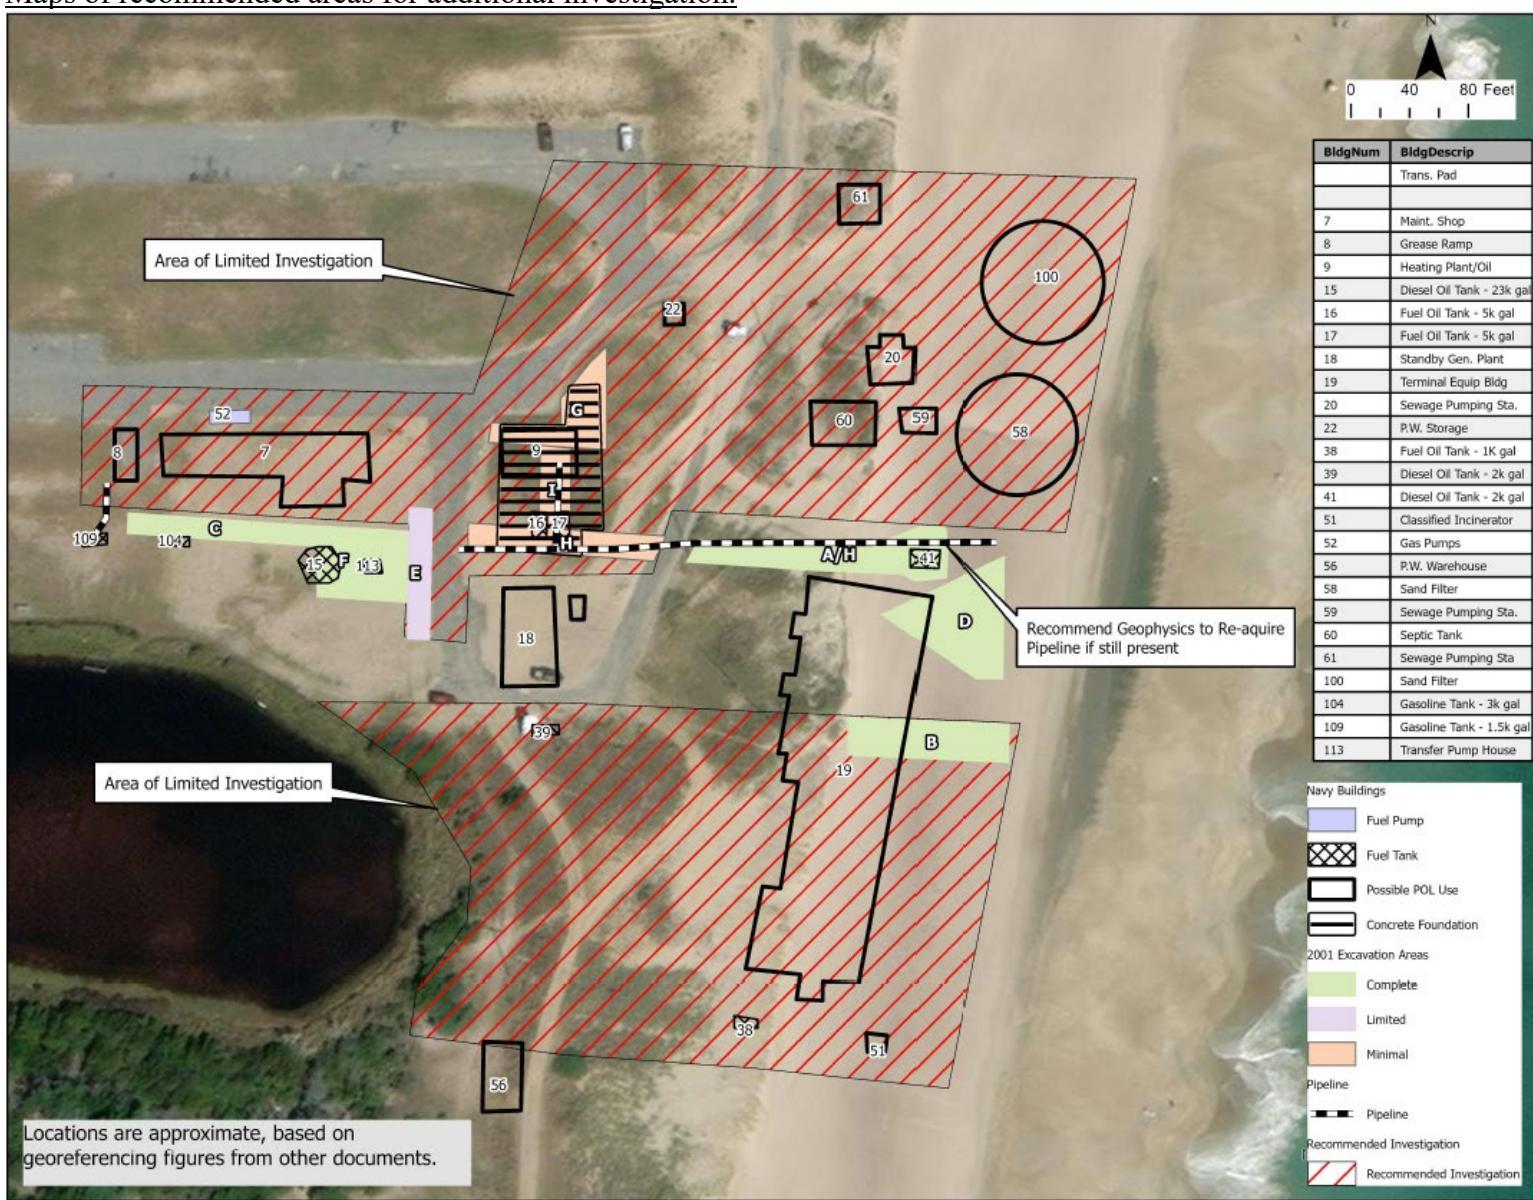
Maps of recommended areas for additional investigation.

- Institute a comprehensive soil and groundwater sampling plan, focusing on areas that have historically had less investigation work and where access (during 2004 removal activities) was limited by buildings, roads, or subsurface infrastructure (Areas E, G, H, and I, see attached figure). The southern portion of former Building 19 extending westward toward the pond is the area where the least amount of investigation has been completed historically (see attached maps, pg. 13&14).

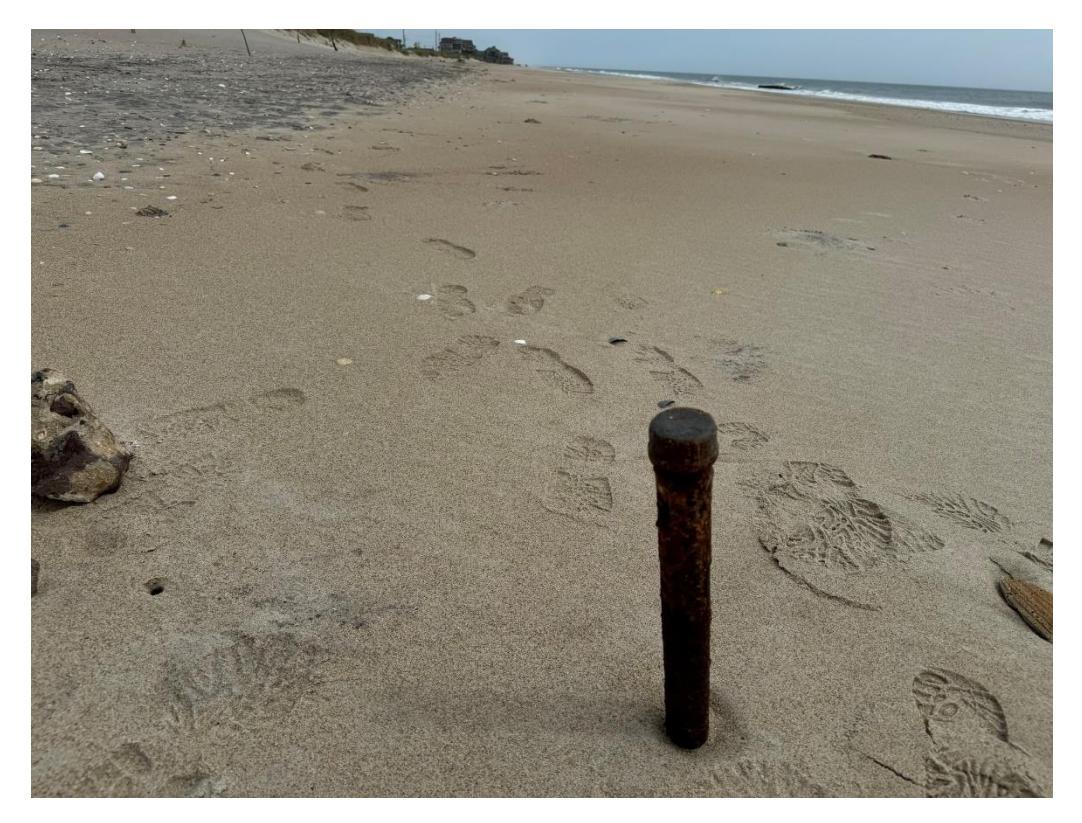
Photo 5 - Small capped metal pipe located south of FUDS site along beach

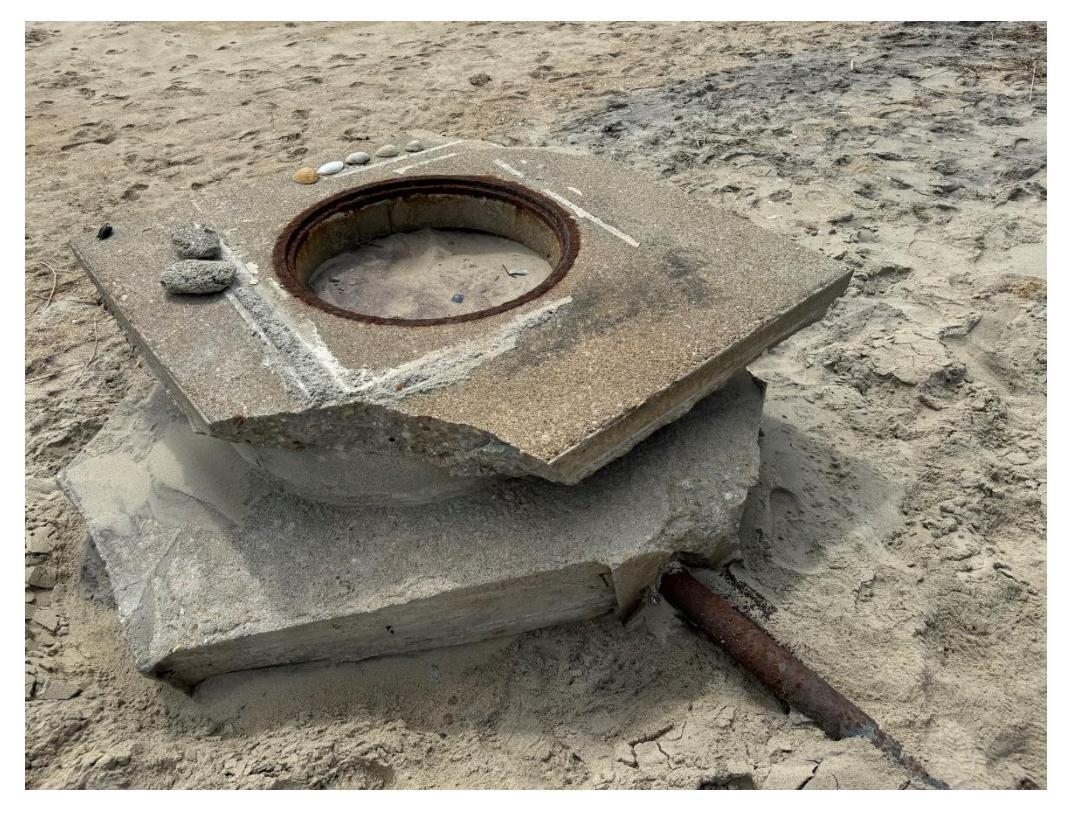
Photo 6 - Manhole structure located near southern part of former Building 19. Note two metal pipes going west from manhole.

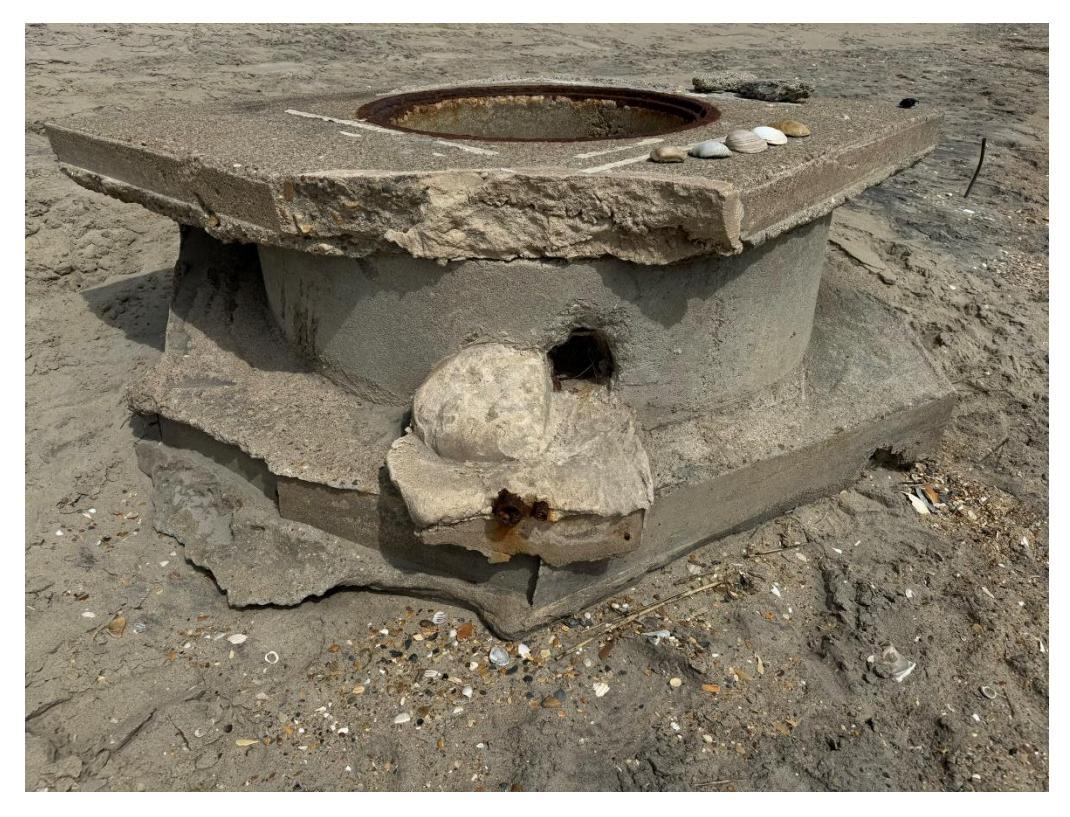
Photo 7 - Additional view of manhole structure. Two smaller pipes/conduits protruding to southeast. Smaller conduit appears to have metal cable inside.

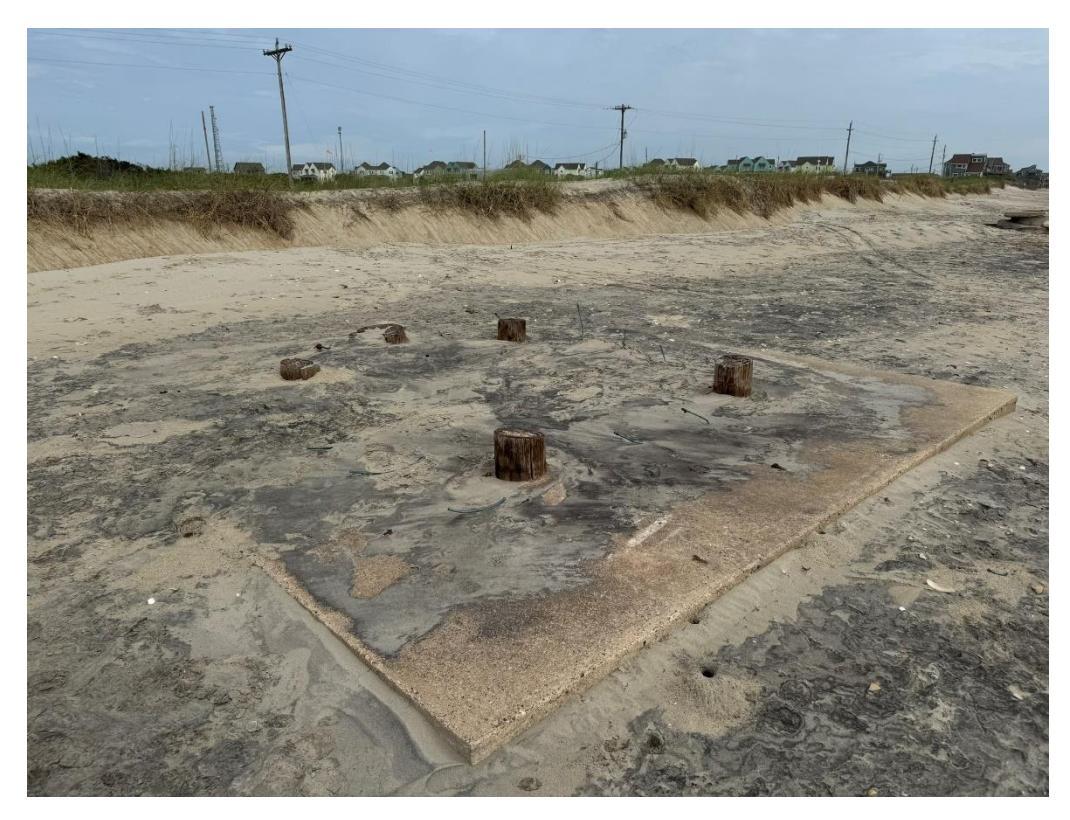
Photo 8 - Concrete pad with timber piers located south of former Building 19 and manhole structure.

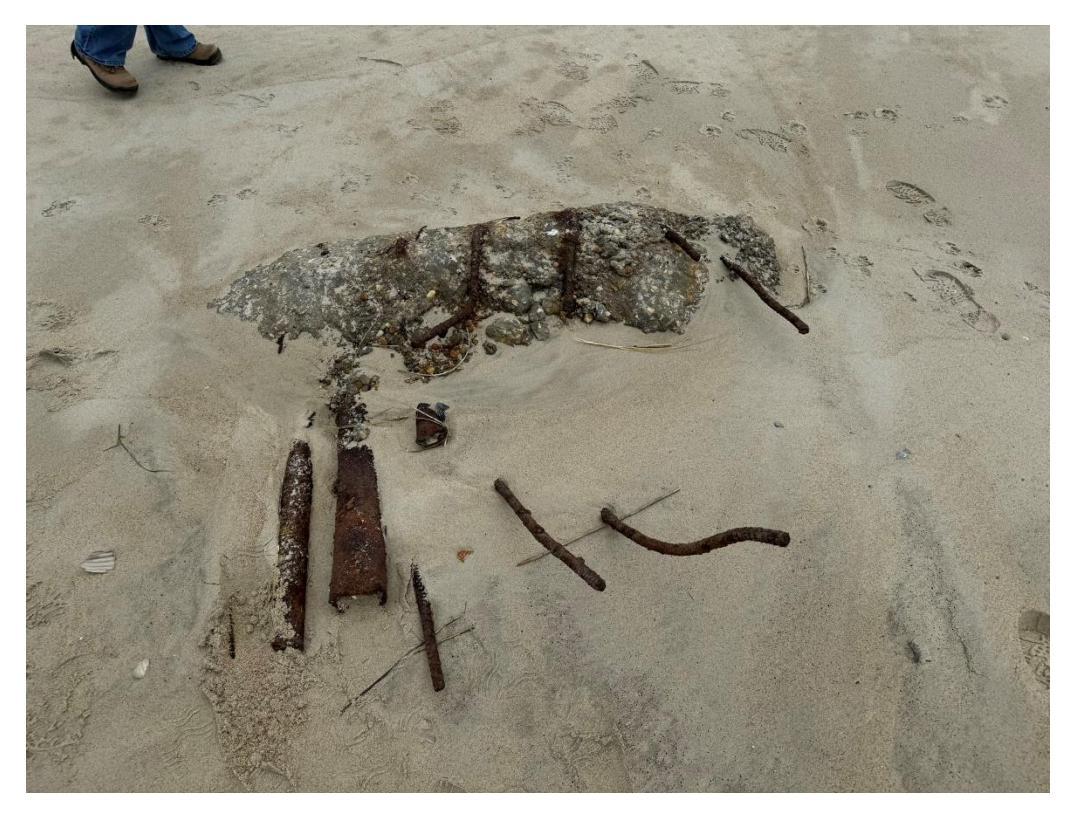
Photo 9 - One of two reinforced concrete structures located in footprint of former Building 19. Believed to be access point for submarine listening equipment to exit building toward beach/water

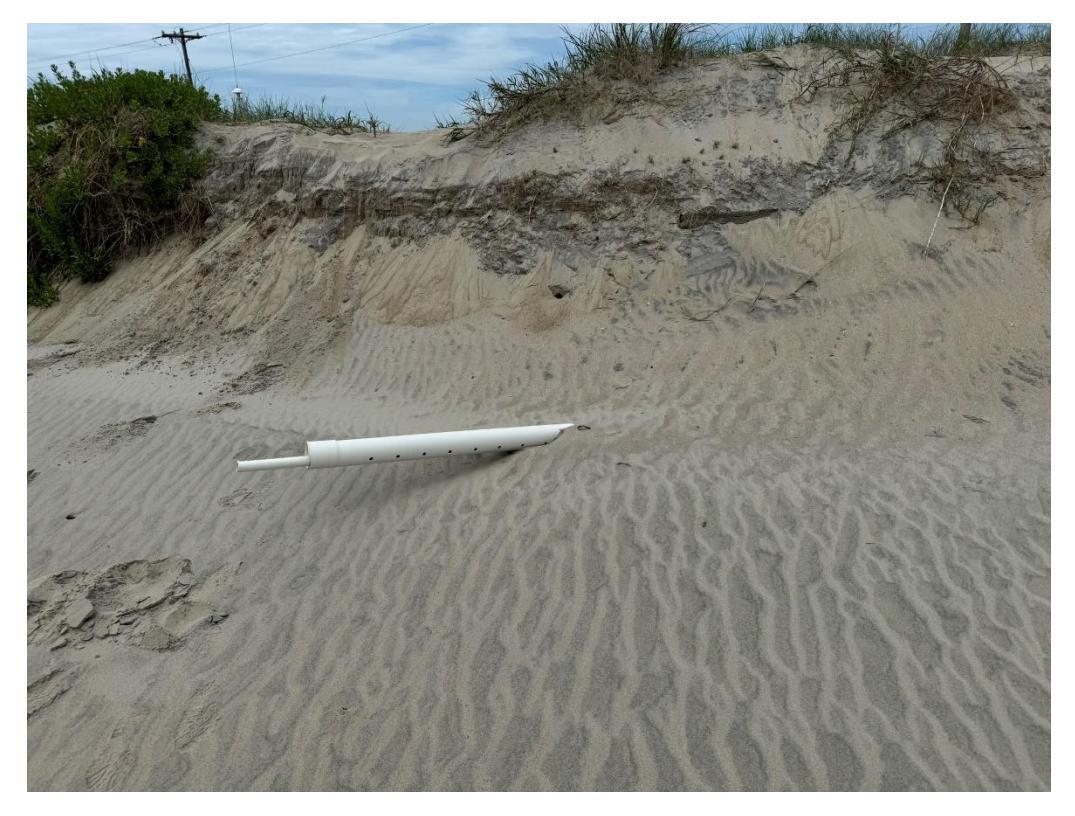
Photo 10 - Assumed sanitary leach field drain pipe located north of former Building 19.

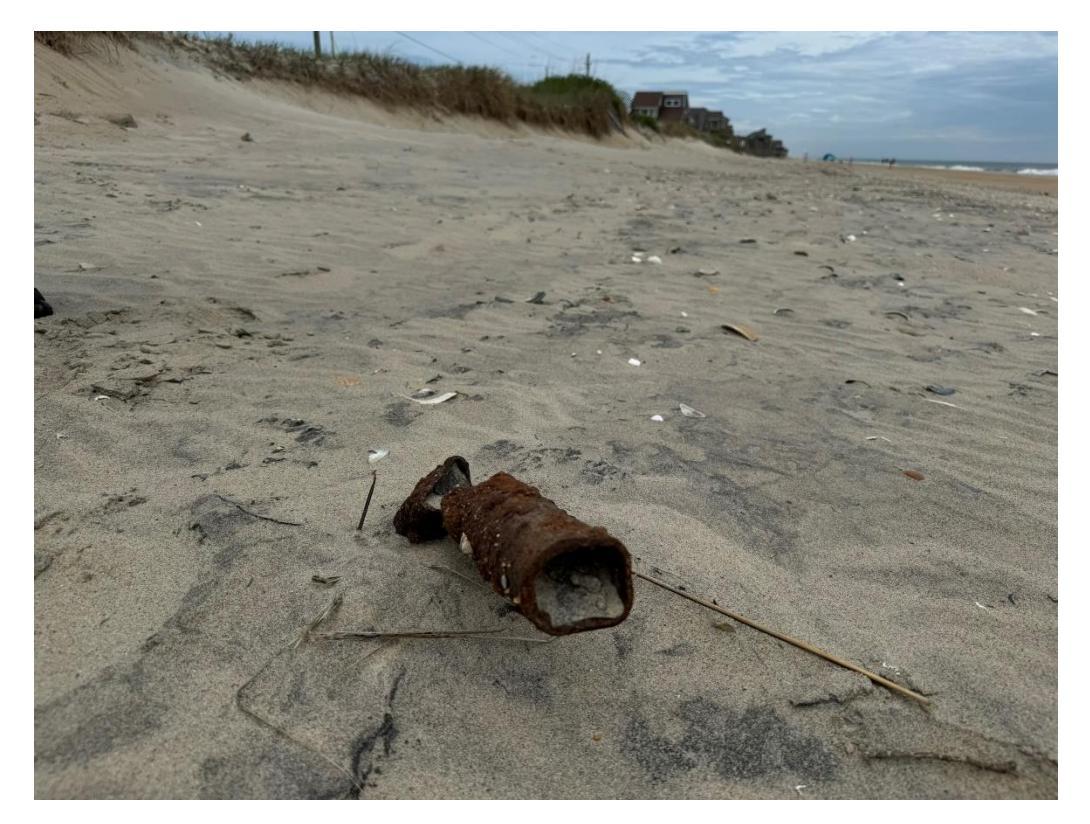
Photo 11 - Small metal pipe located on beach, north of former Building 19

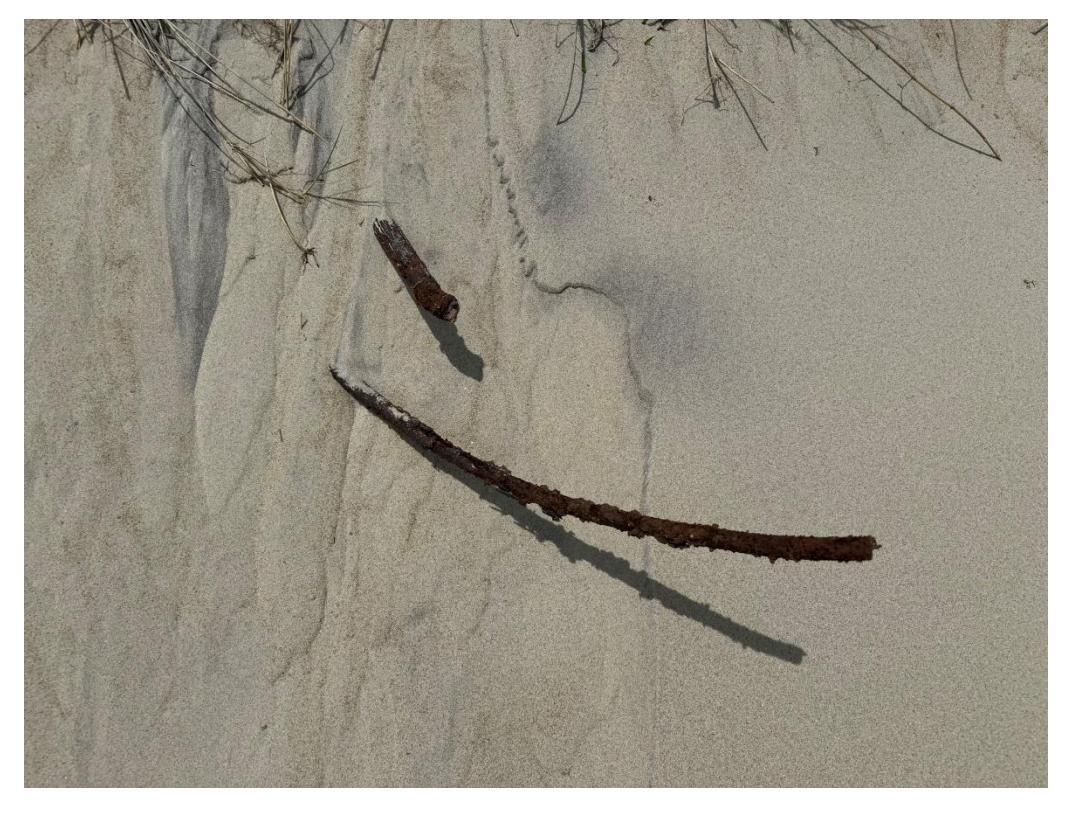
Photo 12 - Two small metal cables/conduits protruding from dune face, near north end of FUDS

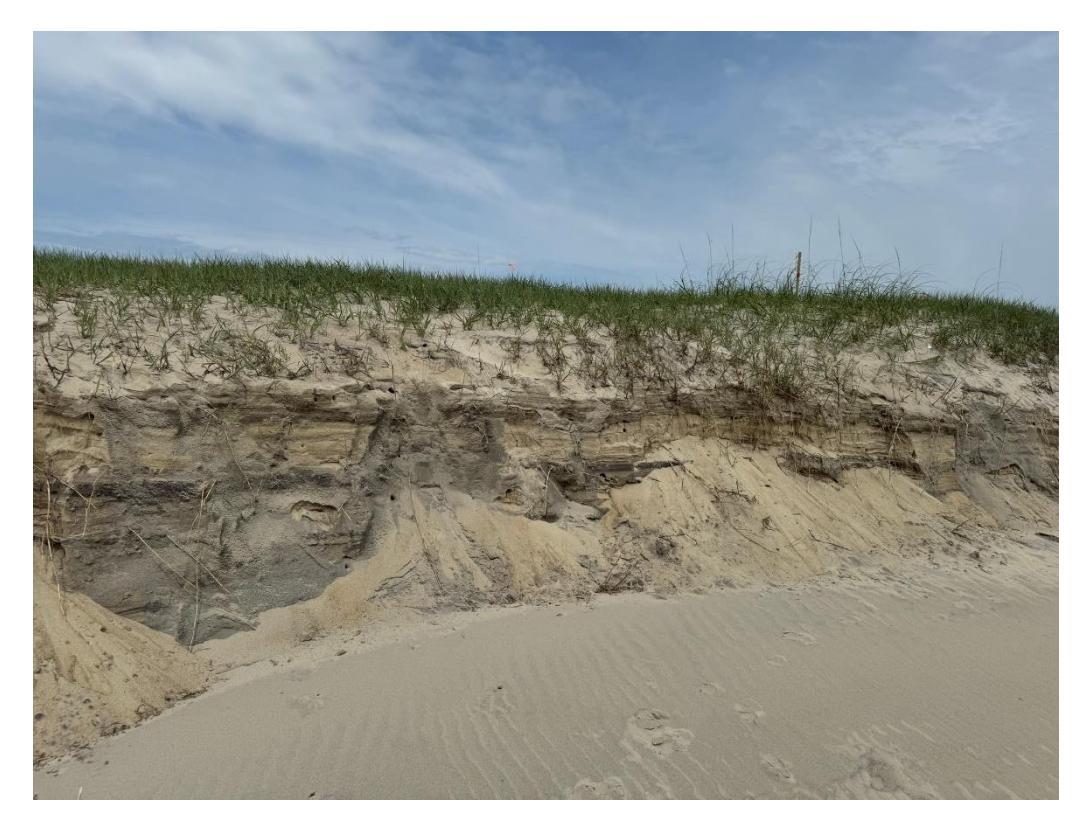
Photo 13 - Exposed dune face showing different soil layers

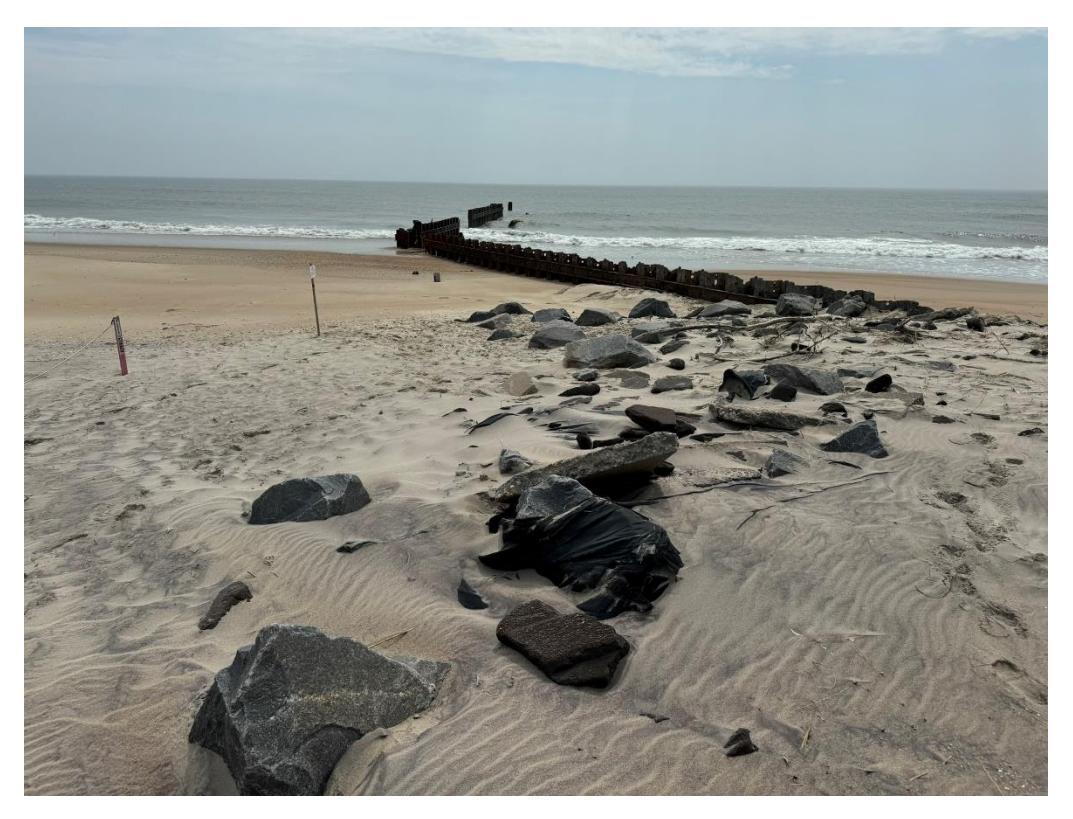
Photo 14 - Boulders and likely asphalt chunks placed on beach near southern "groin" south of FUDS

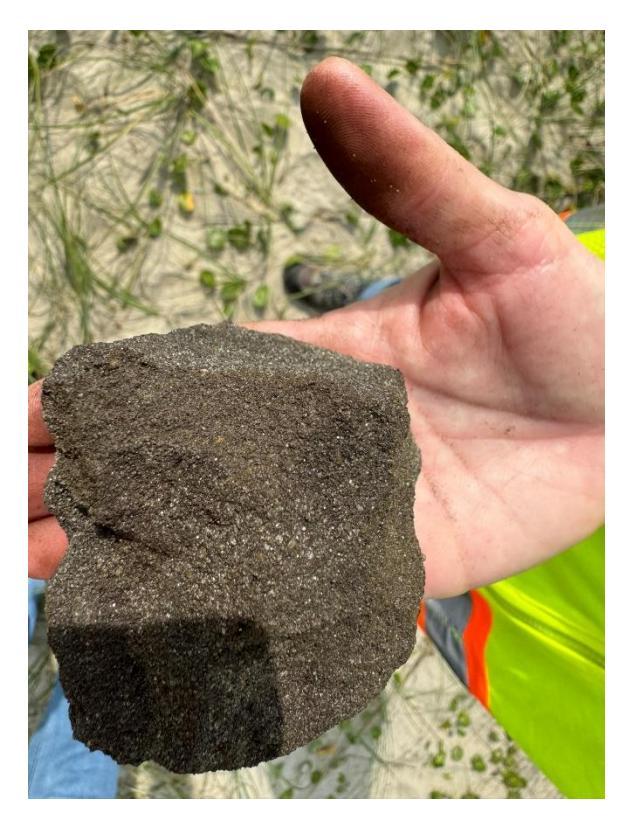
Photo 15 - Example of soil that could be considered "peat-like". This fragment found on dunes, moderately cohesive, no odor, no evidence of organics

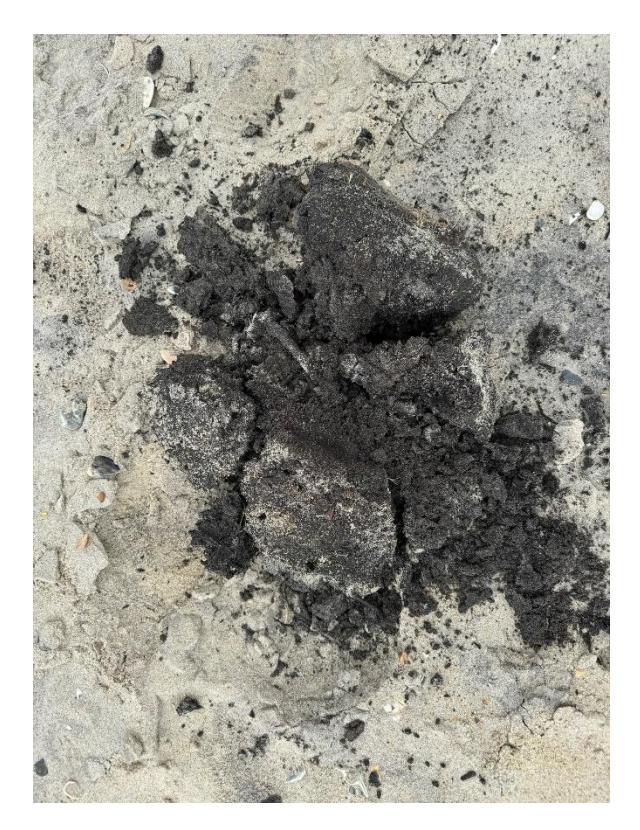
Photo 16 - Example of larger chunk of "peat-like" material found on beach near southern leach field. Material was light, friable, had visible organic material and organic odor.

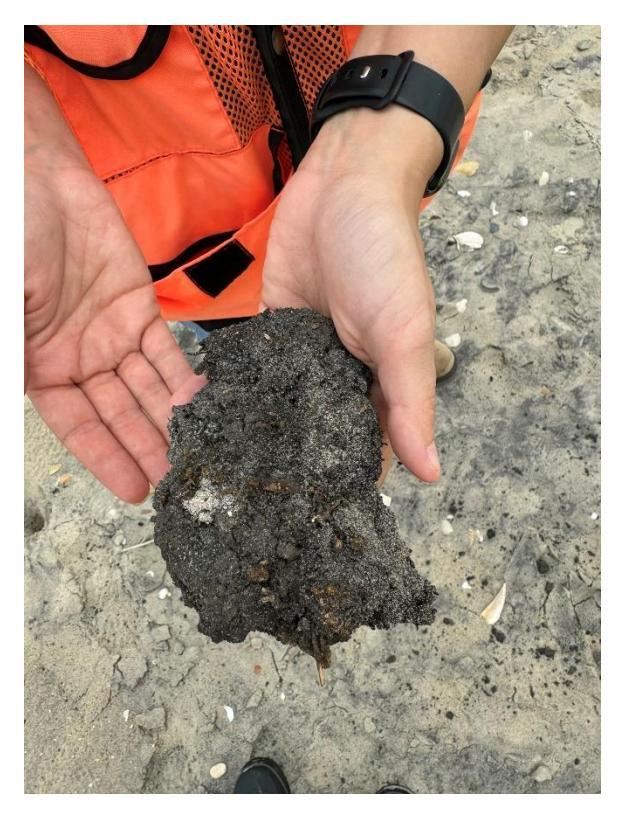
Photo 17 - Additional example of "peat-like" material on beach. Light, friable, visible organic material (wood, leaves), organic odor and possibly fuel-related odor. Some gray discoloration noted.

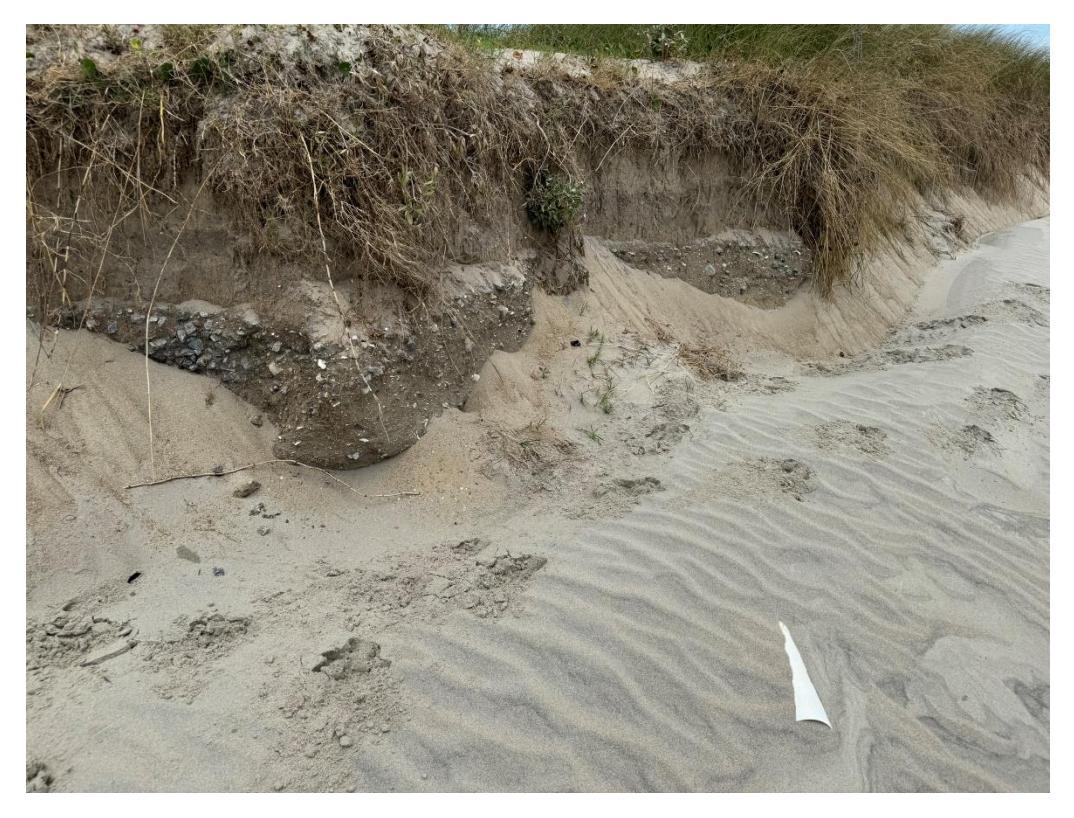
Photo 18 - Additional exposed septic leach field pipe and evidence of backfill (gravel in dune face)

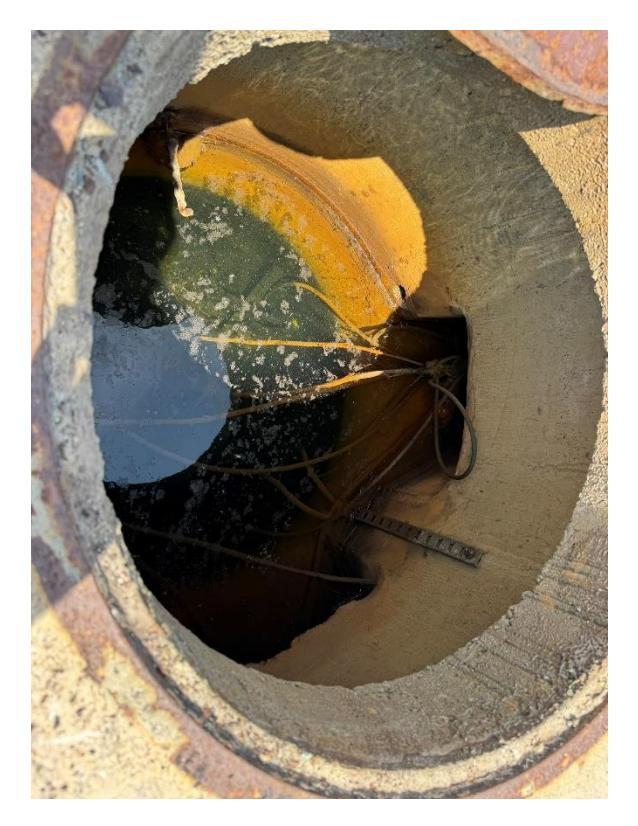
Photo 19 - One of two manholes located west of dunes, eastern/southern part of FUDS. Both contained water, no odor/sheen. Cable conduits going north-south and east-west. Assumed communication cables observed, cut-off metal pipes observed.

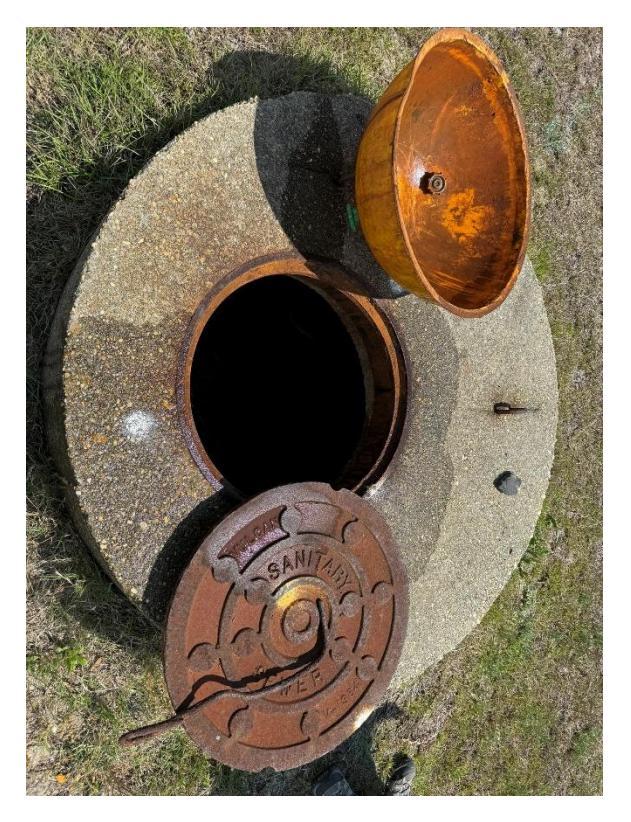
Photo 20 - One of several sanitary sewer manholes noted. Two manholes opened. No odors or sheen. One manhole had small amount of assumed groundwater baseflow

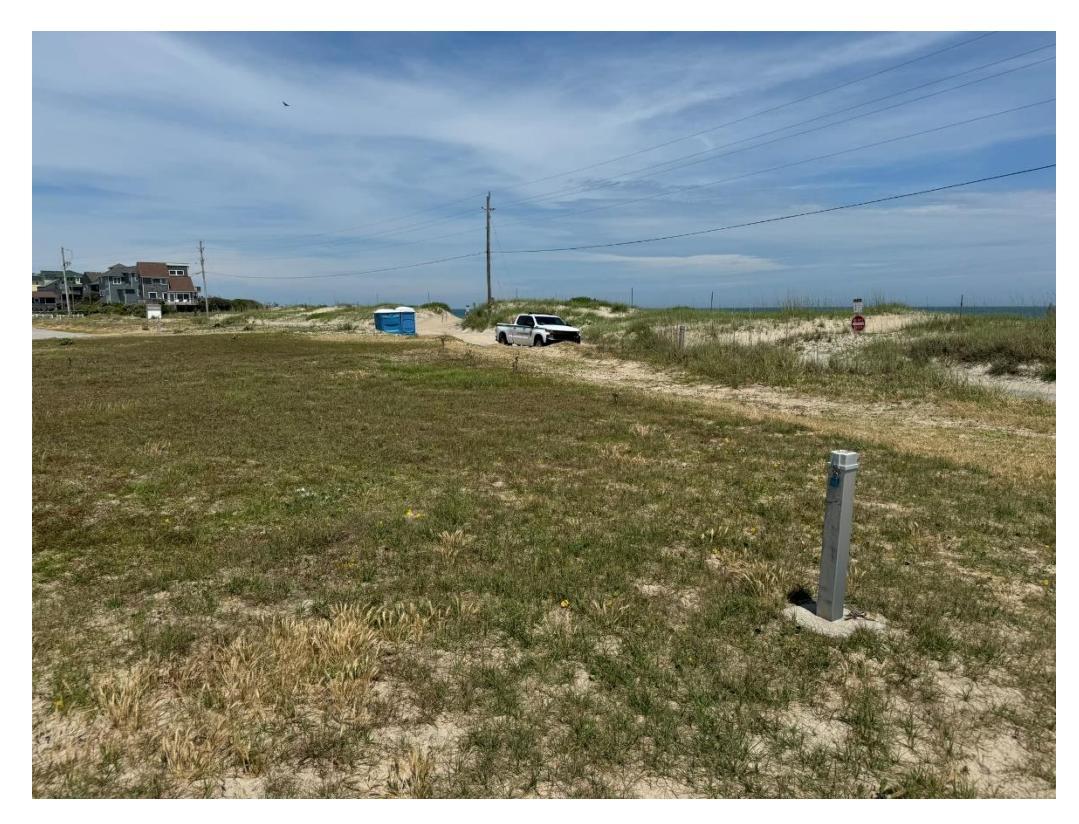
- Monitoring wells were noted on the dunes and further inland. Wells were both flush-mount and stickup type. The monitoring wells were all closed, locked, and in good condition.

Photo 22 - Representative photo of monitoring well
